Final Report

Lower George River Investigation

Lower George Riverworks Trust

June 2018

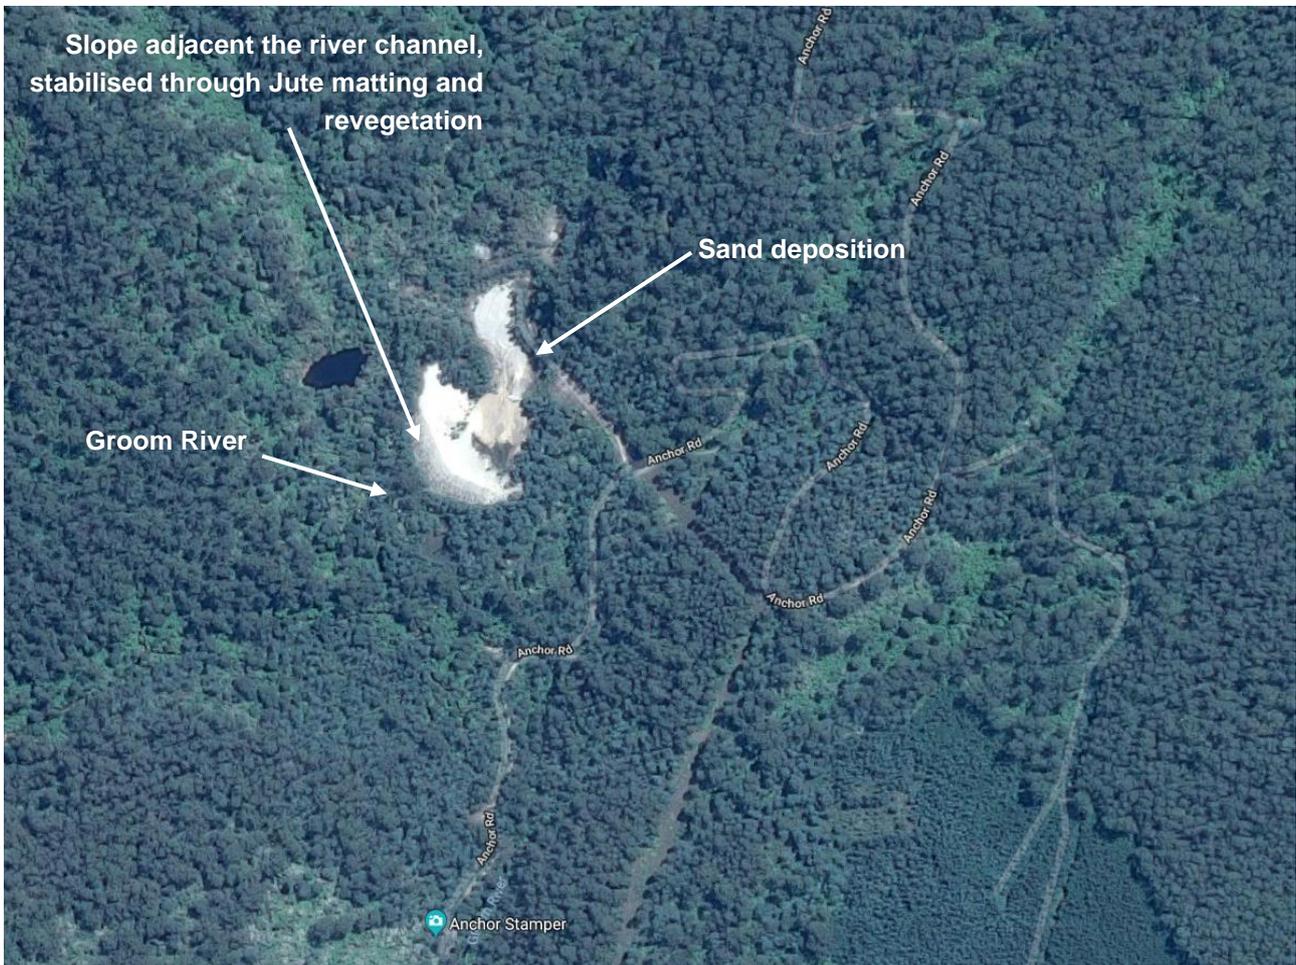
An inspection of a large sand mass at the Anchor Mine (Figure 2-1, Figure 2-2 and Figure 2-3) revealed that the sediment immediately adjacent the waterway has been stabilised through jute matting and revegetation works (Figure 2-1 and Figure 2-4). An inspection of the waterway immediately downstream found no indication that this sediment stockpile at the mine is a current source of sand to the river system (Figure 2-5). However, failure of these works during a catastrophic event is likely to introduce very large volumes of sand into the system.

FIGURE 2-1 GOOGLE MAPS IMAGE OF THE ANCHOR MINE SAND DEPOSITS.

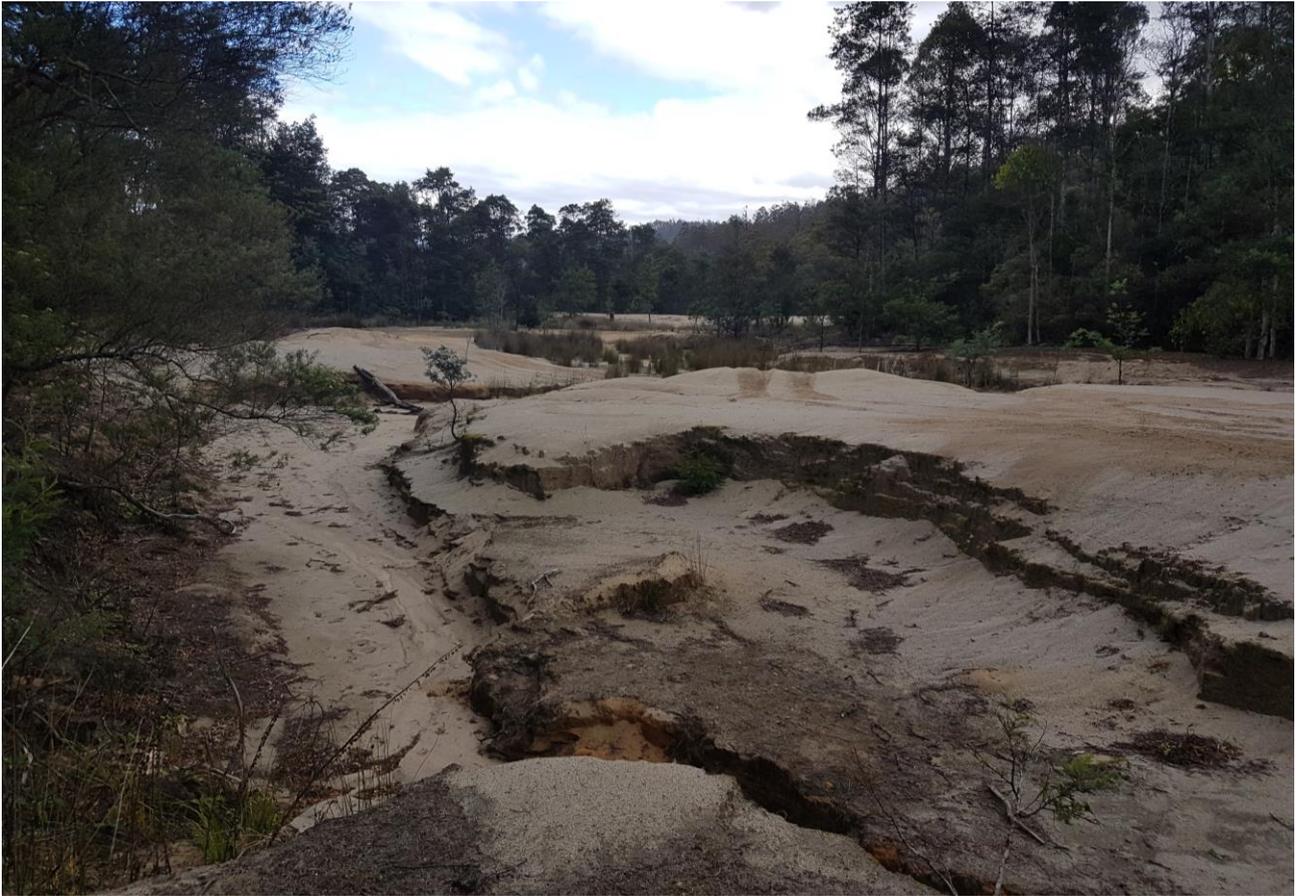
FIGURE 2-2 LARGE SAND SLUG/DEPOSIT LOCATED AT THE ANCHOR MINE.

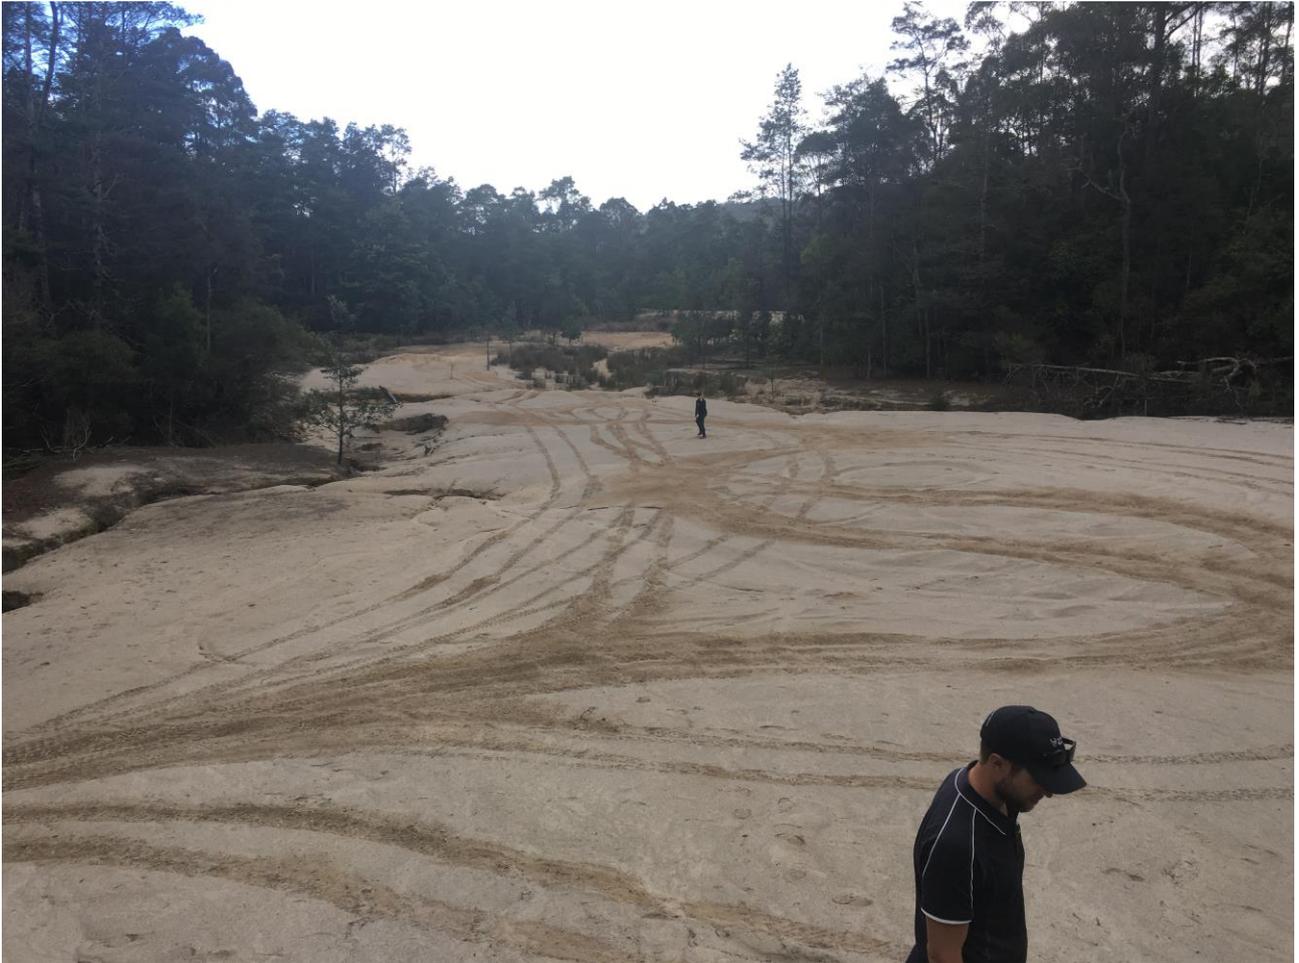
FIGURE 2-3 THE EXTENSIVE SAND DEPOSITS AT THE ANCHOR MINE.

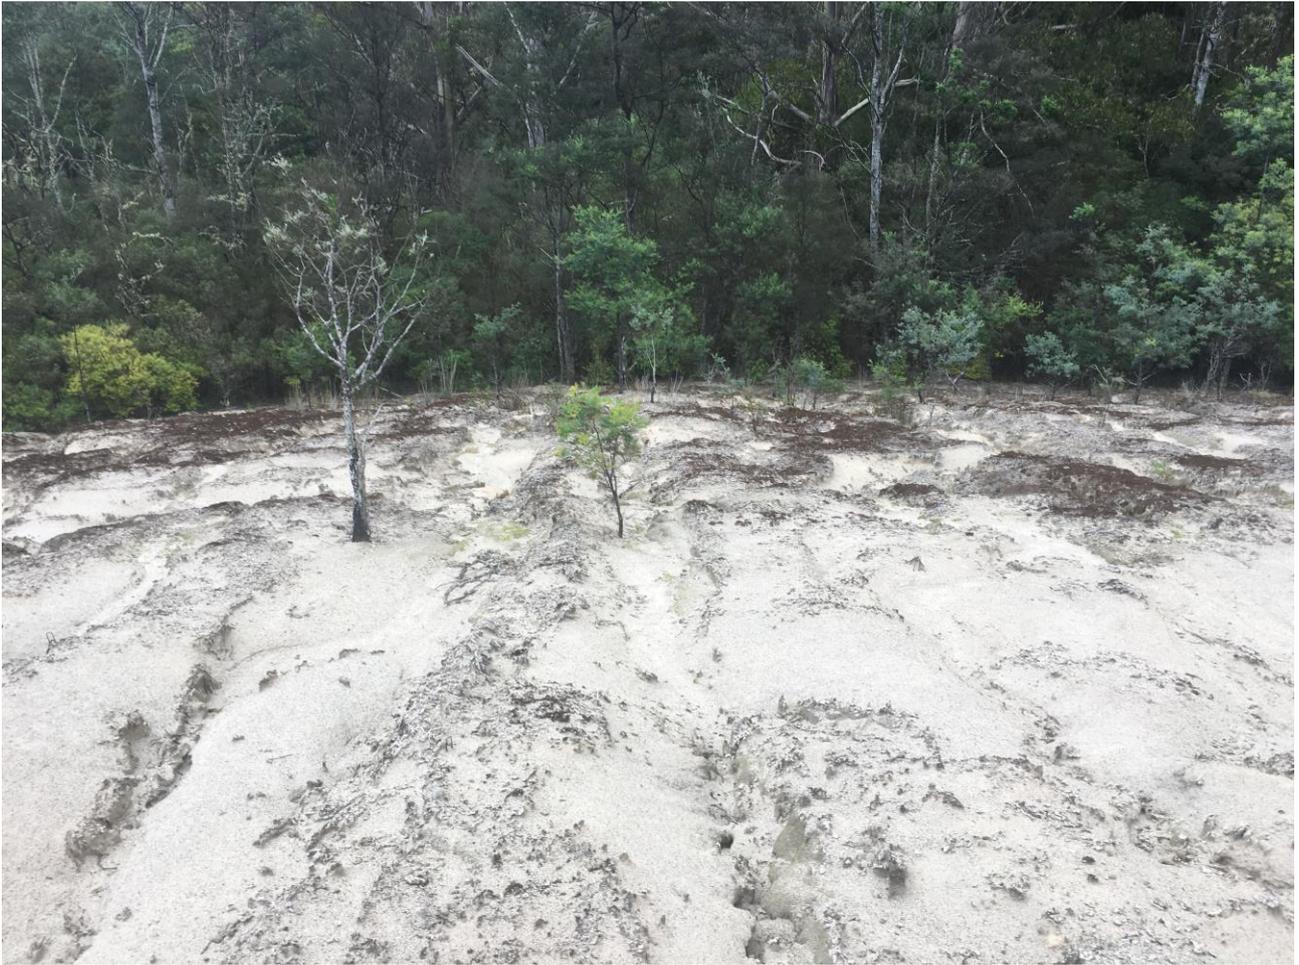
FIGURE 2-4 LOOKING AT THE SAND DEPOSITS IMMEDIATELY ADJACENT THE WATERWAY.

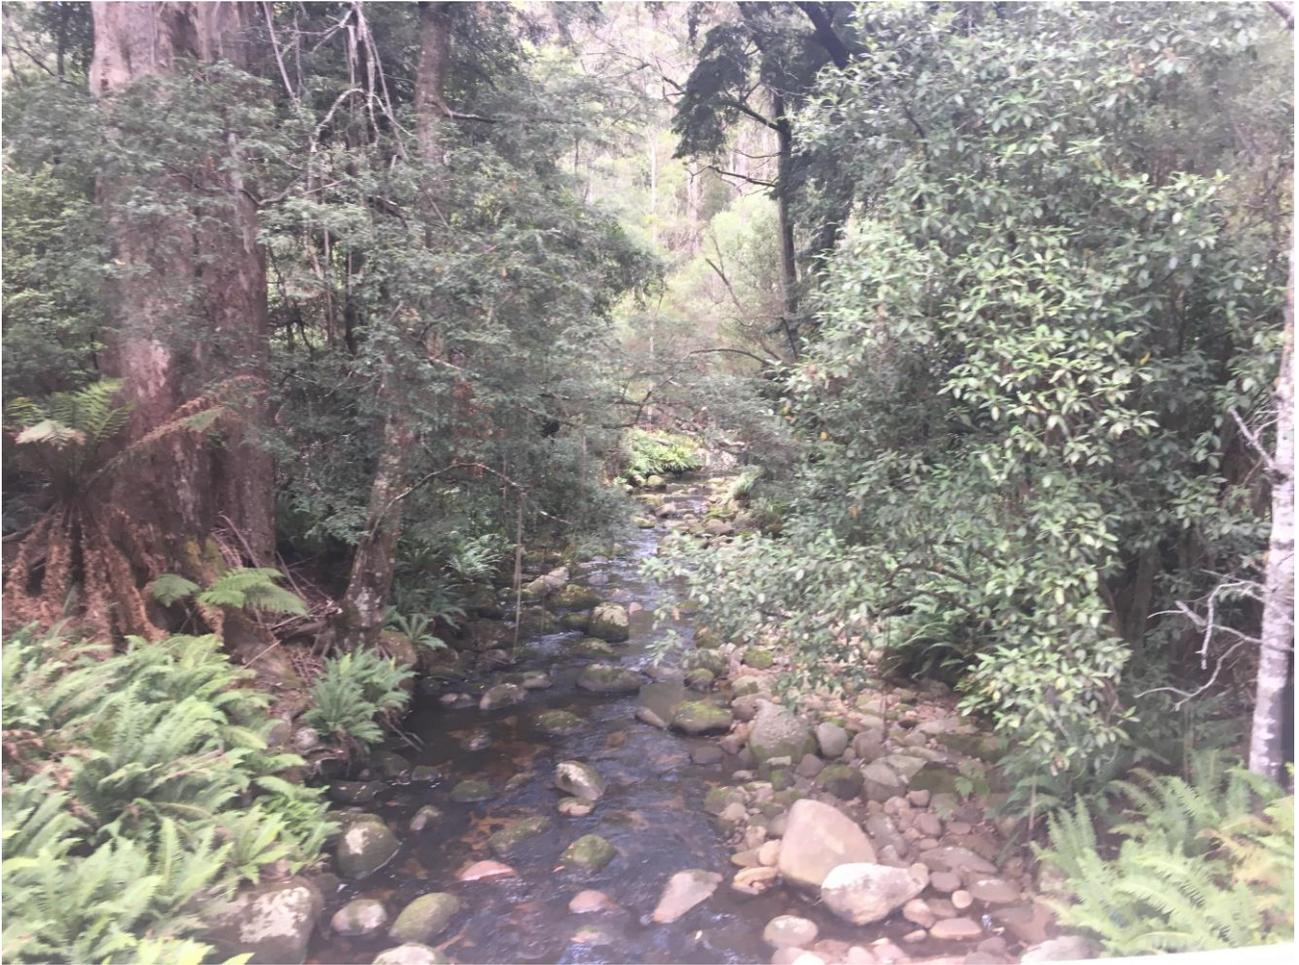
FIGURE 2-5 THE GROOM RIVER DOWNSTREAM OF THE ANCHOR MINE SAND. NOTE THE ABSENCE OF SAND DEPOSITS IN THE CHANNEL.

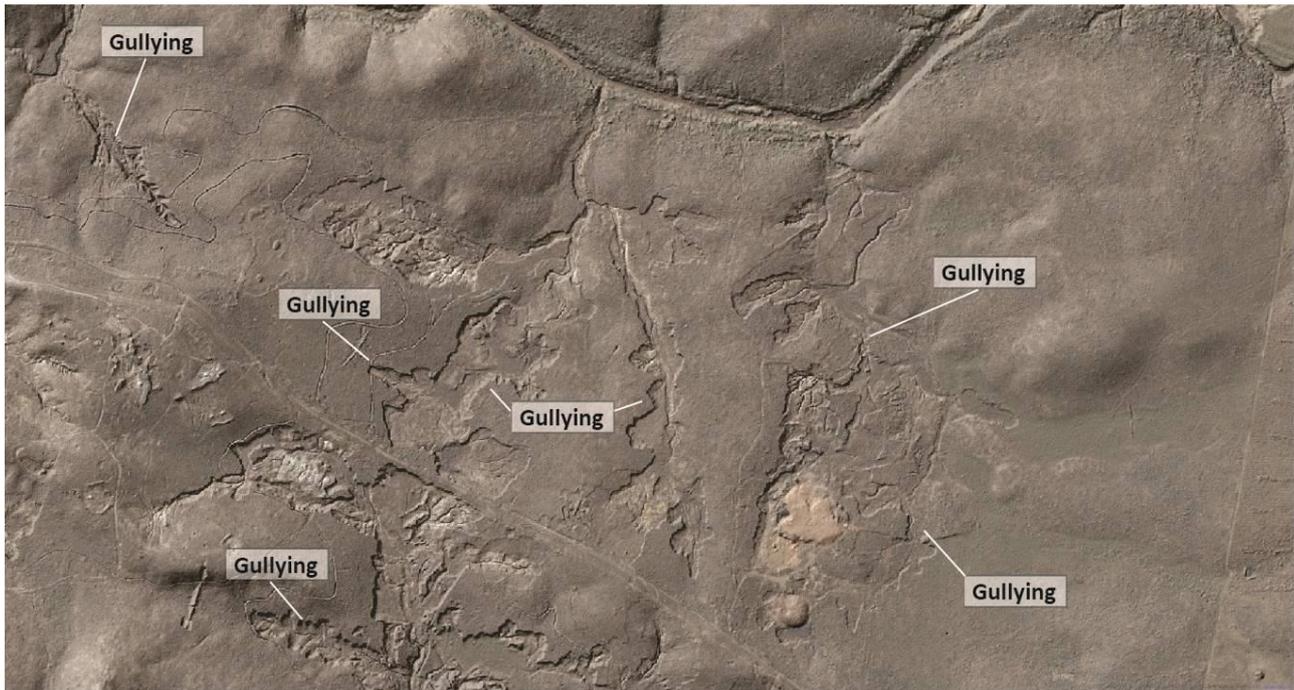
Almost all the mining areas across the catchment have since been reforested. However, evidence of the hydraulic mining can be seen easily in the LiDAR topography (Figure 2-6). Extensive gullying is likely to be occurring in these areas, liberating large quantities of sediment. It was not possible to access these areas; however, this gullying appears to be active and, on such a wide scale, is almost certainly a major and ongoing source of sediment to the system.

FIGURE 2-6 LIDAR TOPOGRAPHY SHOWING EFFECT OF HISTORIC SLUICE MINING AND ONGOING GULLYING.

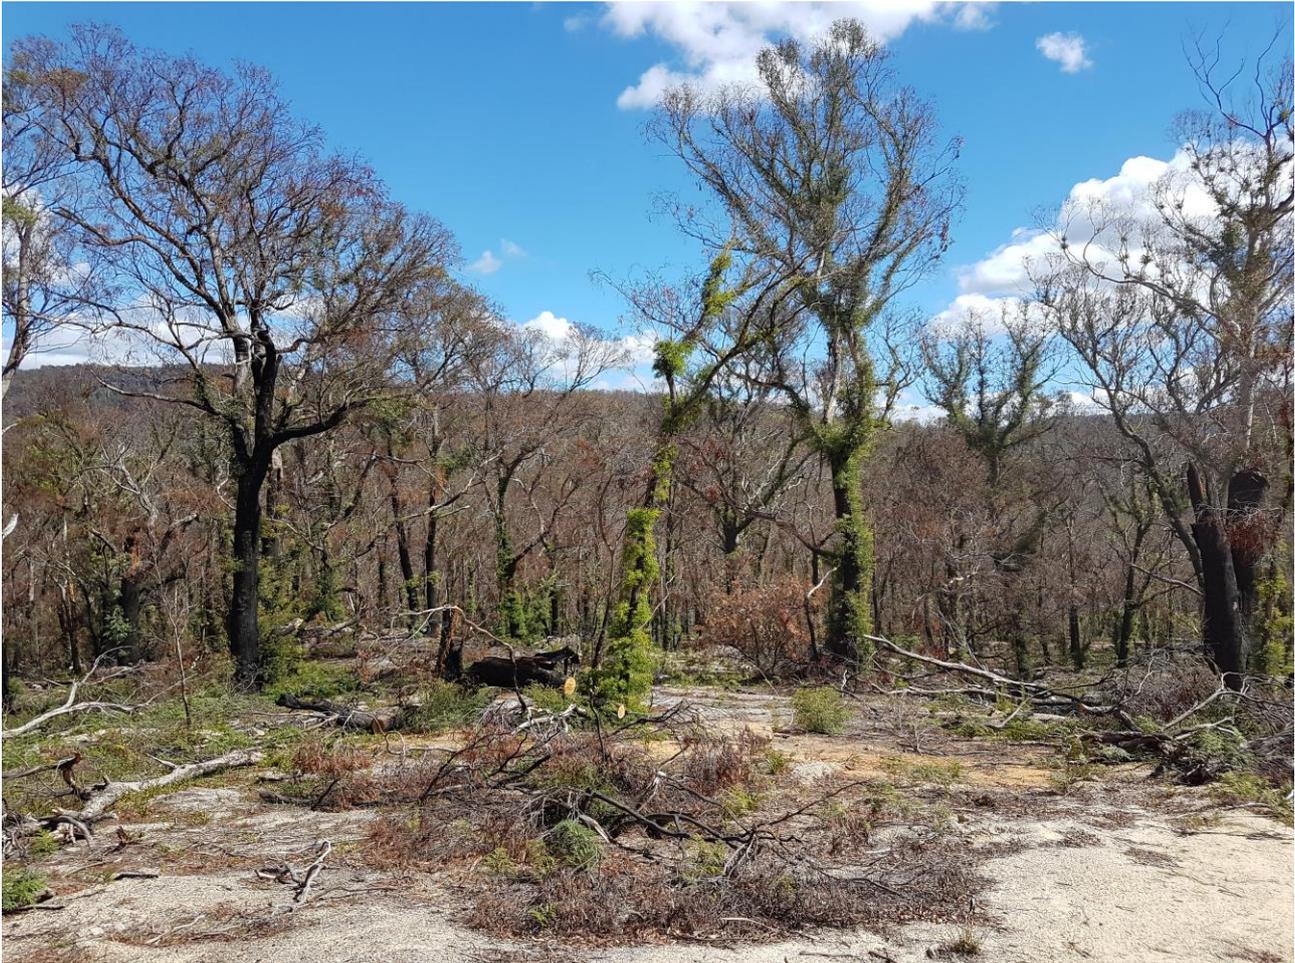
FIGURE 2-7 FIRE DAMAGE AND EXPOSED SAND ON A HILLSLOPE IN THE DERWENT CREEK CATCHMENT (A SUB-CATCHMENT OF THE POWERS RIVULET, ITSELF A TRIBUTARY OF THE GEORGE RIVER).

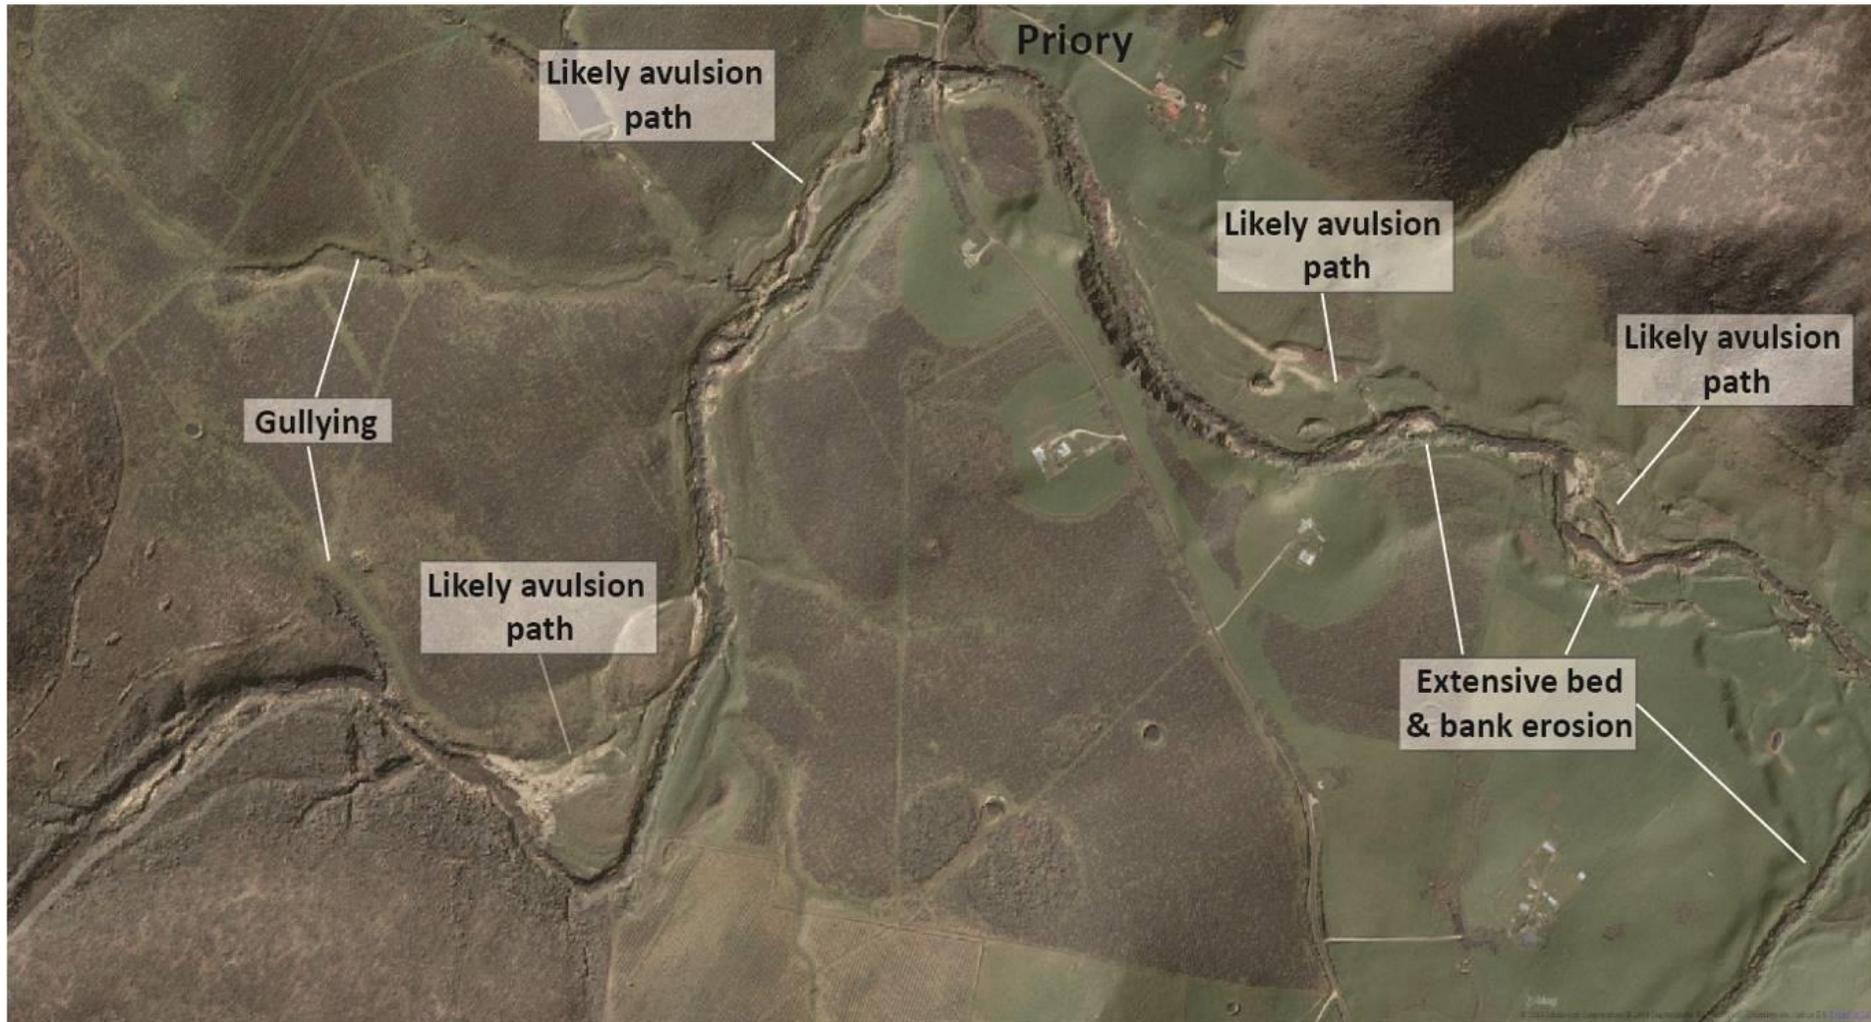
FIGURE 2-8 LIDAR TOPOGRAPHY OVERLAIN ON AERIAL IMAGERY SHOWING THE ACTIVE EROSION PROCESSES.

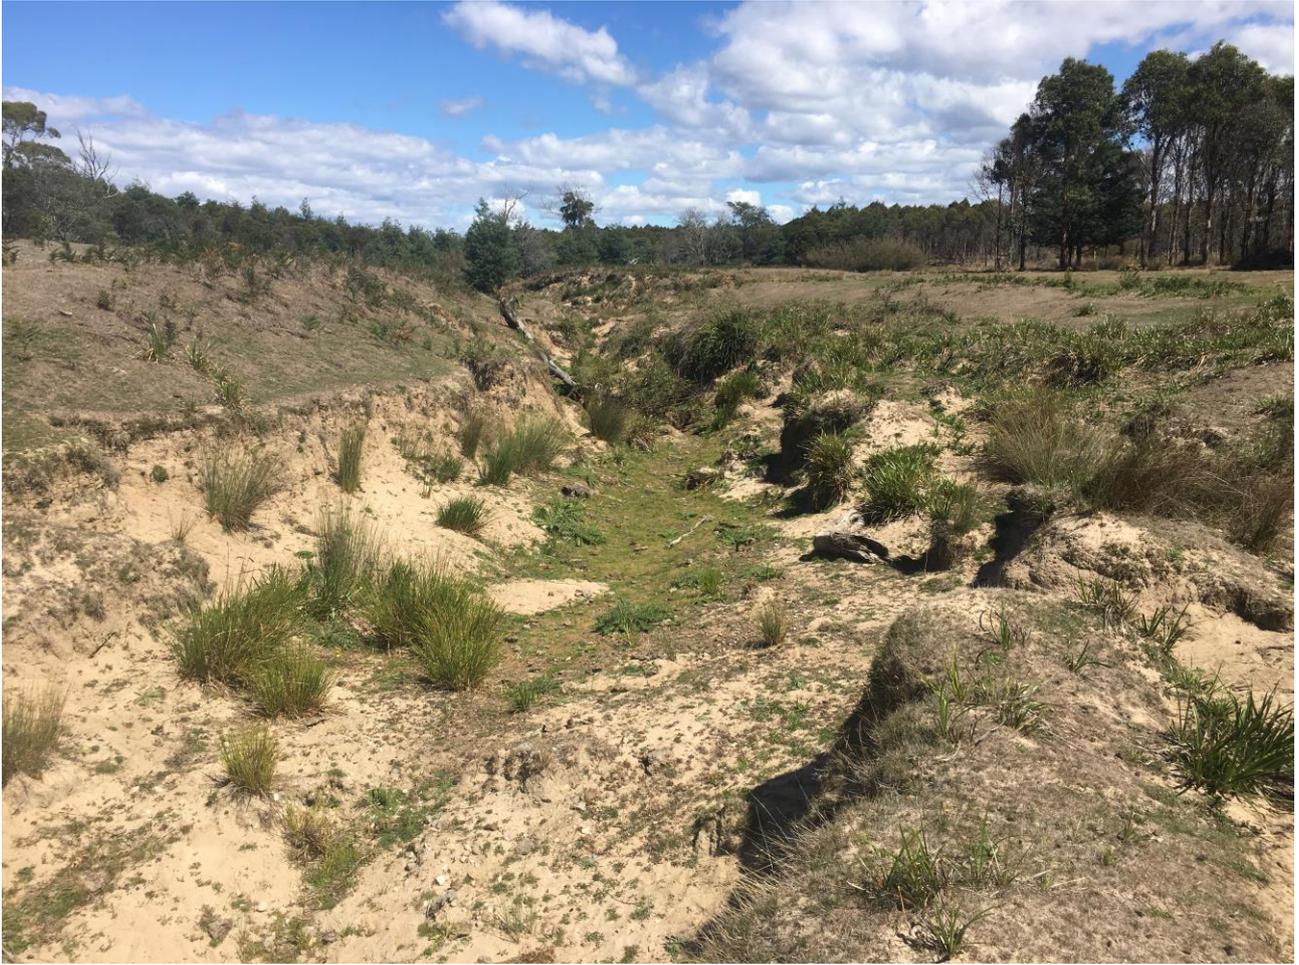
Bank erosion and developing avulsions¹ are occurring on a large scale along much of the upstream river reaches. This is particularly evident at Priory, approximately 16 km upstream of the river mouth where a secondary flow path (avulsion) along the George River is present (Figure 2-8, Figure 2-9 and Figure 2-10). Erosion at this scale is extensive and is observable for approximately 6 km along this reach (Figure 2-8). Whereas bed deepening may have been initially responsible for bank collapse, a majority of the ongoing erosion can be attributed to a lack of riparian vegetation. The channel is now widening along much of its length (Figure 2-11).

FIGURE 2-9 THE AVULSION FLOW PATH NEAR PRIORY.

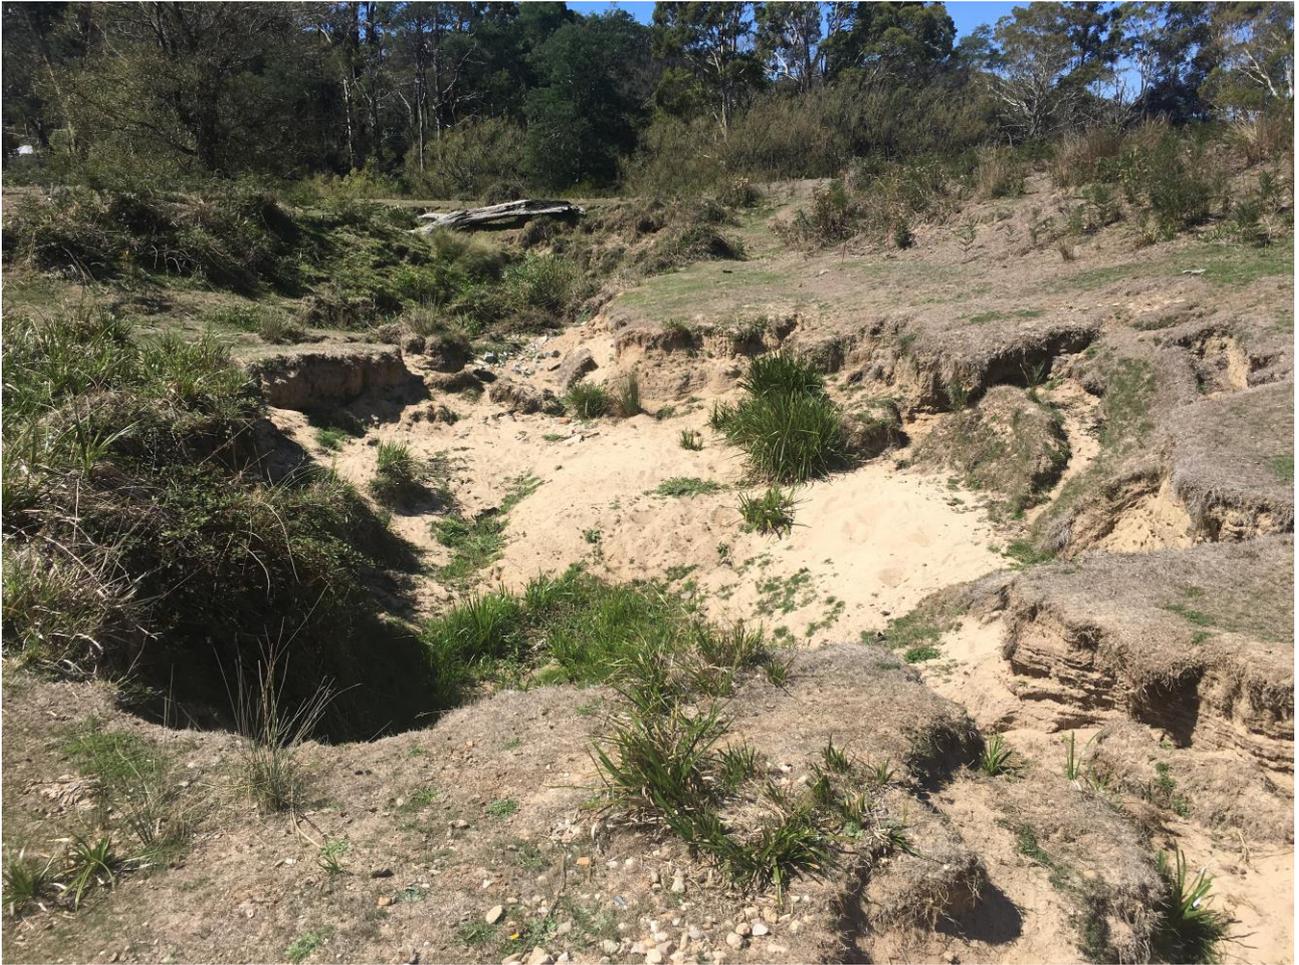
FIGURE 2-10 THE AVULSION FLOW PATH NEAR PRIORY.

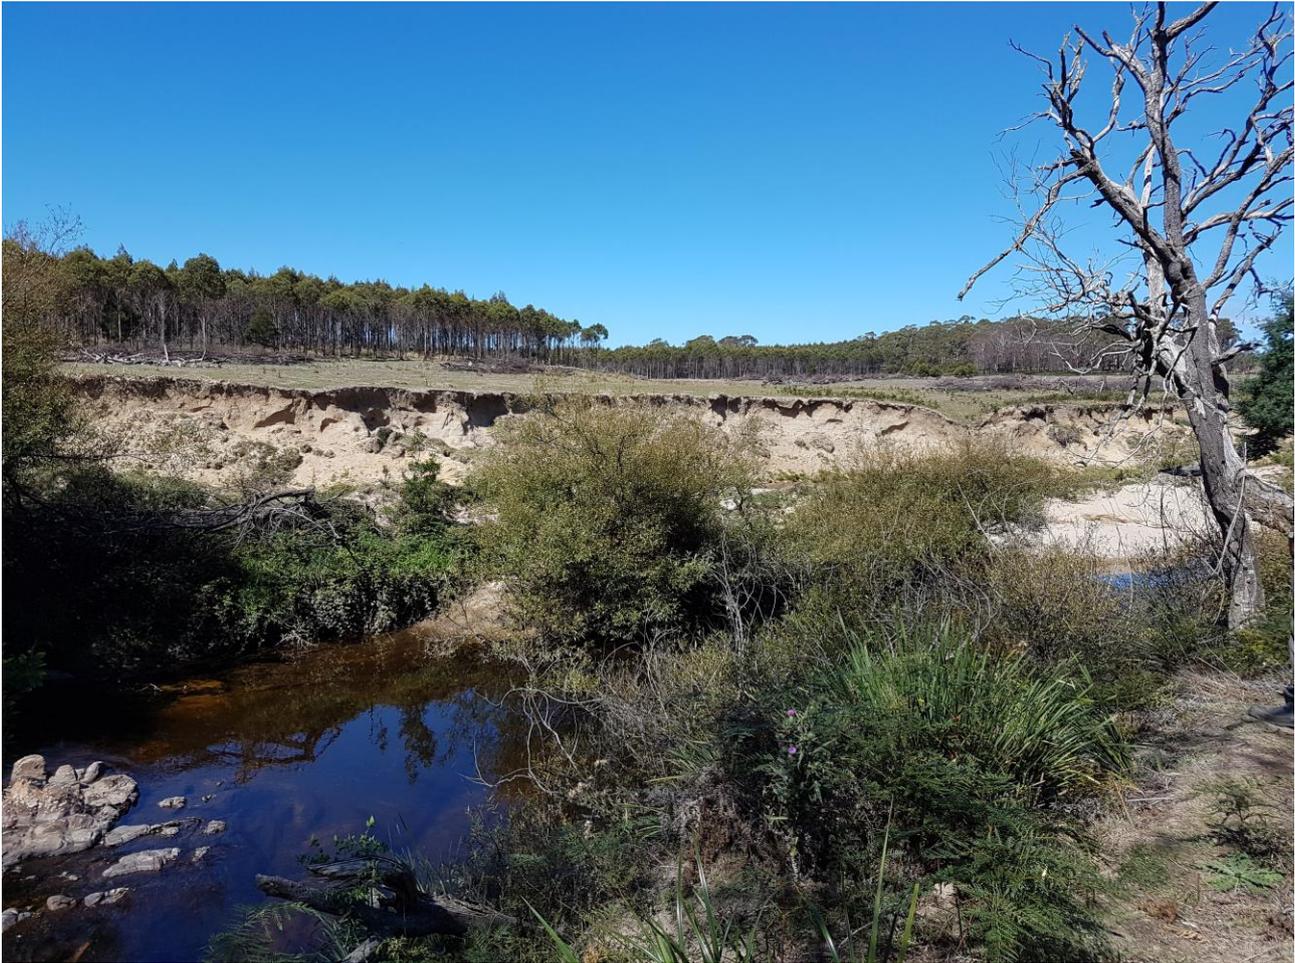
FIGURE 2-11 EXTENSIVE BANK EROSION APPROXIMATELY 8M HIGH, OVER A 400M LENGTH.

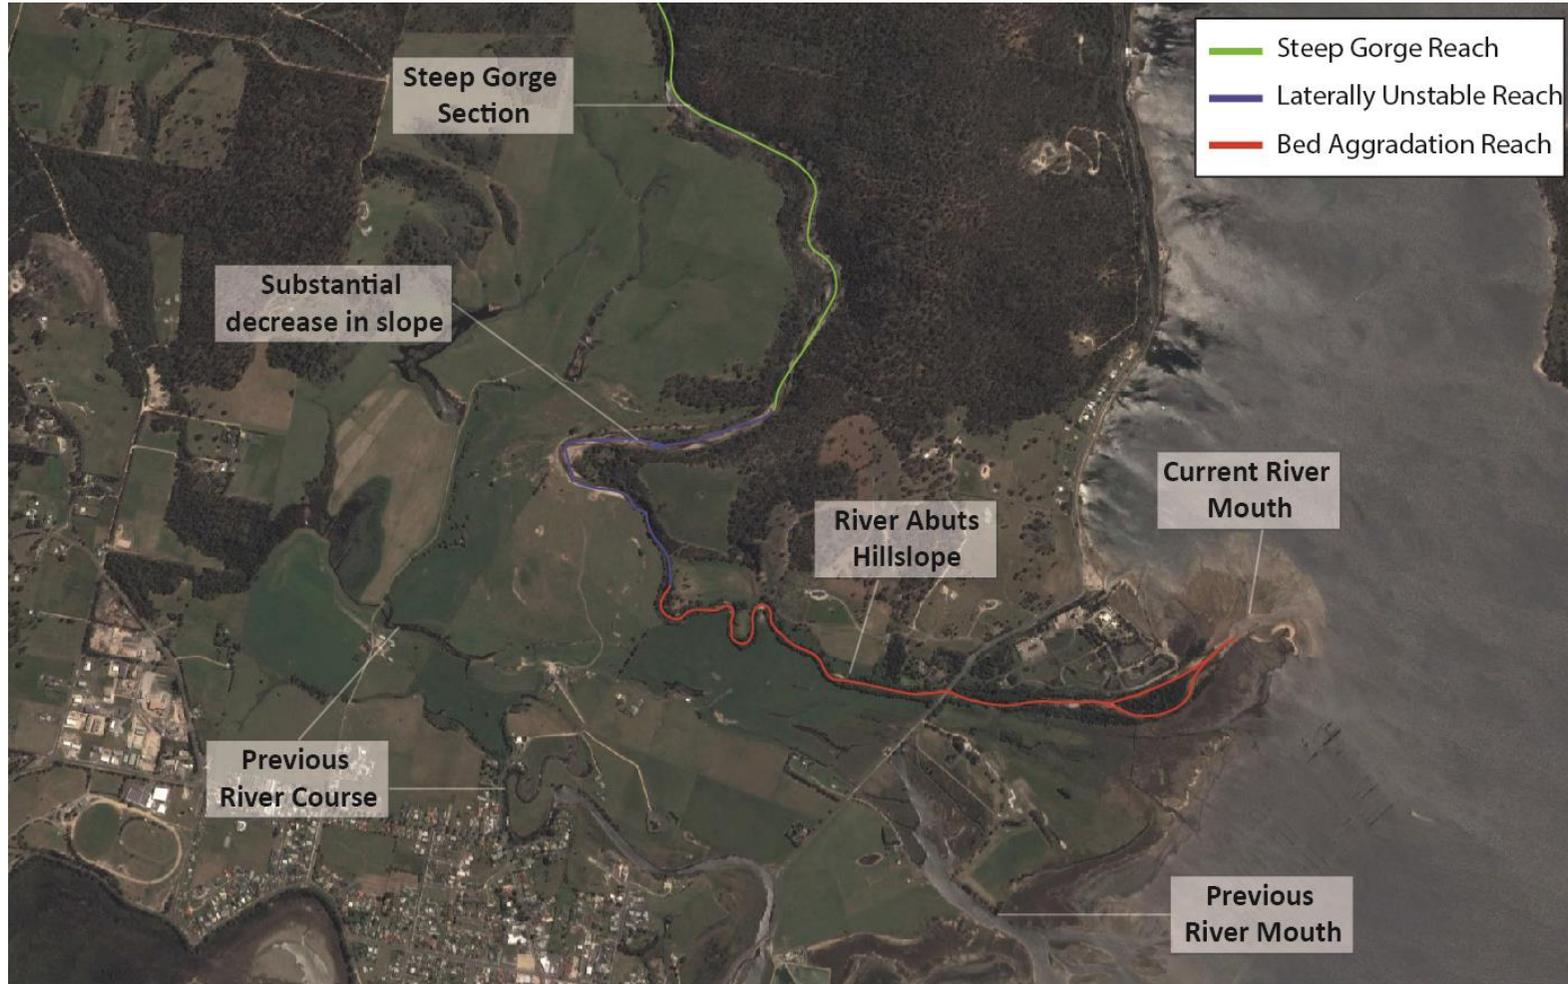
The lower George River is situated immediately downstream of a steep gorge section (Figure 2-12) and runs through a large Holocene delta complex out to Georges Bay. The channel has clearly occupied various locations on the delta surface over the past 10,000 years. Currently, the channel runs along the northern boundary of the delta, flanked by terraces on the left bank and a levee along the right bank.

As can be seen in Figure 2-12, the channel immediately downstream of the gorge section is unvegetated on the right bank. The channel is then lined with willows for almost its entire length of the reach all the way to its mouth. Recent and historic flooding has led to large volumes of sand deposited as splays across the floodplain (Figure 2-12) and as sand slugs within the channel. Aggradation along this reach has led to the channel being infilled and, due to the levee, the channel bed is now higher than the adjacent floodplain in some locations.

FIGURE 2-12 THE LOWER GEORGE RIVER, IDENTIFYING KEY LOCATIONS.

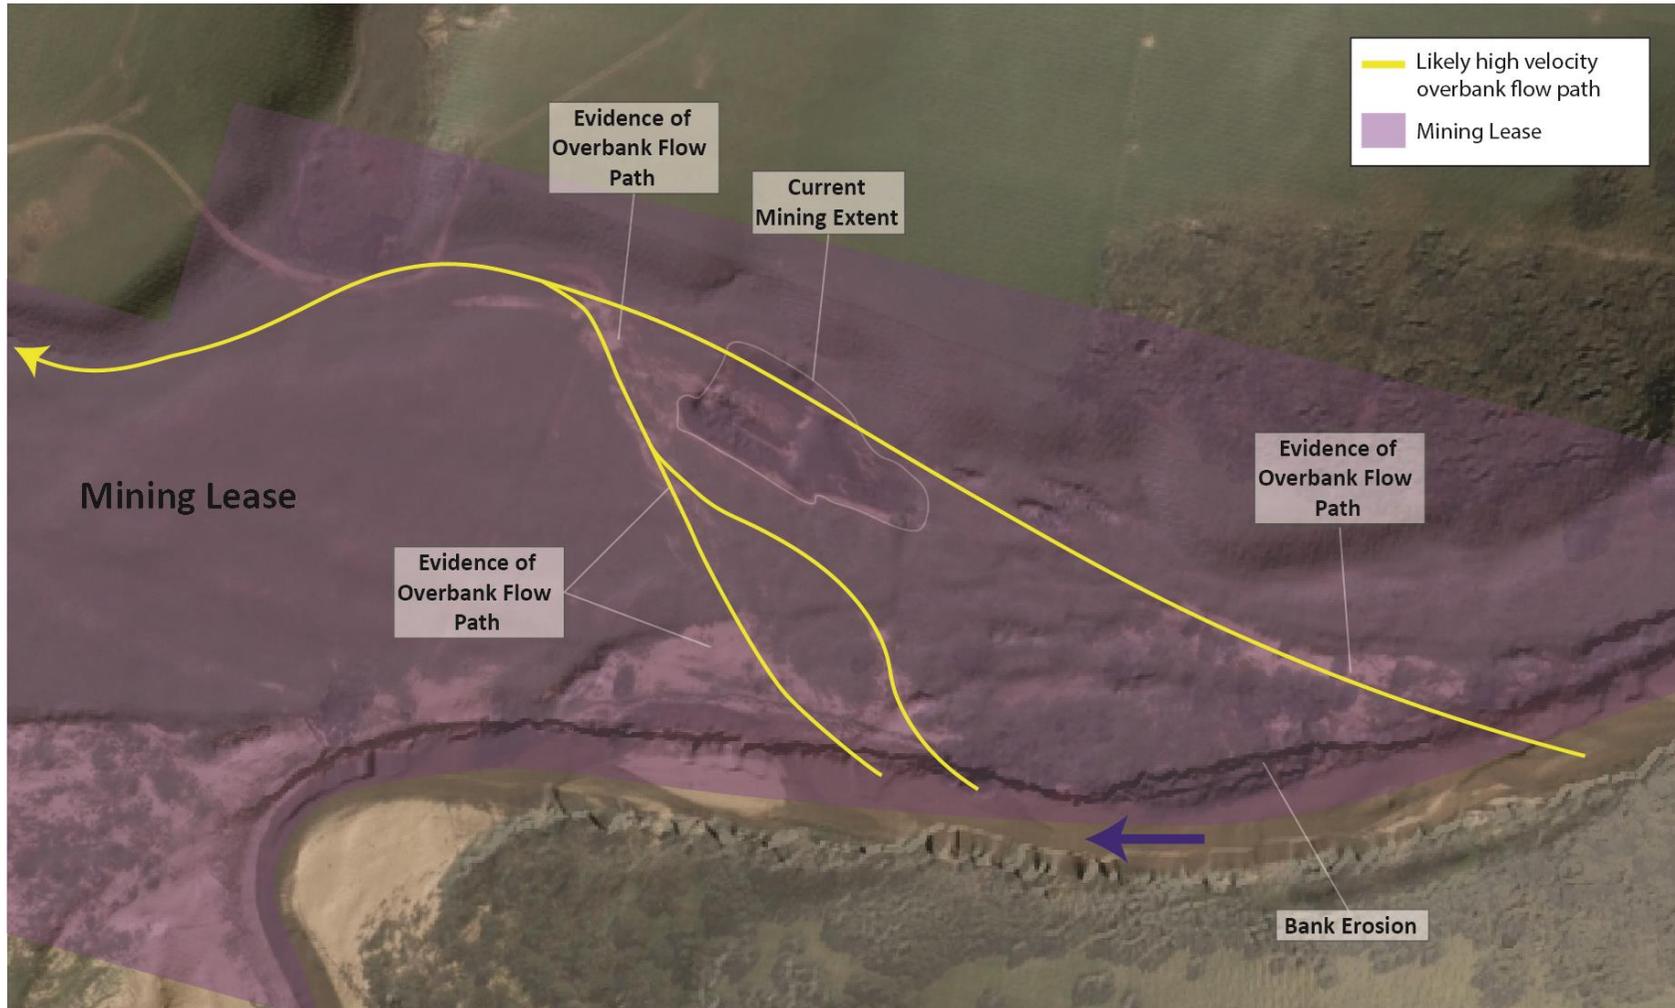
It is understood that an existing mining lease is present on the northern floodplain of the Lower George River, downstream of the gorge section (Figure 2-13). In its current form, sediment extraction has occurred to a limited extent; however, it is understood that future expansion of the mining extent is planned.

As can be seen in Figure 2-13, the current pit lies in the path of overbank flood flows and floodplain scour is already evident between the pit and the George River channel. Avulsion is unlikely at this location due to the location of the pit relative to channel planform. However, pit capture appears to be a real possibility particularly if future mining expansion brings the pit closer to the channel. Pit capture results in the pit being connected to the channel through erosion from overbank flow entering the pit and cutting back through the floodplain. This process is capable of rapidly liberating large volumes of sediment to the system.

FIGURE 2-13 FLOODPLAIN MINING ON THE LOWER GEORGE FLOODPLAIN.

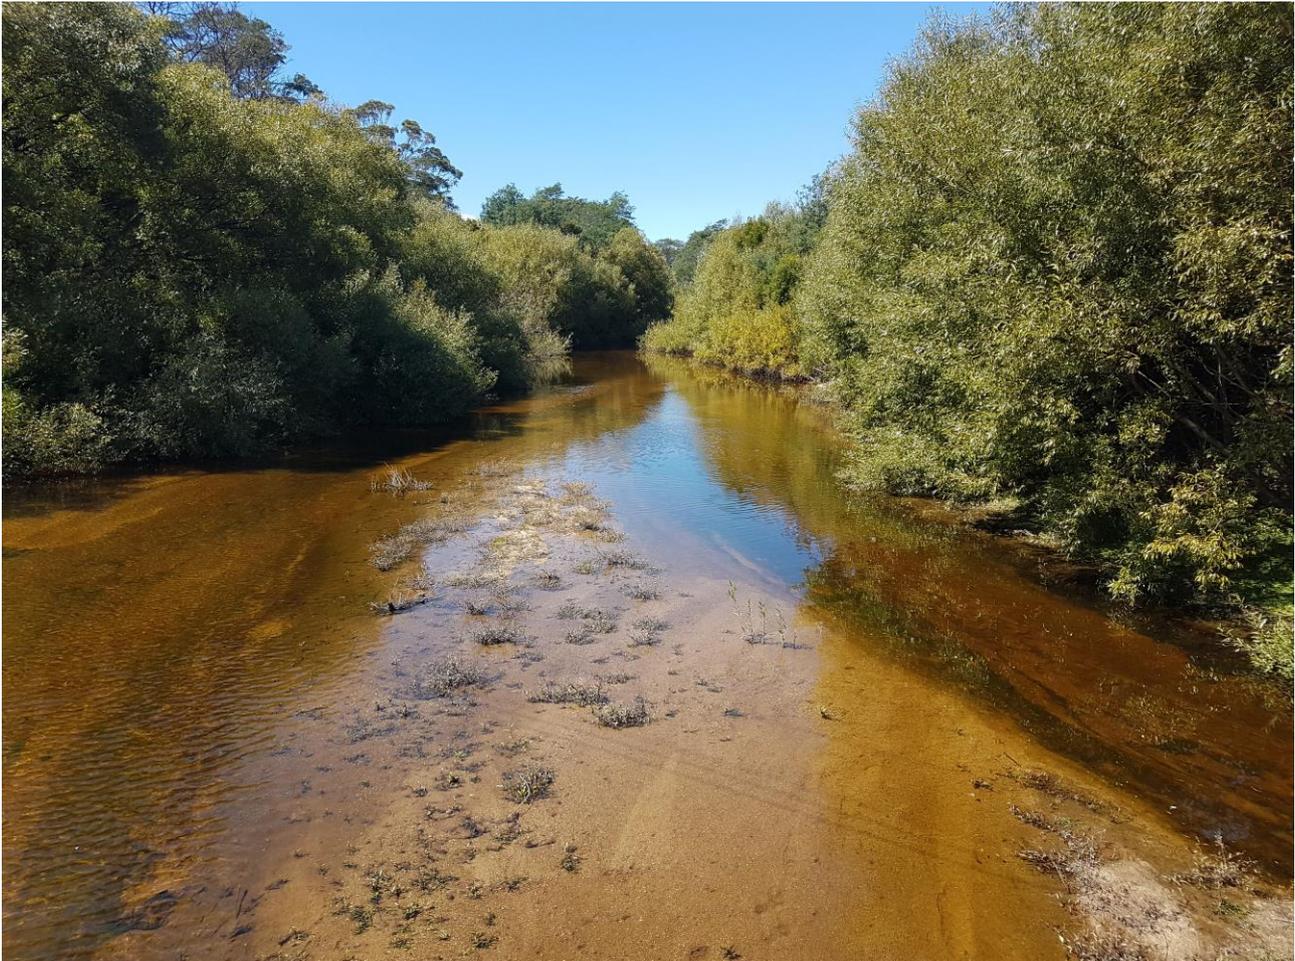
Bed aggradation is occurring in the lower reaches of the Lower George River (Figure 2-12). This is no doubt aided by the dense willow infestation along the entire reach (Figure 2-14) and the levee that runs for approximately 2km upstream of Binalong Bay Road. As the channel fills, bank full flows are less capable of moving sediment due to reduced channel capacity. Reduced channel capacity forces flow out of the channel, depositing sediment on the floodplain/delta. If those overbank flows find a new, more hydraulically efficient, flow path, a wholesale shift in channel planform (avulsion) will be initiated.

FIGURE 2-14 GEORGE RIVER CHANNEL, IMMEDIATELY UPSTREAM OF THE BINALONG BAY ROAD BRIDGE, SHOWING DENSE WILLOW INFESTATION AND BED AGGRADATION.

An associated problem in this reach is that of the willow infestation. The long-term solution to the bed aggradation issue in the river must involve the removal of the willows and their replacement with native woody vegetation. However, it is strongly recommended that this occurs after the sediment extraction and after a period of monitoring.

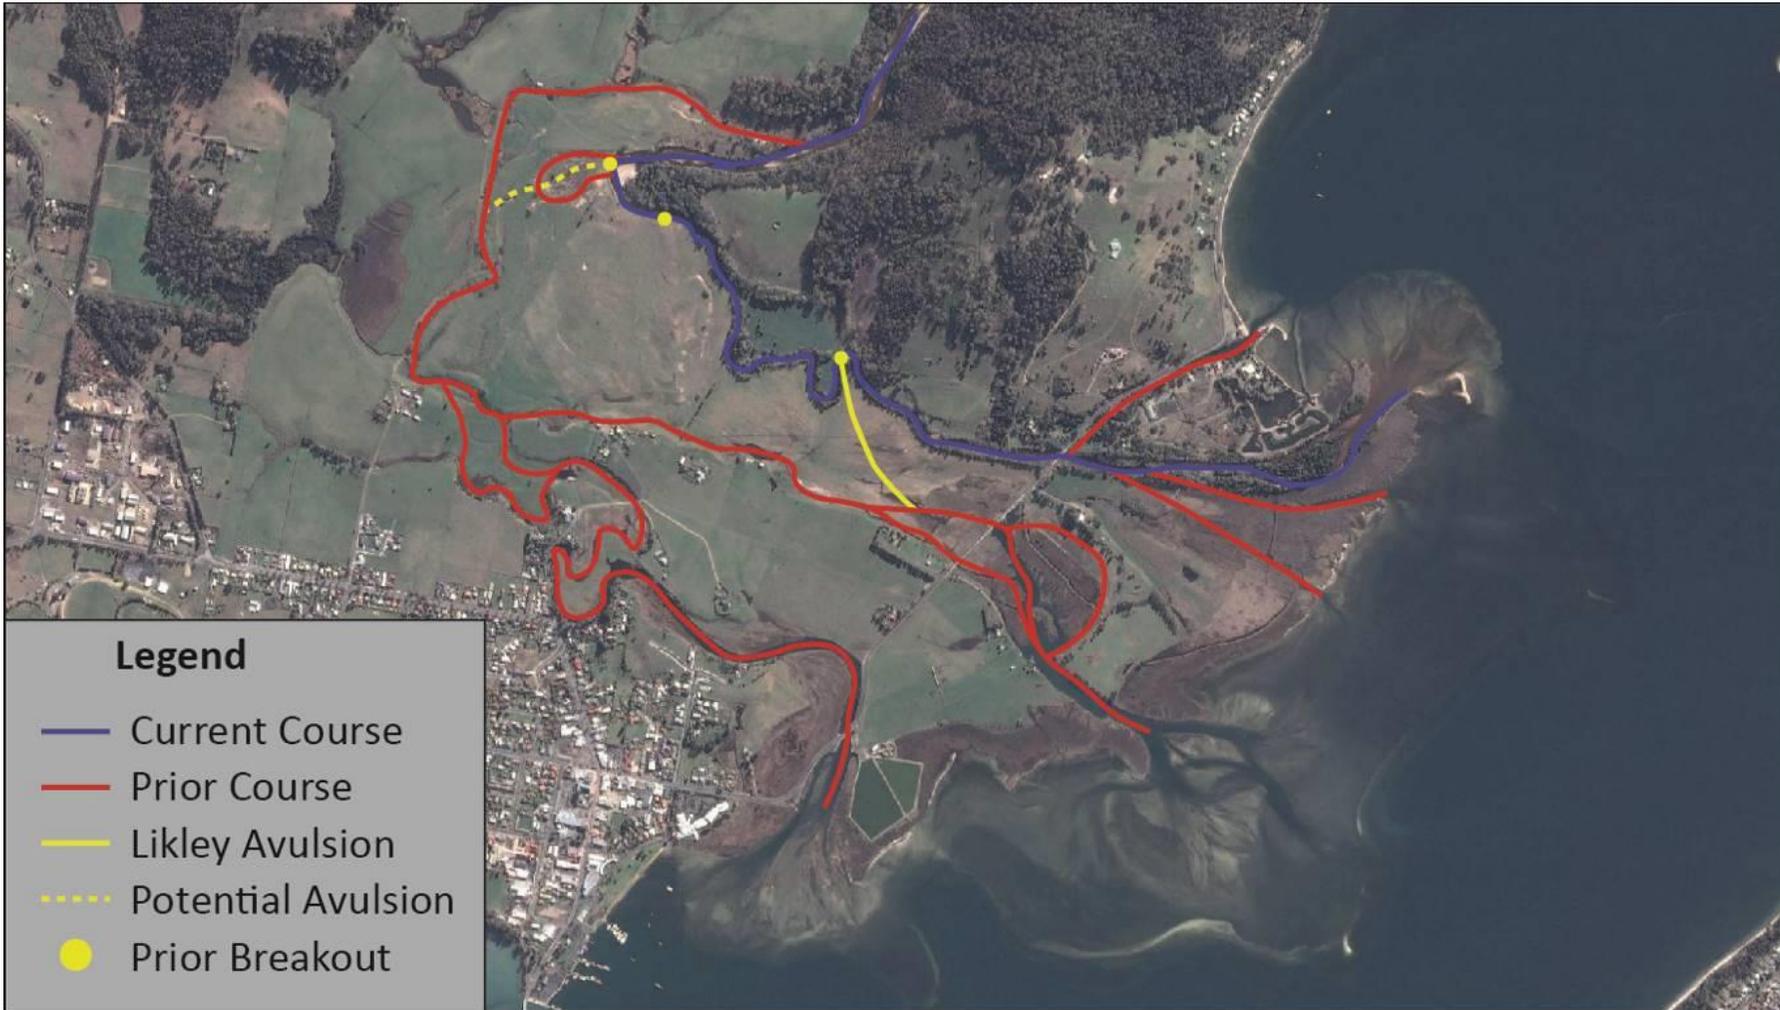
Several potential breach locations (exit points for flood flows) exist along the lower George River, based on topography and channel planform. However, only three are confirmed by photographic and anecdotal evidence. Of the three confirmed locations, only one is considered a likely avulsion path due to the downstream channel length and thus grade increase (Figure 2-15).

FIGURE 2-15 LIDAR TOPOGRAPHY SHOWING PREVIOUS COURSES OF THE GEORGE RIVER ALONG WITH POTENTIAL FUTURE COURSES AND BREAKOUT POINTS.

Planning for a controlled avulsion and allowing the river to relocate to the path identified in Section 2.3.3 may be substantially cheaper than extracting sediment from the channel. Analysis of topography and previously conducted hydraulic modelling (flood hazard results provided in Pitt and Sherry, 2013) provides the likely and most achievable path for an avulsion when the channel fills past the critical flow conveyance threshold. The path is slightly longer than the current channel but steeper due to the lack of deposition. The path also has the additional advantage of an existing bridge on Binalong Bay Road. Currently, the channel is protected from deepening through knickpoint migration by a concrete weir structure. This structure could be removed to promote the formation of a new channel and redirection of the George River. This would also require replacement of willows with native vegetation and revegetation efforts along the new channel. A controlled avulsion also comes with risks and analysis would be required to assess and mitigate these risks.
