Development Applications

DA Number DA 2025 / 00082

Proposal Visitor Accommodation - Additional Use for Visitor Accommodation

RE: Coastal Erosion and Landslip Hazard Appraisal 35 St Helens Point Road, Stieglitz

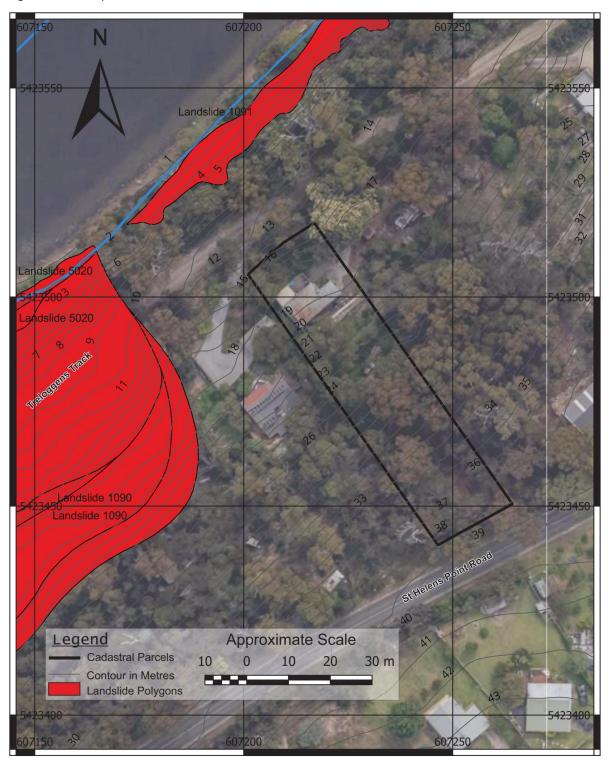
Figure 1: MRT LIST Landslide Polygon of Tasmania overlayed within the vicinity of the

A small recent or active earth slide, Landslide ID. 1091, is located directly downslope from the northwest boundary of the site, downslope of Treloggens Track, along the shoreline. (refer to Figure 1 below).

Examination of the MRT LIST Landslide Polygon overlay indicates that there are no known mapped landslide features within the site. A recent or active soil slide, with activity recorded prior to 1971 (Landslide ID No. 1090), is located 28m cross-slope from the south-western boundary of the site, with its affected area extending across property Nos. 23 to 31. A small recent or active earth slide, ID. 5020, is located within this feature along the shoreline.

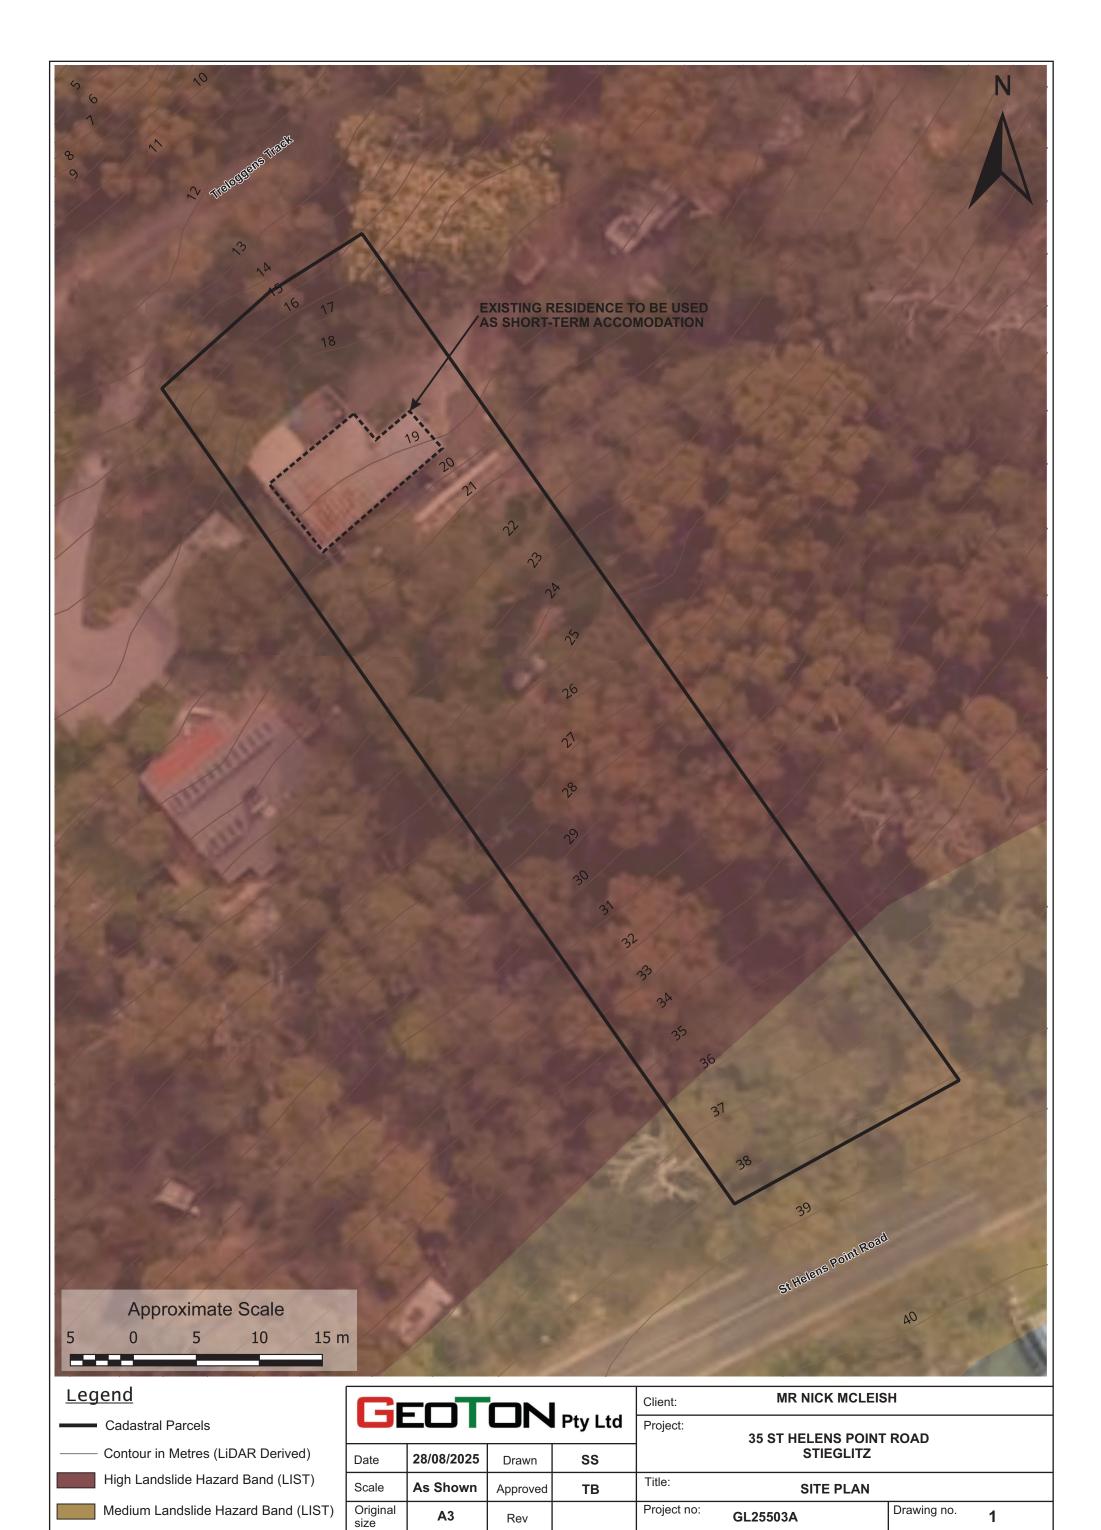
Drawing 1 – Site Plan

Examination of the LIST Landslide Planning Map indicates that the middle and north-western portions of the site, including the footprint of the existing dwelling, are within a mapped high landslide hazard band, and the front south-eastern portion of the site along St Helens Point Road is within a mapped medium landslide hazard band (refer to Drawing 1 – attached).

Furthermore, the property is situated at an elevation of at least 14 metres above sea level at its lowest point (refer to Drawing 1 – Site Plan) and is therefore not considered at risk from sea level rise or storm surge impacts.
