# **SCAMANDER RIVER COASTAL HAZARDS RISK MITIGATION & PATHWAYS PLANNING**

**Outlook Report – Coastal and River System Processes,  
Hazards and Climate Change Memorandum**

Produced For Break O'Day Council

Date **5<sup>th</sup> September 2025**

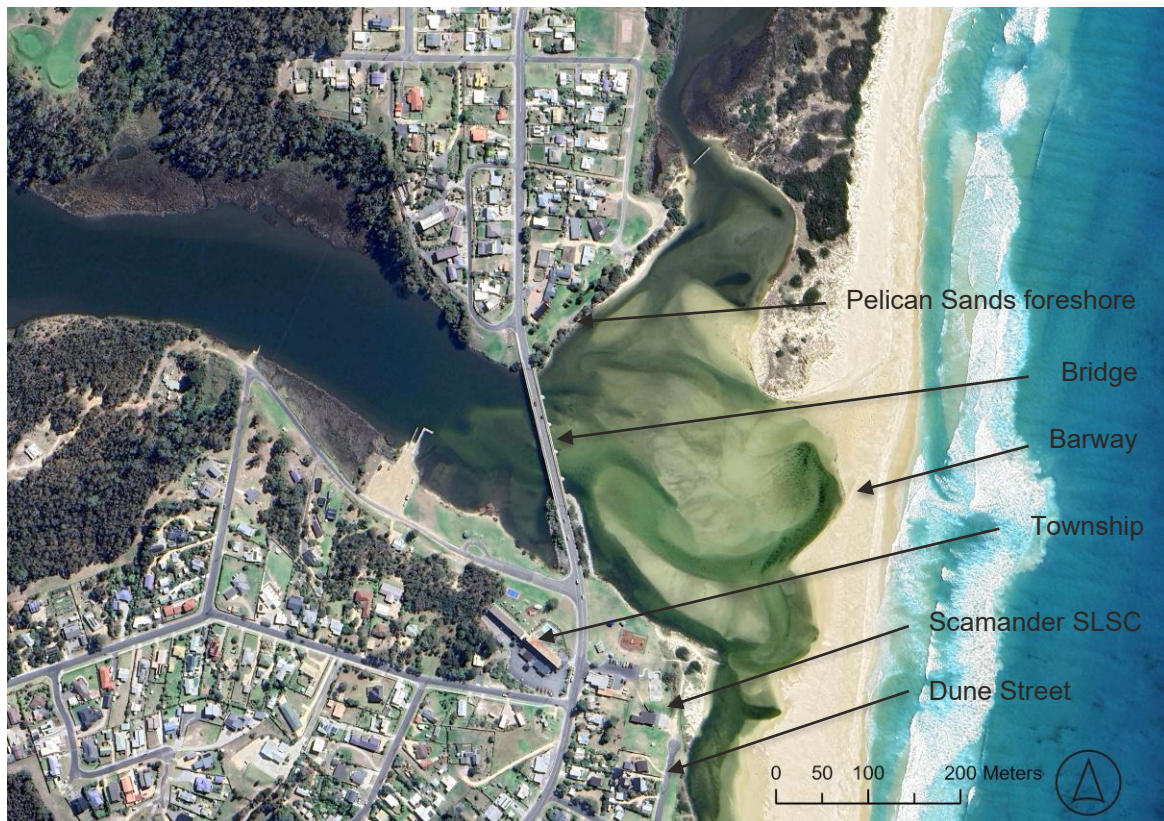
**FIGURE 2: SCAMANDER RIVERMOUTH WITH KEY LOCATIONAL TERMINOLOGY DENOTED**

The study area of the Coastal Hazards Risk Mitigation & Pathways Plan and therefore the study reported herein comprises the township and immediately surrounding environment. For the convenience of this study, the key areas covered by the study area and referenced throughout this report have been denoted on **Figure 2**. Specific geomorphological features and physical processes are further described in later sections.

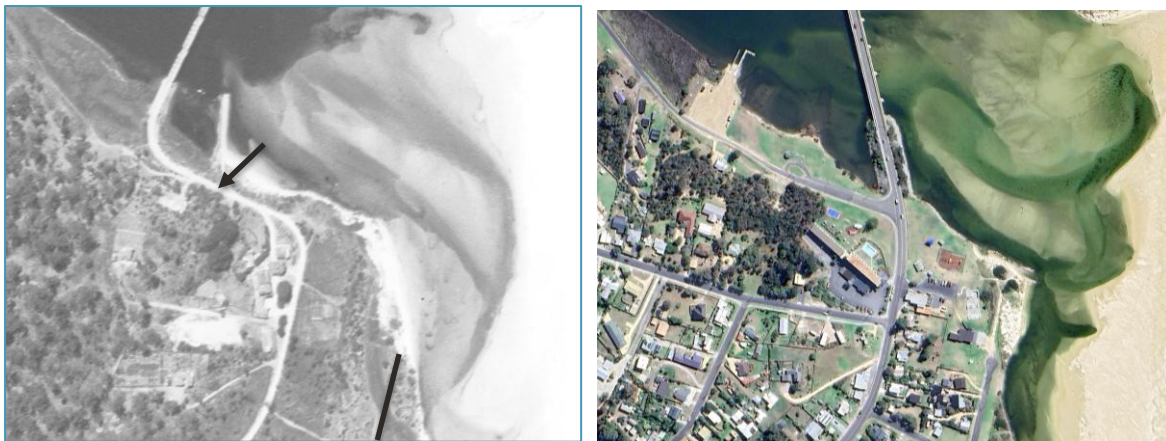
**FIGURE 3: AERIAL IMAGES FROM 1950 (LEFT) AND 2024 (RIGHT) SHOWING DEVELOPMENT OF THE TOWNSHIP IN THE SOUTHERN SIDE OF THE RIVER MOUTH. FOR ORIENTATION AND REFERENCE, THE CURRENT POSITION OF DUNE STREET (ROAD) IS MARKED ON THE 1950 AERIAL IMAGE WITH A BLACK LINE. BRIDGE ESPLANADE IS MARKED BY ARROW.**

The township of Scamander has developed around the river mouth and coast, including estuary foreshores. In places infrastructure and property have been located in low lying areas, and/or adjacent to the coastal, estuarine and river foreshores. An example is at Bridge Esplanade, where a number of properties are located on the low lying river bank, as well as at Dune Street, which north of Hodgman Street, has been develop within previous dunes and sand flats/beaches (**Figure 3**).

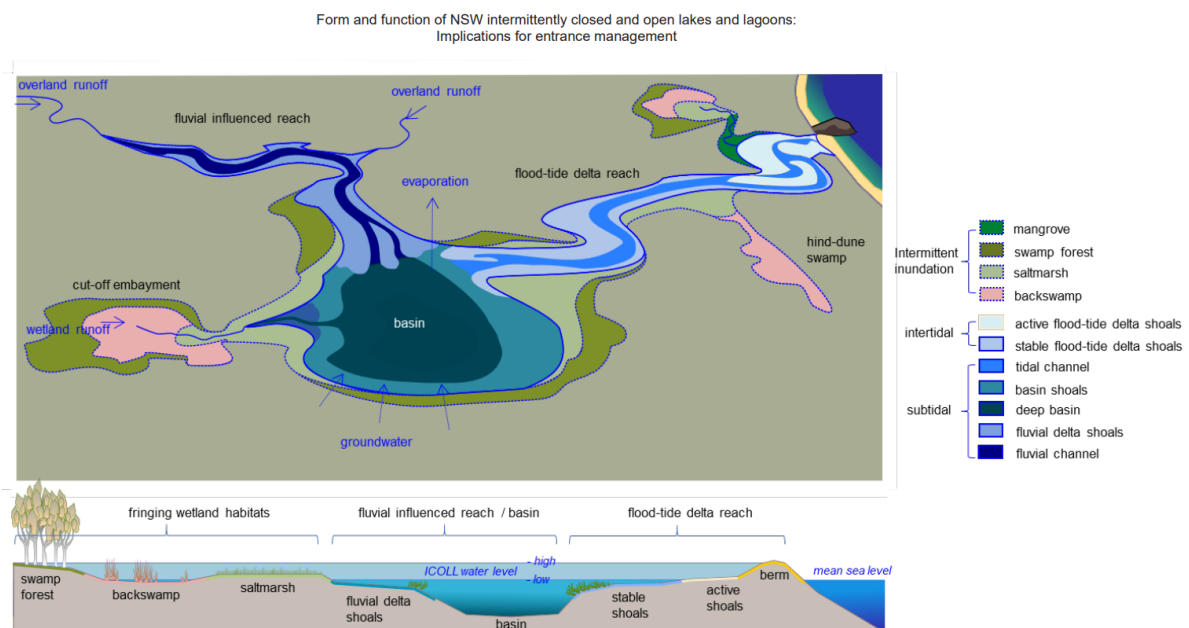
**FIGURE 4: TERMINOLOGY IDEALISED ICOLL SHOWING THE DISTRIBUTION OF KEY FUNCTIONAL ZONES AND SUBENVIRONMENTS (FROM NSW DPIE, 2021)**

At Scamander, the ICOLL generally reflects a typical formation, with some variation (**Figure 4**). Due to the geological controls of the lower Scamander River (Fearman, 2021), there is an unusual gorge feature. The key features are described below and are annotated for convenience in **Figure 5**. Representative photos of key features are presented in **Figure 6** to assist description.

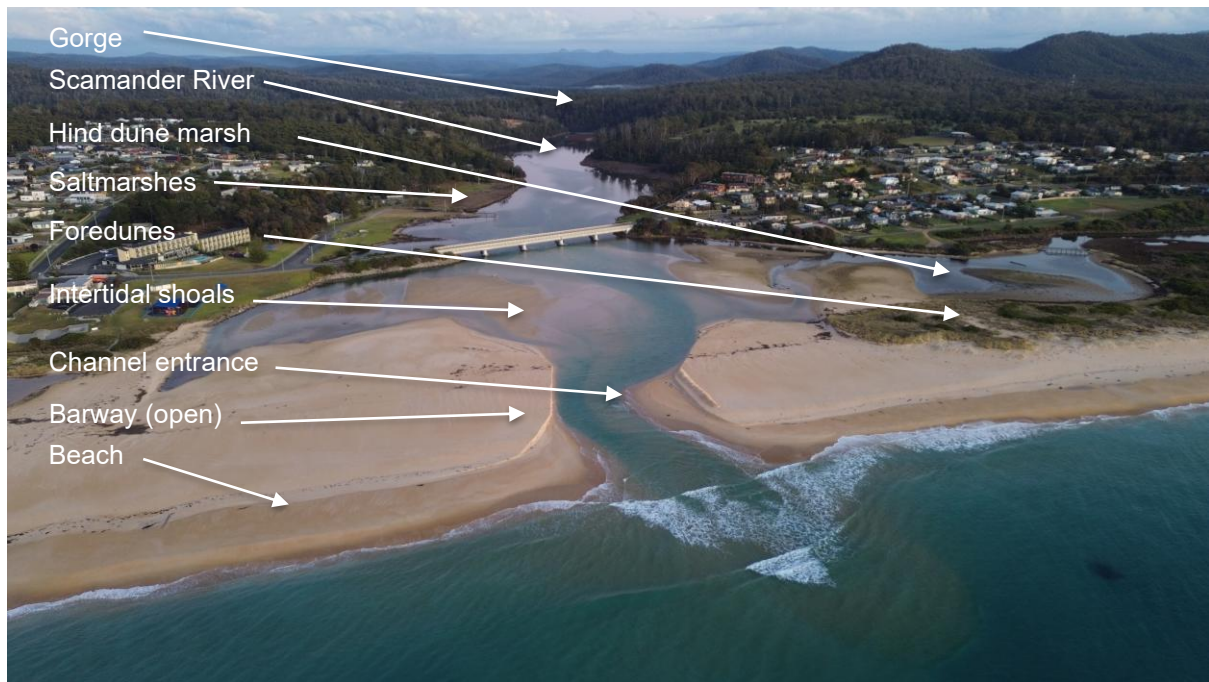
**FIGURE 5: IDENTIFICATION AND INDICATIVE LOCATION OF KEY GEOMORPHOLOGICAL FEATURES**

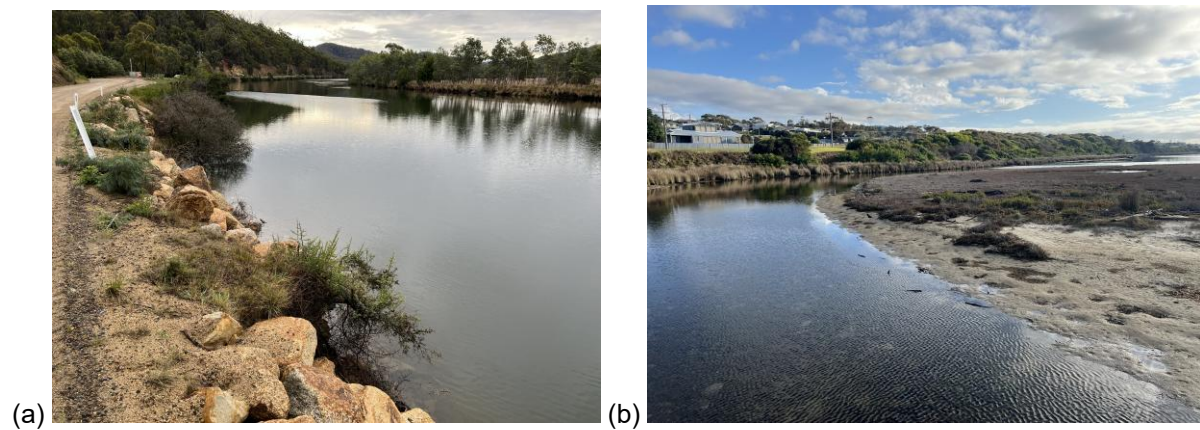
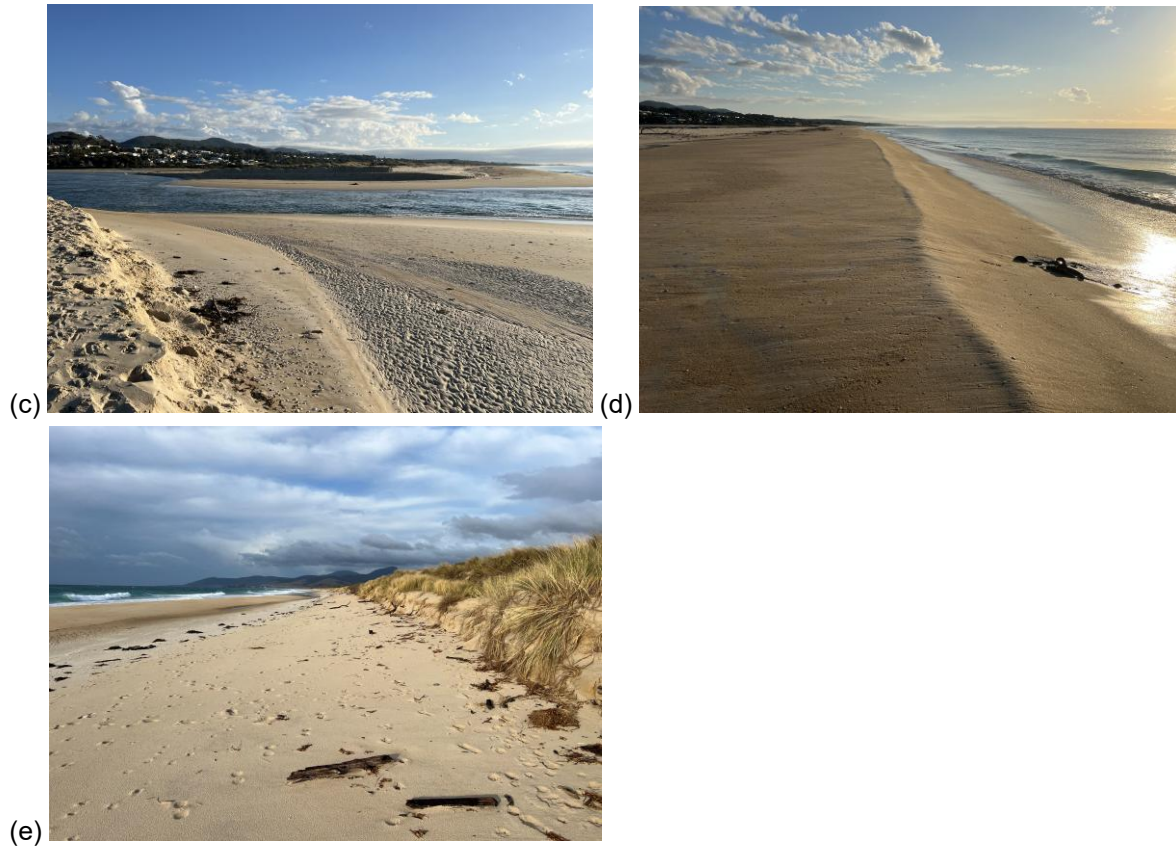
**FIGURE 6: PHOTOS OF KEY GEOMORPHOLOGICAL FEATURES: (A) SCAMANDER RIVER; (B) HIND DUNE MARSH; (C) ENTRANCE (IN OPEN STATE) (D) BEACH AND BARWAY (E) INCIPIENT DUNES AND FOREDUNES (PHOTOS BY N. LEWIS).**

In the lee of the dunes, hind dune lagoons have formed north and south. Foredunes (also called frontal dunes), typically fronted by an incipient dune run parallel to the beach, they can be symmetric or asymmetric dune ridges located at the landward edge of the beach. They are formed by windblown sand deposited within vegetation. Generally, they occur as two main types, incipient and established foredune(s) (DTAE, 2007). Incipient dunes are located in front of an established foredune at the upper margin of the beach.

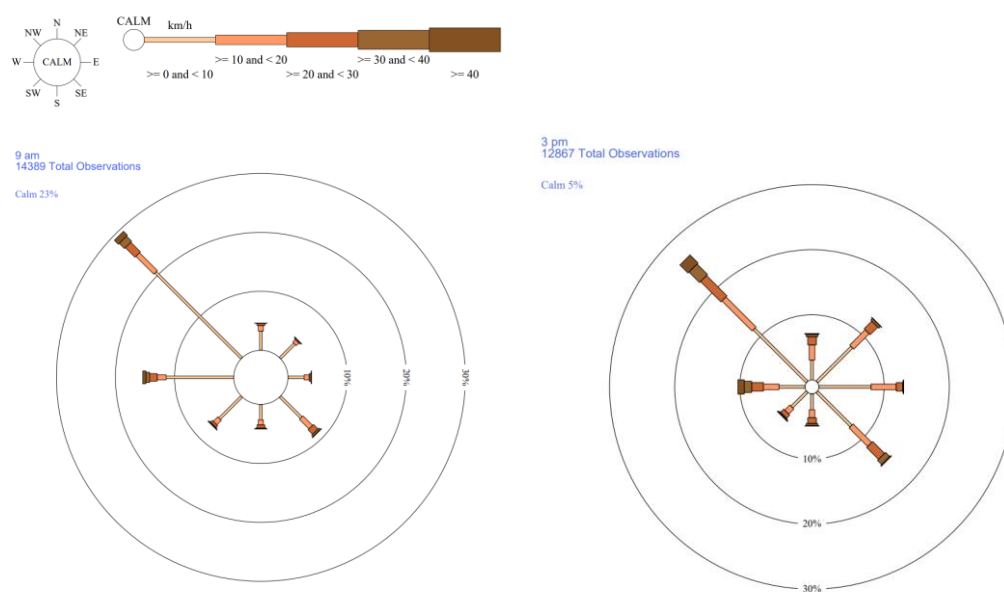
FIGURE 7: WIND ROSES FOR ANNUAL DATA - COLLECTED AT 9AM (LEFT) AND 3PM (RIGHT)

Wind data was extracted from the Bureau of Meteorology's online dataset<sup>4</sup>, which includes wind speed and direction roses. The observation point for the obtained data was the St Helens Post Office, site number 092033, recorded between 1957 to 2001. Data was extracted for 9am and 3pm readings, for annual, winter and summer datasets summaries, presented below in **Figure 7**, **Figure 8** and **Figure 9** respectively. At Scamander, the prevailing wind direction is from the northwest, particularly in winter, with more SE, E and NE contributions in summer.

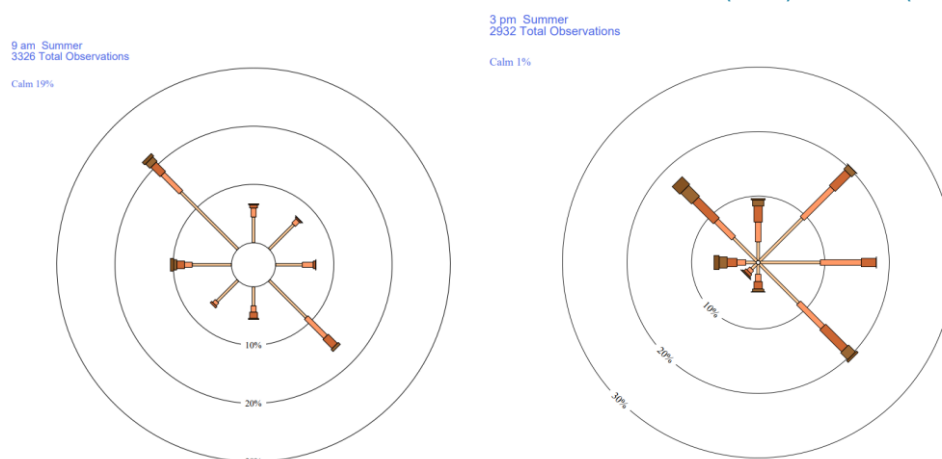
**FIGURE 8: WIND ROSES FOR SUMMER DATA - COLLECTED AT 9AM (LEFT) AND 3PM (RIGHT)**

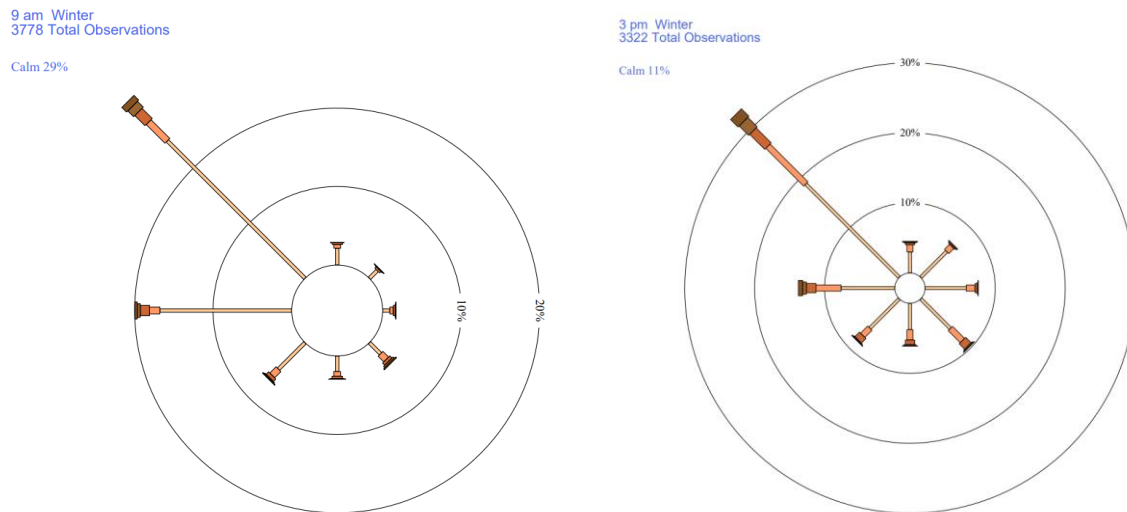
**FIGURE 9: WIND ROSES FOR WINTER DATA - COLLECTED AT 9AM (LEFT) AND 3PM (RIGHT)**

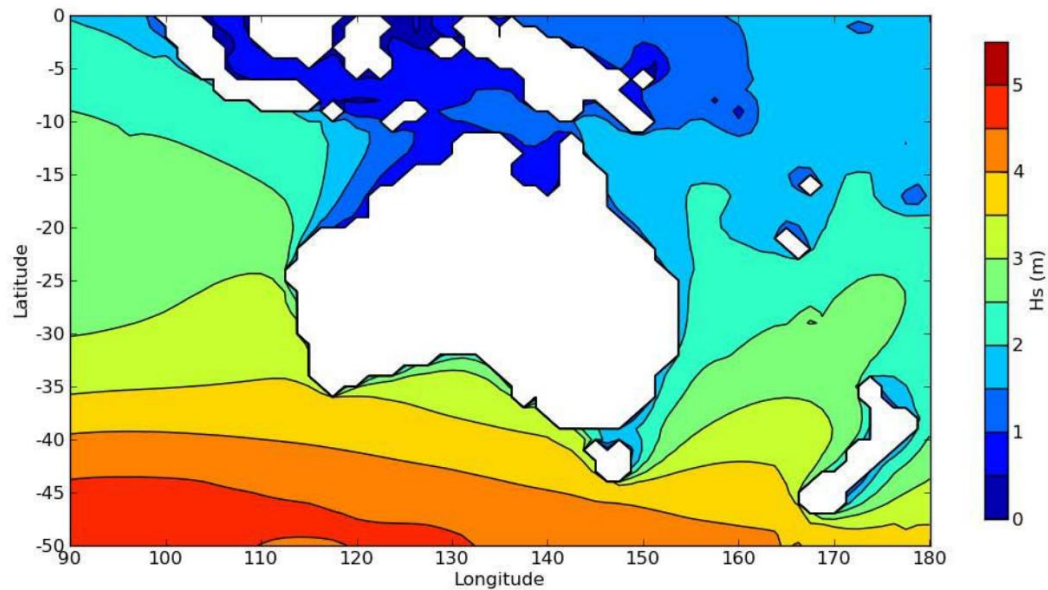
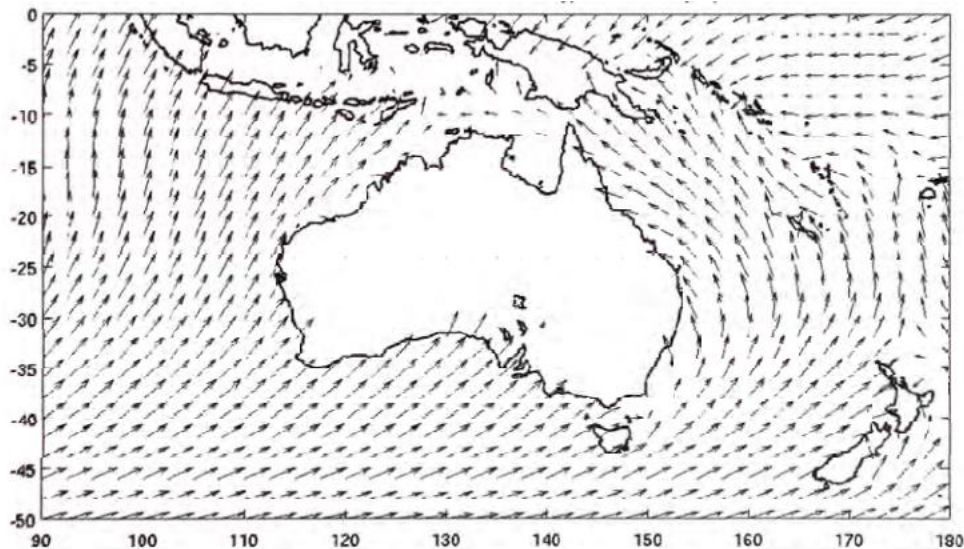
**Figure 5:** Coarse-resolution modelling of long-term mean significant wave height ( $H_s$ ) for Australian coasts, from Hemer *et al.* (2007). Significant wave height is the average of the highest one third of waves in a wave train or wave record, and is related to wave energy. Despite the coarse resolution of this model several distinctive wave climates are clearly definable around the Tasmanian coast, ranging from a high energy west-southwest coast regime to lower energy east coast and Bass Strait coast wave climates.

**FIGURE 10: LONG-TERM MEAN SIGNIFICANT WAVE HEIGHT (TOP) AND MEAN WAVE DIRECTION (BOTTOM) AROUND AUSTRALIA BASED ON NWW3 MODEL (1997 - 2007) (FROM HEMER ET AL., 2007)**

Mean significant wave height for Australian coasts is presented in **Figure 10**.

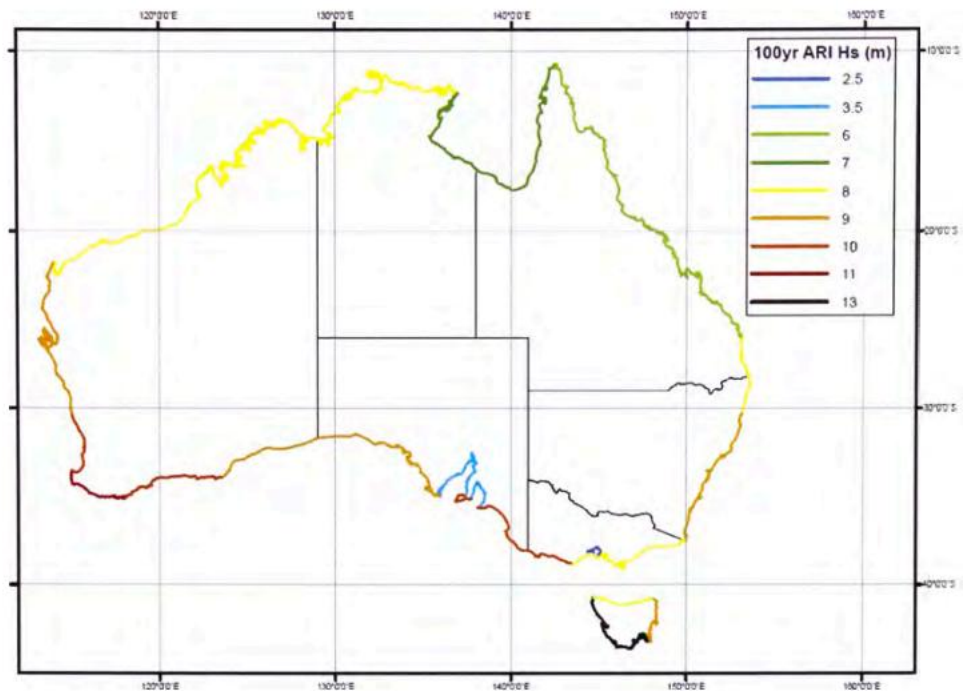
FIGURE 11: 100 YEAR ARI SIGNIFICANT WAVE HEIGHT (FROM MARIANI ET AL. 2012).

The identification and analysis of large events observed within a historical record allows quantification of extreme event and, using appropriate extreme value analysis, characterisation of large, low probability wave events. Maps showing adopted peak (1 hour) significant wave height around Australia for a 100 year ARI events are shown below (**Figure 11**) adopted by after collation of various studies. For the east coast of Tasmania, the 100 year ARI (1 hour) significant wave height ( $H_s$ ) was estimated as 9m (indicated by orange line).

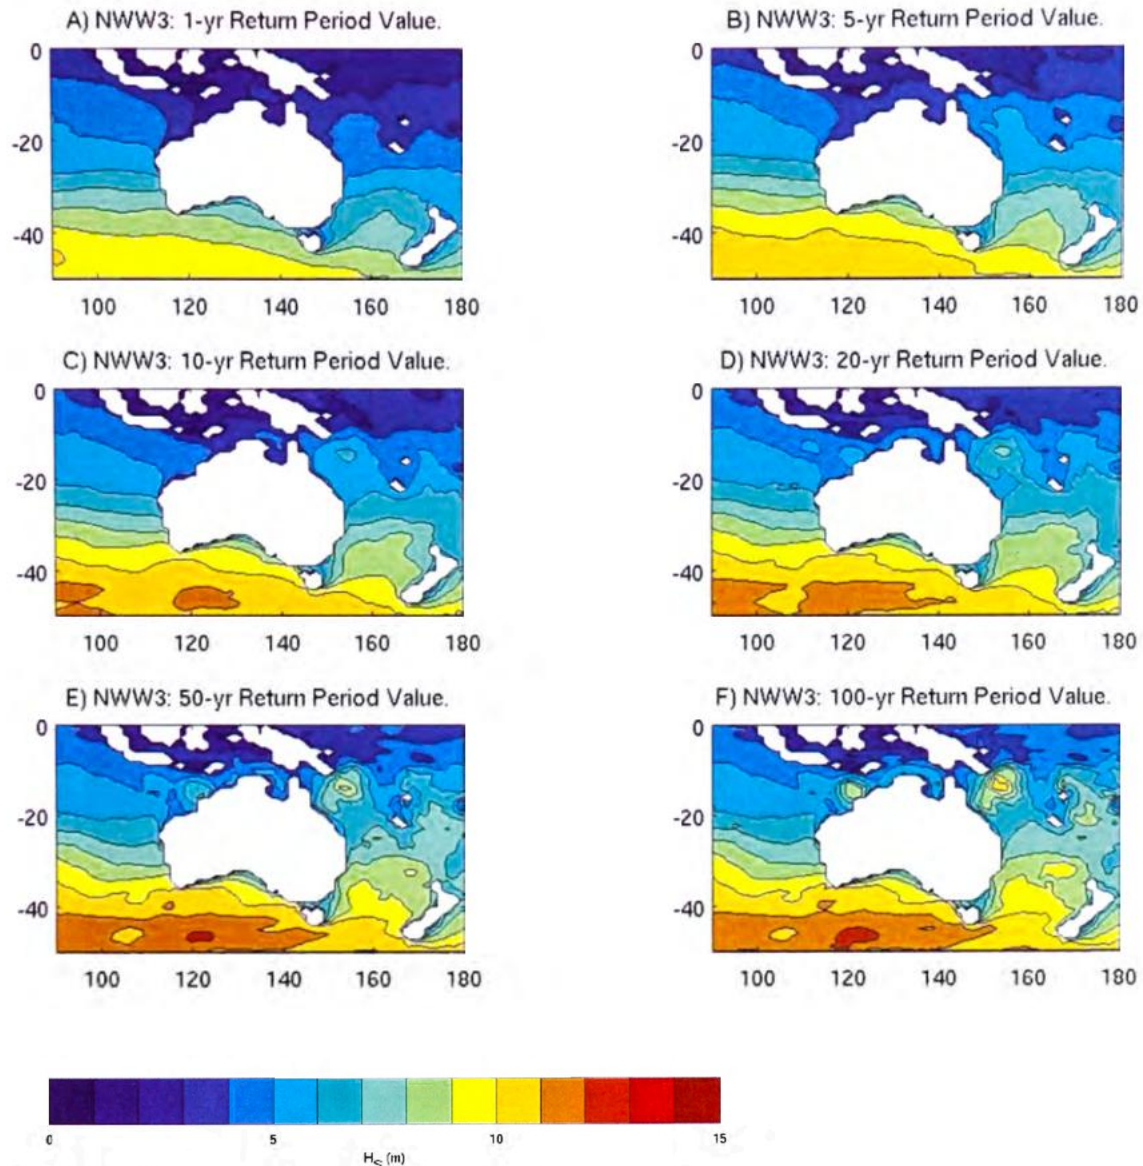
**FIGURE 12: N-YEAR RETURN AVERAGE RECURRENCE INTERVALS DETERMINED FROM NWW3 NUMERICAL DATASETS (SOURCE: HEMER ET AL., 2007)**

Hemer et al. (2007) derived extreme wave height values around Australia using the C-ERA-40 numerical hindcast (1957 - 2002) and NOAA WavewatchIII (NWW3, 1997 - 2009) numerical forecasts, for a range of return periods (**Figure 12**). The results presented by Hemer et al. (2007) indicated that for the north-east coast of Tasmania, the  $H_s$  is 8-9m, 5m and 4m for the 100 year ARI, 5 year ARI and 1 year ARI respectively.

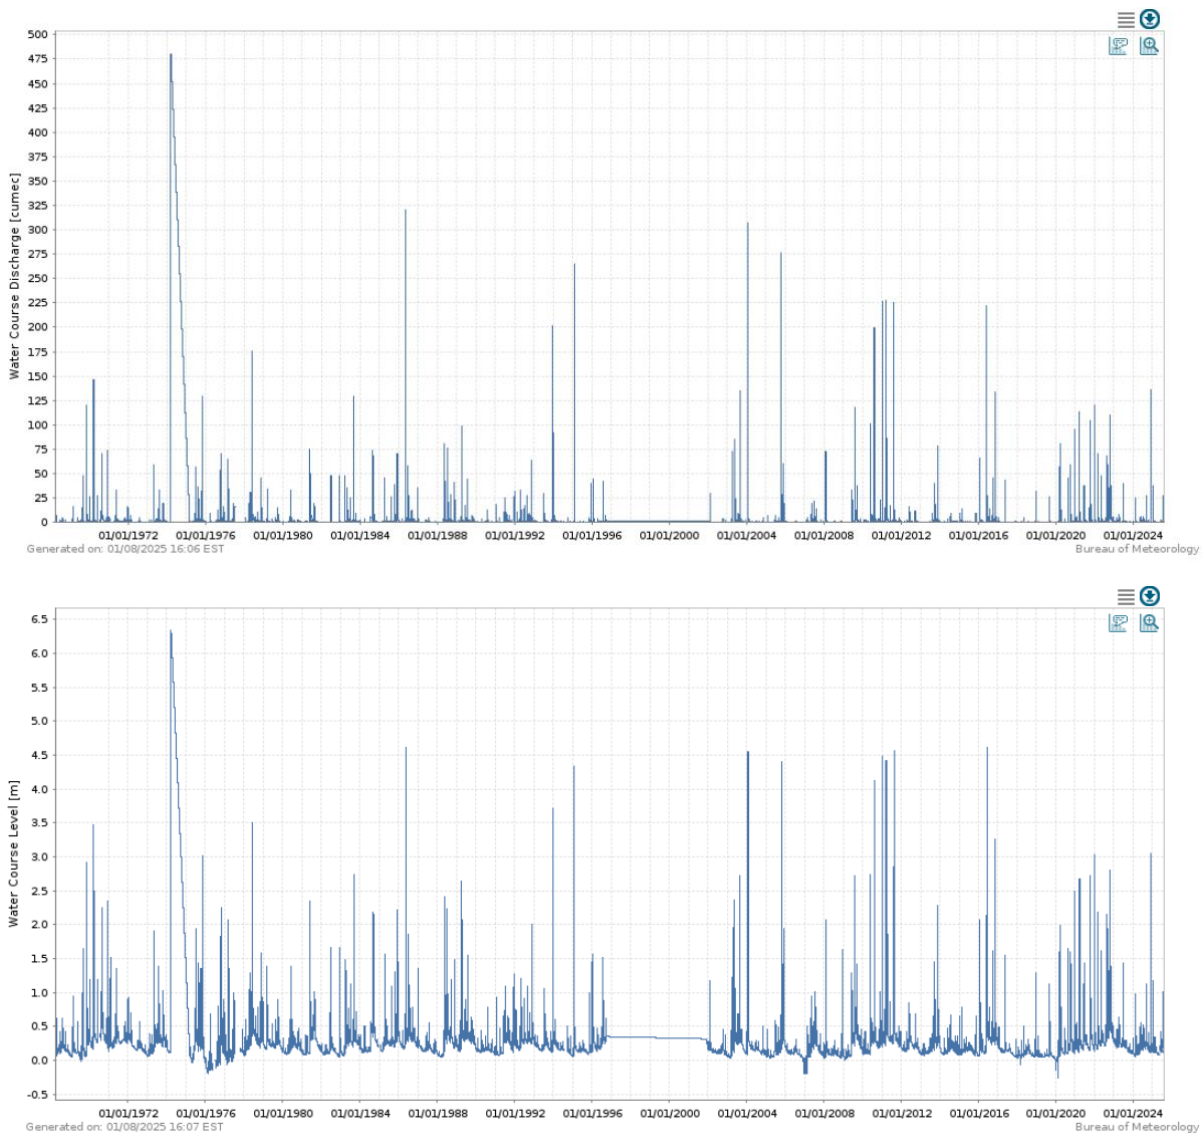
FIGURE 13: SCAMANDER RIVER U/S SCAMANDER WATER SUPPLY (STATION NUMBER 2206.1) WATERCOURSE DISCHARGE (TOP) AND WATERCORUSE LEVEL (BOTTOM) FOR THE RECORD PERIOD OF 1972 TO 2024.

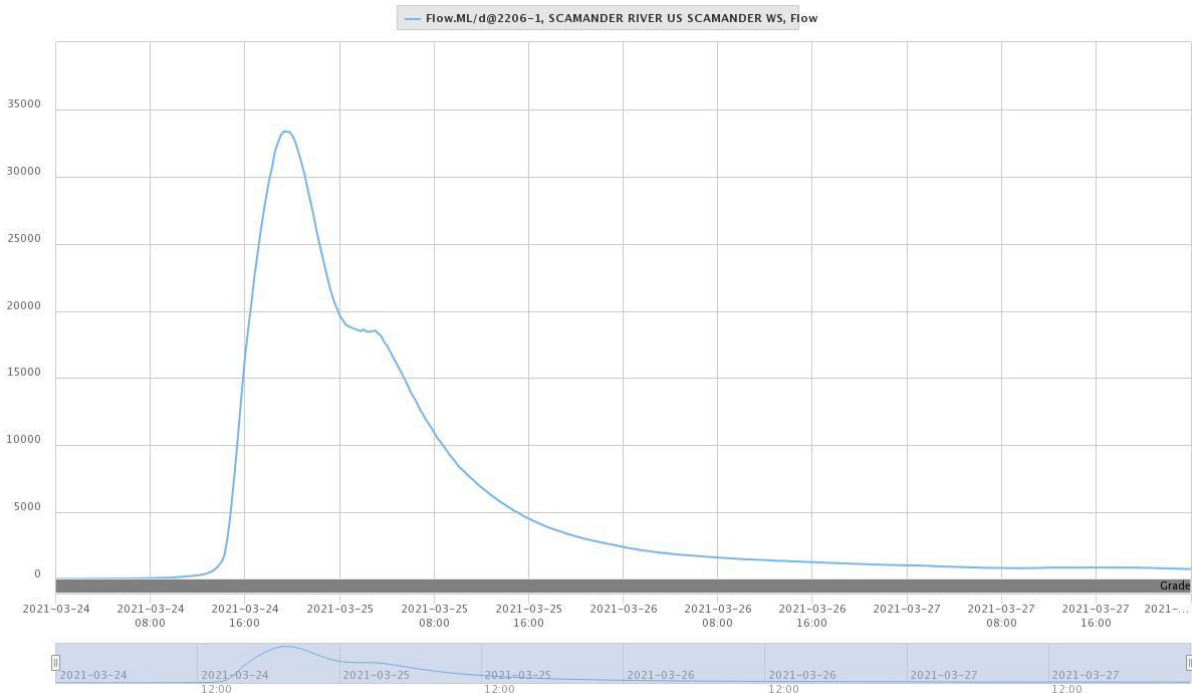
FIGURE 14: HYDROGRAPH OF THE MARCH 2021 HIGH RIVER FLOW EVENT.

influence on bridge longevity. Based on the March 2021 flood event, the rate of rise of flood waters was approximately 4 hours (Figure 14).

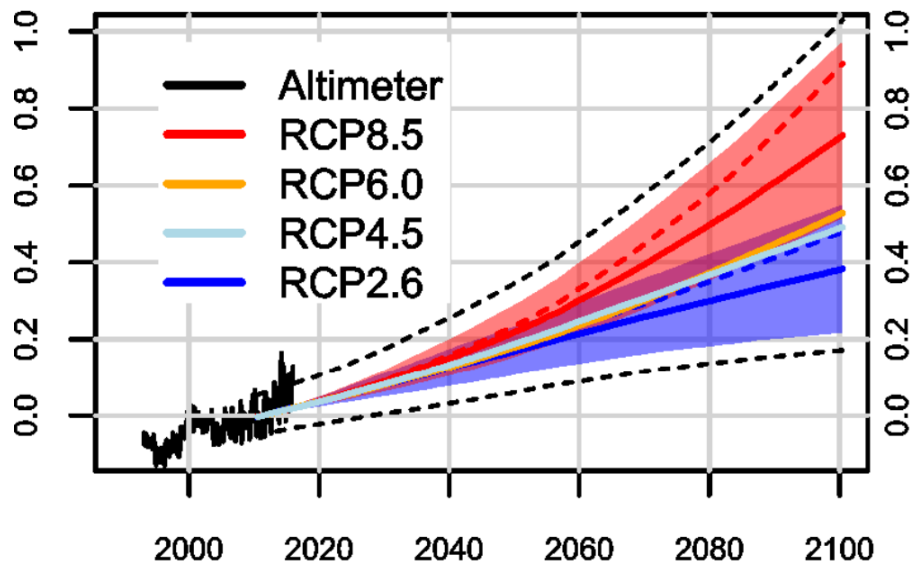
FIGURE 15: PROJECTED SEA-LEVEL RISE FOR BREAK O'DAY COUNCIL. THE BLACK LINE SHOWS THE SATELLITE-DERIVED SEA-LEVEL VARIABILITY SINCE 1993. MULTI-MODEL MEAN PROJECTIONS (THICK RED AND BLUE LINES) FOR RCP8.5 AND RCP2.6 WITH THE 5-95 PERCENTILE RANGE SHOWN BY THE RED AND BLUE SHADED REGIONS FROM 2010 TO 2100. THE BLACK DASHED LINES REPRESENT ESTIMATES OF INTERANNUAL VARIABILITY DETERMINED FROM THE SATELLITE ALTIMETER DATA COMBINED WITH THE RANGE OF THE PROJECTIONS. THICK LIGHT BLUE AND ORANGE LINES REPRESENT MULTI-MODEL MEAN PROJECTIONS FOR THE RCP 4.5 AND 6.0 SCENARIOS, RESPECTIVELY (FROM MCINNES ET AL., 2016).

In March 2016, the Tasmanian Government engaged the Commonwealth Scientific and Industrial Research Organisation (CSIRO) to develop sea level rise planning allowances for Tasmania's coastal councils based on the International Panel on Climate Change (IPCC)'s Fifth Assessment Report (AR5). This provided sea level rise predictions for a number of Tasmanian council areas (including Break O'Day) (**Figure 15**). In addition, the work provided regional appropriate sea level rise projections and allowances (SLRPAs) for all of Tasmania to 0.92 m by 2100 in the northeast of Tasmania (McInnes et al, 2016). These projections are based on the IPCC AR5's high emissions, 'business-as-usual' scenario, known as Representative Concentration Pathway 8.5, or RCP 8.5.

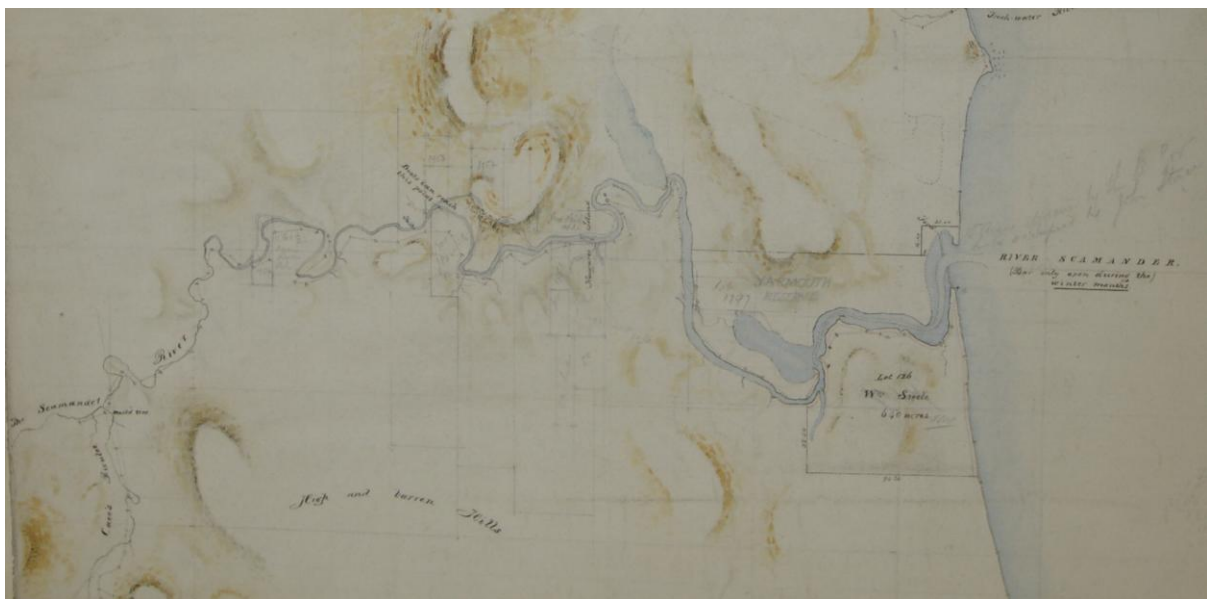
**FIGURE 16: EARLY MAP OF THE ESTUARY AND OPENING OF THE SCAMANDER RIVER: (DAWSON, CIRCA 1844). NOTE: BRIDGE SITE, SPIT TYPICAL OF WAVE DOMINATED ESTUARIES EXTENDING NORTHWARD SOME 400 METRES ACROSS THE OPENING FROM THE SOUTHERN BANK, AND SOME 50 METRES SOUTH FROM NORTHERN BANK. DOTTED LINES REPRESENT A DEEPER CHANNEL WITHIN THE MAIN CHANNEL, RUNNING CLOSE TO A ROCKY POINT AT THE NORTHERN END OF THE BRIDGE. A FORD IS INDICATED FROM THE TIP OF THE SOUTHERN SPIT TO THE CONCAVE NORTHERN BANK, INSIDE THE RIVER MOUTH. (TASMANIAN HISTORICAL ARCHIVES) (FROM FEARMAN, 2021)**

The trend analysis allowed for identification of key changes over time in the morphology of the entrance and shoreline position. Of interest to the project was the condition of the entrance (open/closed) and when open, the location. The location of the entrance and it's state (open/closed) through time is presented in **Figure 17** and **Figure 18** below. It should be noted that on Dawson's map, the river opening is described as 'open only in the winter months' and sediments across the river mouth were sufficiently compacted to allow fording with wagons' (Dawson, Circa 1844) (reported in Fearman, 2021).

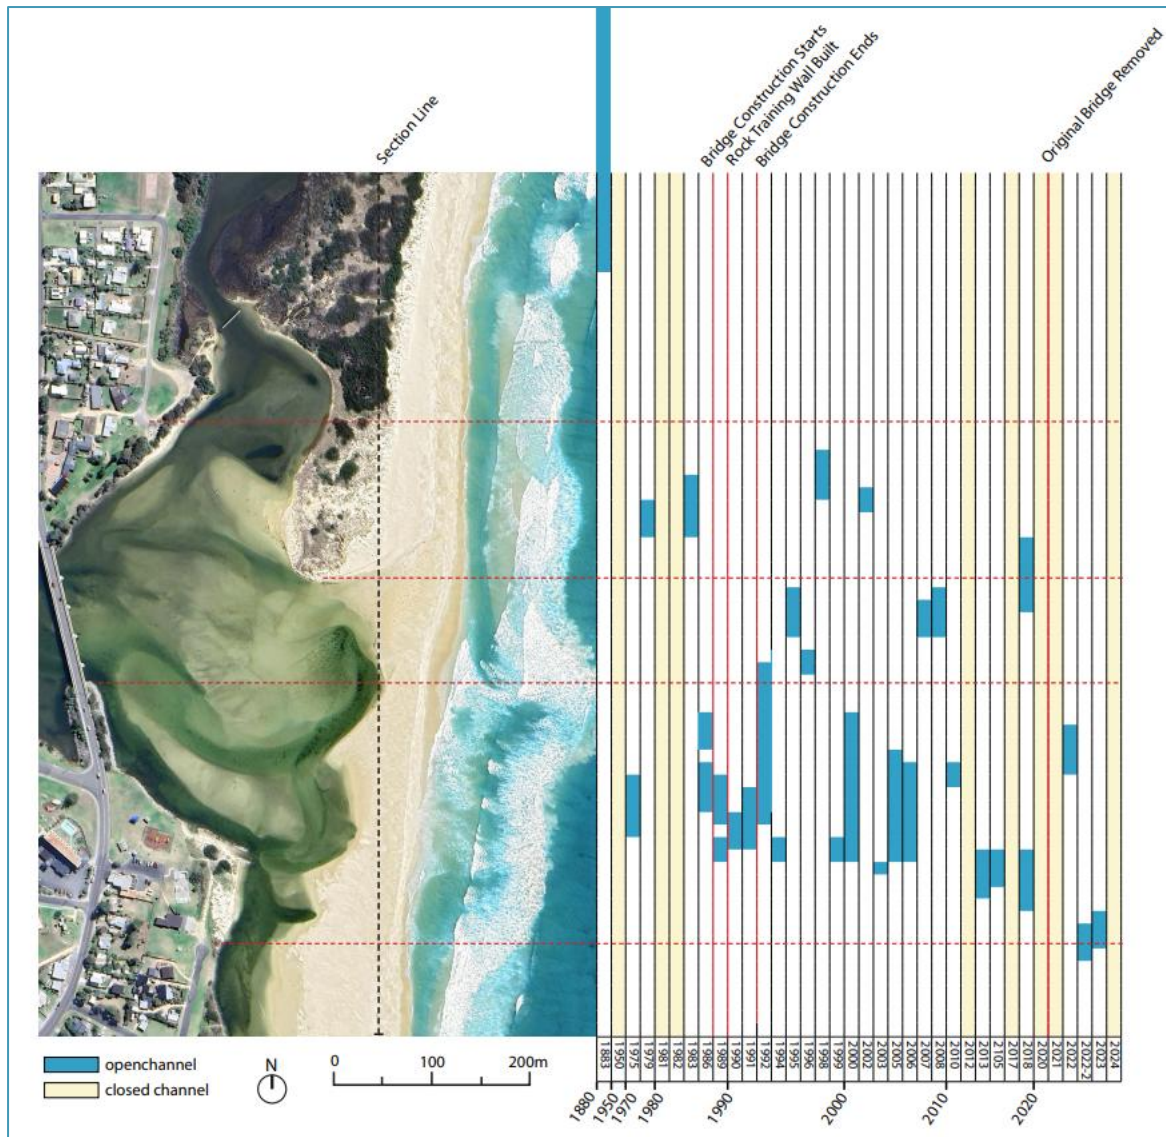
FIGURE 18: SCAMANDER RIVER ENTRANCE STATE (OPEN/CLOSED) AND LOCATION (IF OPEN) - GRAPHED AGAINST CURRENT (2025) AERIAL IMAGE. INFORMED BY AVAILABLE AERIAL IMAGES AND HISTORIC MAP.

The entrance was closed in seven of the 36 aerial images. The location of the entrance ocellated north and south, when open.

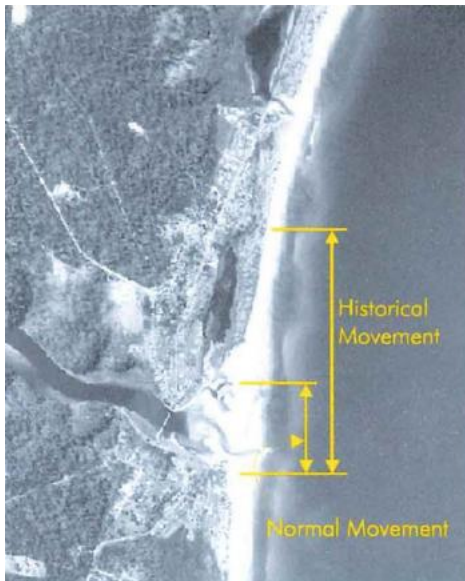
**FIGURE 19: HISTORICAL AND NORMAL MOVEMENT OF THE SCAMANDER RIVER CHANNEL ENTRANCE (FROM BYRNE 2000)**

From an extent point of view, the analysis is broadly consistent with the analysis of Byrne (2000) who determined that the maximum historical extent of the movement is probably up to 1500 metres, judging by the length of coastal escarpment north of the township. Byrne (2000) suggested that the normal movement appears to be less than 500 metres (**Figure 19**). However, the above analysis, supplemented by on-site photographs shows that the channel has migrated further south in recent years.

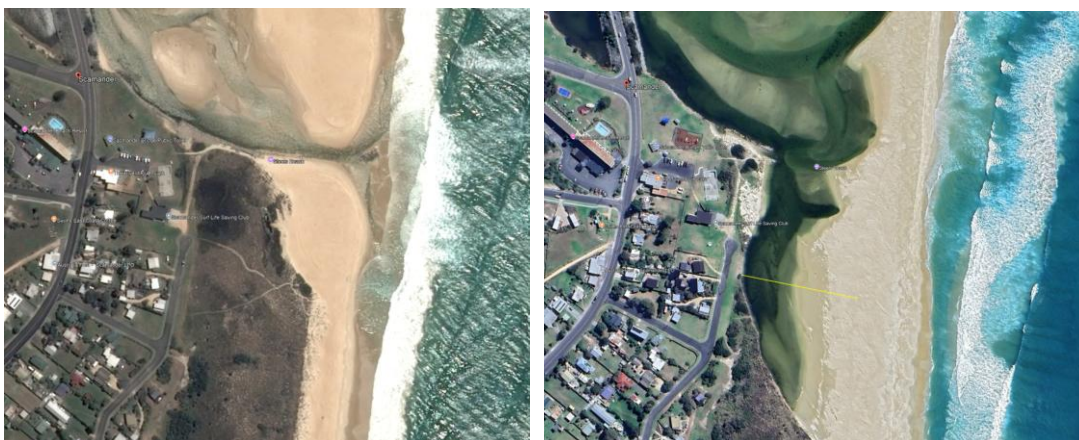
FIGURE 20: AERIAL IMAGERY FROM 2015 (LEFT) AND 2024 (RIGHT) SHOWING MEASURED DISTANCE OF FORESHORE CHANGE

A recent significant change has been the shoreline recession and channel alignment in front of Dune Street. Since 2015 there has been significant change. Approximately 120m of recession of dune line adjacent to Dune Street has occurred (**Figure 20**) since 2015. This change appears to coincide (maybe correlate) with damage to the landward portion of the training wall, which is still visible in the 2015 image. The result is a reformation of a hind dune marsh (**Figure 21**). The change appears to have occurred in three episodes (from interpretation of the available aerial imagery):

1. between 2015 and 2017;
2. again in 2021; and
3. another change between 2023 and 2024.

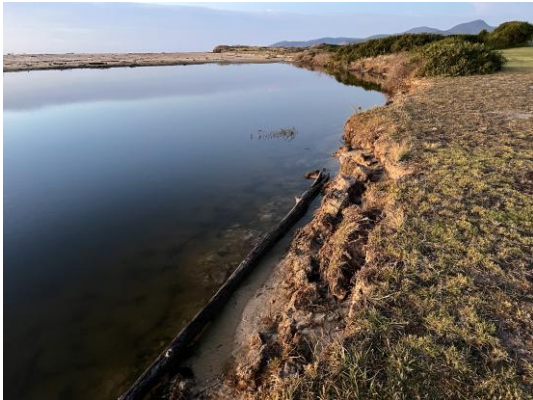
FIGURE 21: HIND DUNE MARSH FORMED IN FRONT OF DUNE STREET. THE FORESHORE IS SHOWING EVIDENCE OF ACTIVE EROSION (PHOTO BY N. LEWIS)

There is an ongoing erosion and risk of further erosion along the river and estuary foreshore. Notably, there is active erosion at Dune Street (described earlier in **Figure 21**). A cursory inspection of the riverbanks along Upper Scamander Road identified riverbank sections protected from rock and gabions (refer **Figure 31** below). In places the riverbank is close to the road and low lying.

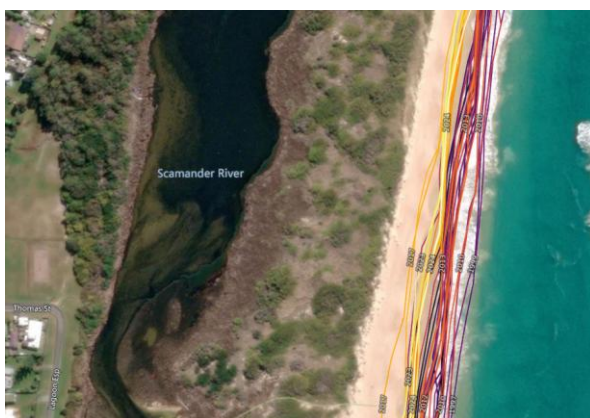
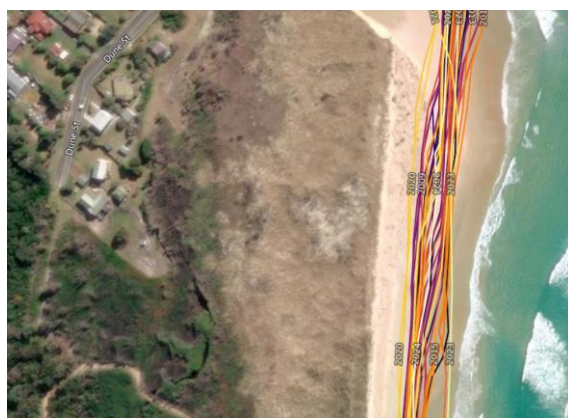
Historical shoreline position has been mapped by Geosciences Australia<sup>8</sup> who have mapped the average shoreline position each year between 1988 and 2024. Whilst the mapping includes the inner estuary including the channel(s) and sand shoals, mapping of the complex inner estuary features is complex and not conducive to analysis by straight line shoreline mapping. It does however, corroborate the trend analysis above in showing the dynamic movement of the channels, mouth & entrance condition. Refer above for a more useful spatial trend analysis of the entrance channel. The data presented is useful for indicating the long-term trend of open coast shoreline position. The mapping demonstrates the following trends, presented for locations approximately 400m north and 400m south of the entrance respectively (**Figure 22**):

- **North of the entrance** - This coastline has retreated by -0.5 metres ( $\pm 0.3$ ) per year on average since 1988. The shoreline at this location was most seaward in 1999, and most landward in 2018. Since 1988, the median annual position of the shoreline has moved over a total distance of approximately 51 metres.
- **South of the entrance** - This coastline has been net stable since 1988 (no significant trend of retreat or growth). 'Net stable', as defined in the mapping are coastlines or regions that have remained relatively unchanged since 1988, or where shorelines have fluctuated between growth and retreat over time. The shoreline at this location was most seaward in 2023, and most landward in 2019. Since 1988, the median annual position of the shoreline has moved over a total distance of approximately 29 metres.

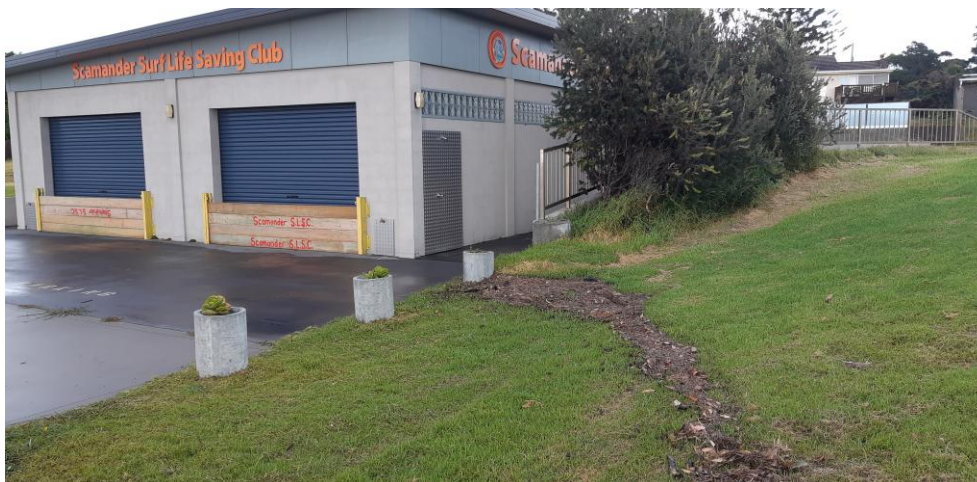
**FIGURE 23: DEBRIS LINE AT THE SCAMANDER SLSC FOLLOWING THE MARCH 2021 EVENT**

The March 2021 event was the largest recent event and comprised both river flooding and a coastal storm. A peak river flow of 34,000 MI/day peak flow (393m<sup>3</sup>/s) (somewhere in between the 10% and 20% event) was achieved. The barway was initially closed, and then opened mechanically. Storm surge and wave runup caused overtopping of the barway and foreshore areas. The channel migrated south and caused the foreshore in front of Dune Street to erode landward. The extent of wave runup was evident from debris lines (**Figure 23**), visible along Dune Street, the Pelican Sand foreshore and across the reserve on the south of the river, including Scamander SLSC. Refer **Appendix B** for more photos.

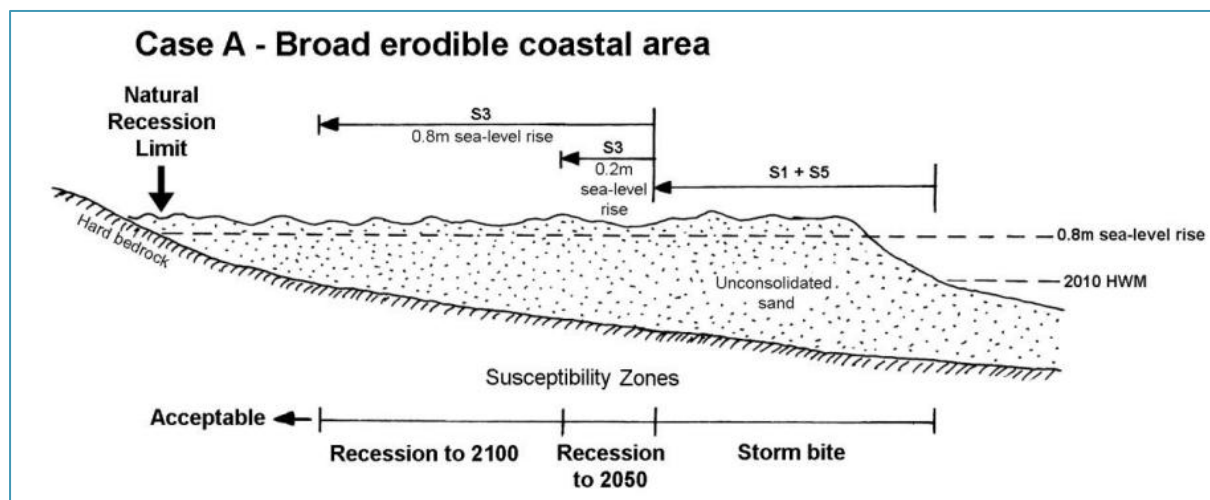
**FIGURE 24: DIAGRAM ILLUSTRATING HOW COASTAL EROSION SUSCEPTIBILITY ZONES FOR TASMANIAN SWELL-EXPOSED (OPEN COAST) SANDY BEACHES ARE DEFINED IN SHARPLES ET AL (2013). COASTAL EROSION HAZARDS ARE 'ACCEPTABLE' (I.E., UNLIKELY) TO LANDWARDS OF THE NATURAL RECESSION LIMIT OR THE FULL EXTENT OF (S1 + S3 (0.8M SLR) + S5), WHICHEVER COMES FIRST. 'HWM' IS THE MEAN HIGH WATER MARK.**

Sharples, et al. (2013) used SBEACH and XBEACH modelling software was used to calculate generic short-term storm bite magnitudes (S1) for a 'design storm' comprising two back-to-back 100 year ARI storms; an allowance for a zone of reduced foundation capacity (or dune instability) backing the consequent erosion scarp was calculated as an additional setback (S5) using the method of Nielsen et al. (1992); and long term shoreline recession resulting from two sea-level rise scenarios of 0.4 m and 0.9 m rise by 2050 and 2100 relative to 1990 was estimated using a simplified application of the Bruun Rule. See Mariani et al. (2012) for further details of the conceptual basis and methodology used. The erosion susceptibility zones are shown diagrammatically in (Figure 24). Distances calculated for the Tasmanian east coast for S1, S3 and S5 are provided in (Table 3).

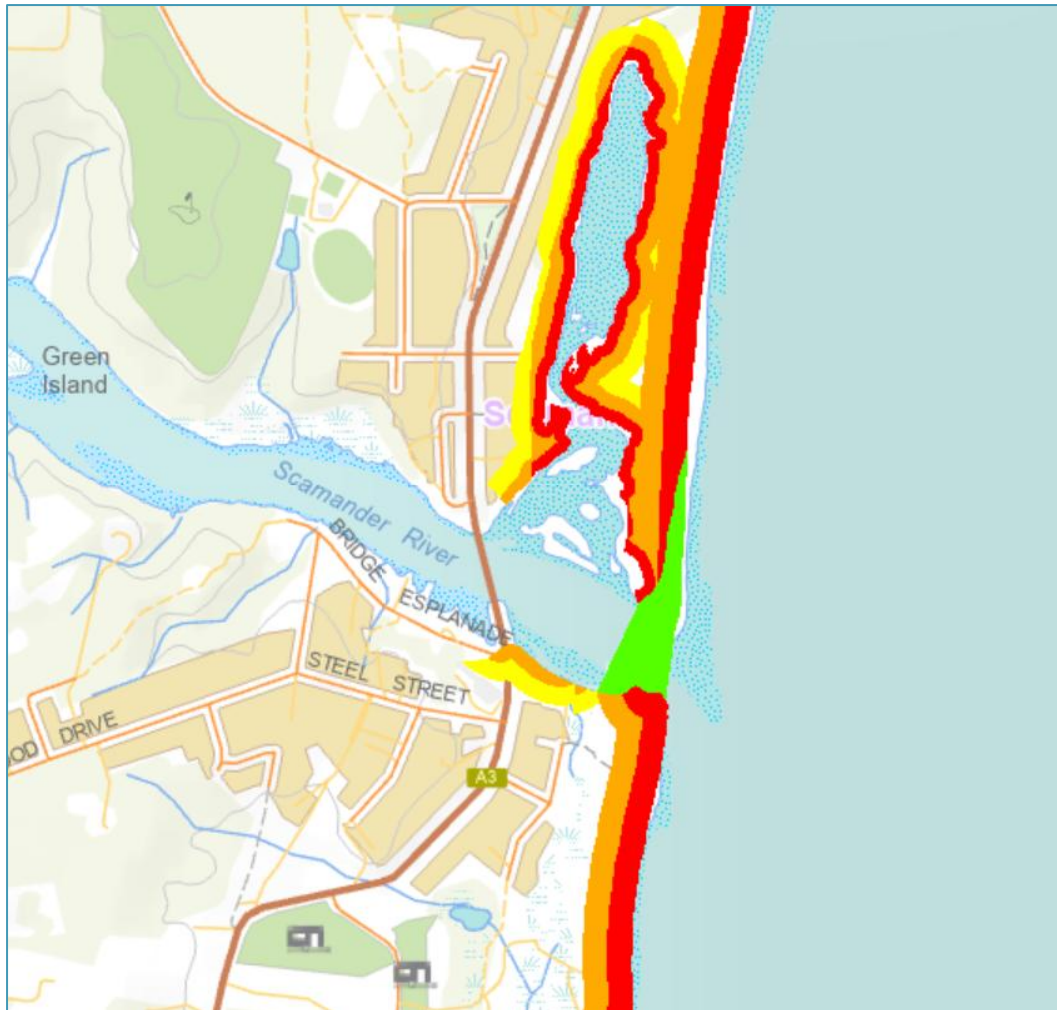
FIGURE 25: EROSION HAZARD BANDS; HIGH (RED); MEDIUM (ORANGE); LOW (YELLOW) (SHARPLES ET AL., 2013).

Dune Street is not assessed as being susceptible to erosion. This is most likely due to the shoreline position during the assessment (which has now changed) and also the fact that the assessment does not account for erosion associated with river channel movements (see below section on limitations / recommendations).
