# **SCAMANDER RIVER COASTAL HAZARDS RISK MITIGATION & PATHWAYS PLANNING**

**Outlook Report – Coastal and River System Processes,  
Hazards and Climate Change Memorandum**

Produced For Break O'Day Council

Date **5<sup>th</sup> September 2025**

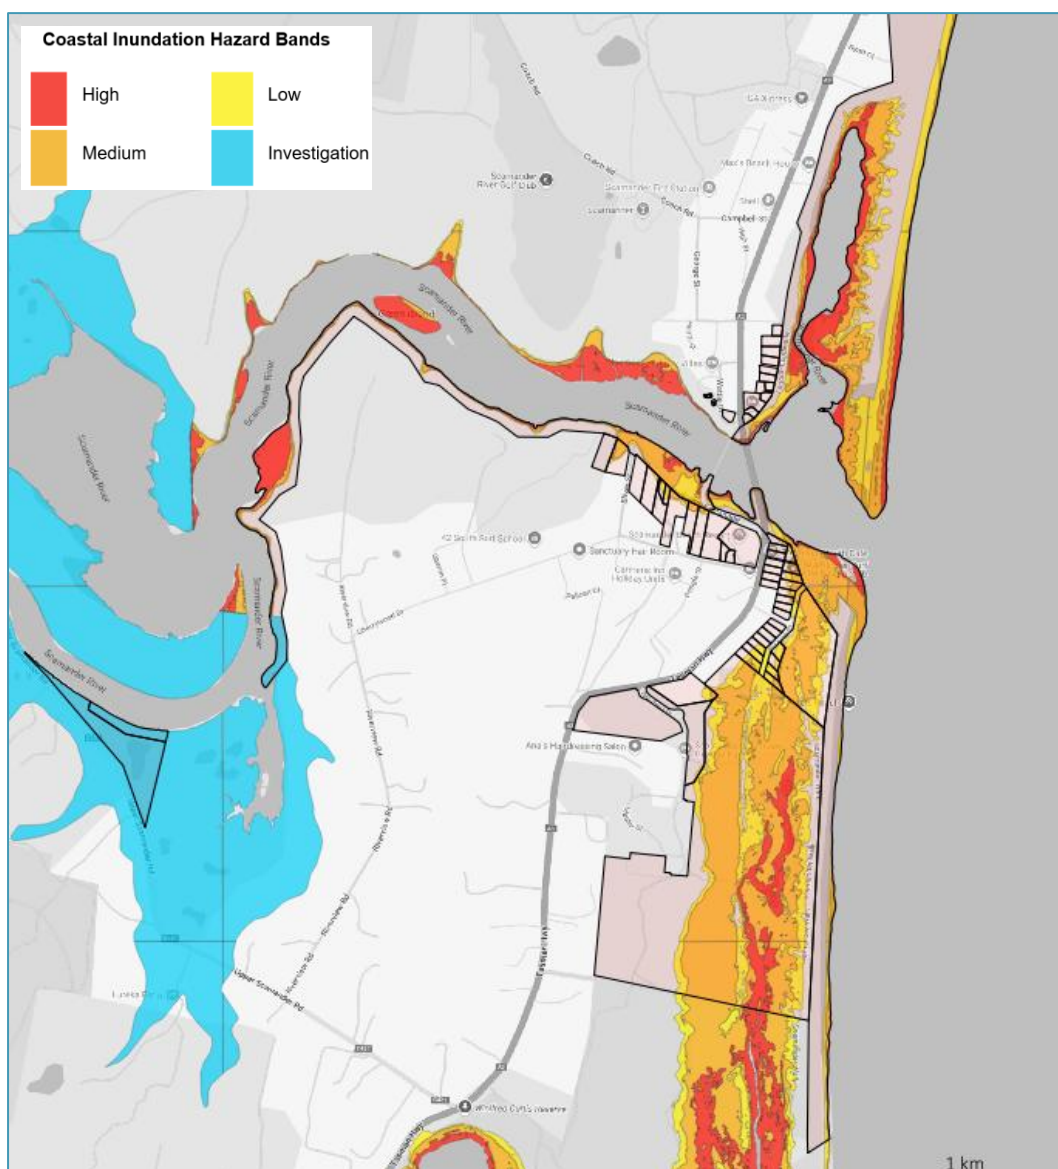
**FIGURE 26: COASTAL INUNDATION HAZARD BANDS AT SCAMANDER (LACEY ET AL, 2016, ACCESSED THROUGH TASMANIA LIST)**

- Dune Street – a number of properties in the low hazard band and one in the medium band.
- Scamander SLSC and adjacent foreshore in Medium and Low bands.
- Bridge Esplanade (road), as well as adjacent foreshore (north) and properties (south) in the Low and Medium bands.
- Foreshores of the hind dune marshes almost exclusively in the Low and Medium bands,
- Pelican sands foreshore, including pump station – in the Low and Medium bands.

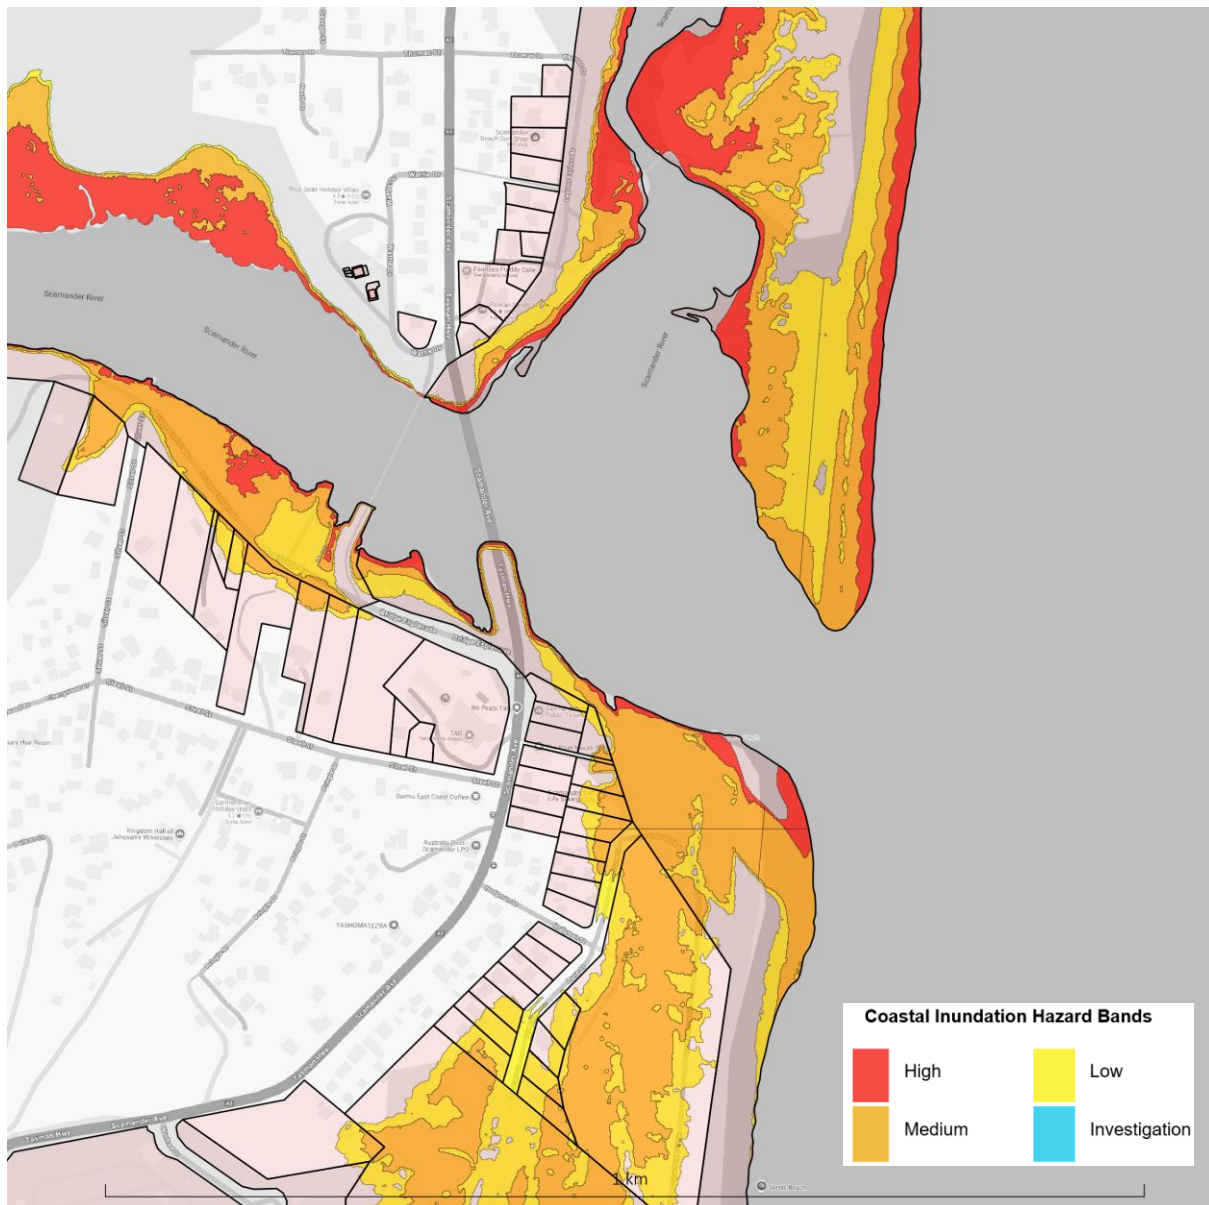
**FIGURE 27: COASTAL INUNDATION HAZARD BANDS AT SCAMANDER (LACEY ET AL, 2016). ZOOM IN TO TOWNSHIP.**

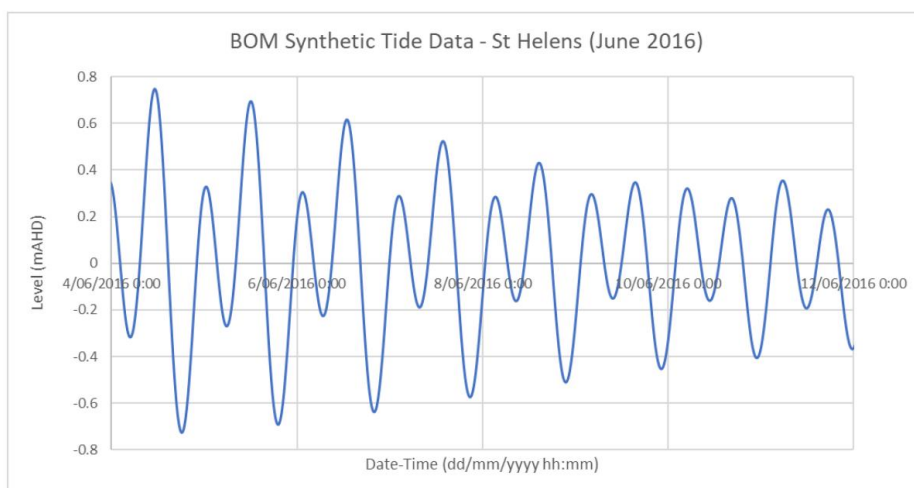
**FIGURE 28: SYNTHETIC TIDE DATA OFF THE COAST OF ST HELENS (JUNE 2016) USED AS DOWNSTREAM BOUNDARY IN THE FLOOD MODELLING (WMA WATER, 2023)**

Downstream boundaries were applied at the base of the model to provide interaction with the ocean. Synthetic tide data was provided by the Bureau of Meteorology (BOM) and was used to set a varying tide level for the calibration events. This data was extracted off the coast of St Helens at 10 min time increments and was imported as a time varying boundary condition. The below **Figure 28** shows an example of the synthetic tide data that was extracted off the coast of St Helens for the June 2016 event. Note there is no calibration information to verify the function of the tailwater condition thus the study did not make any allowance for local storm effects.

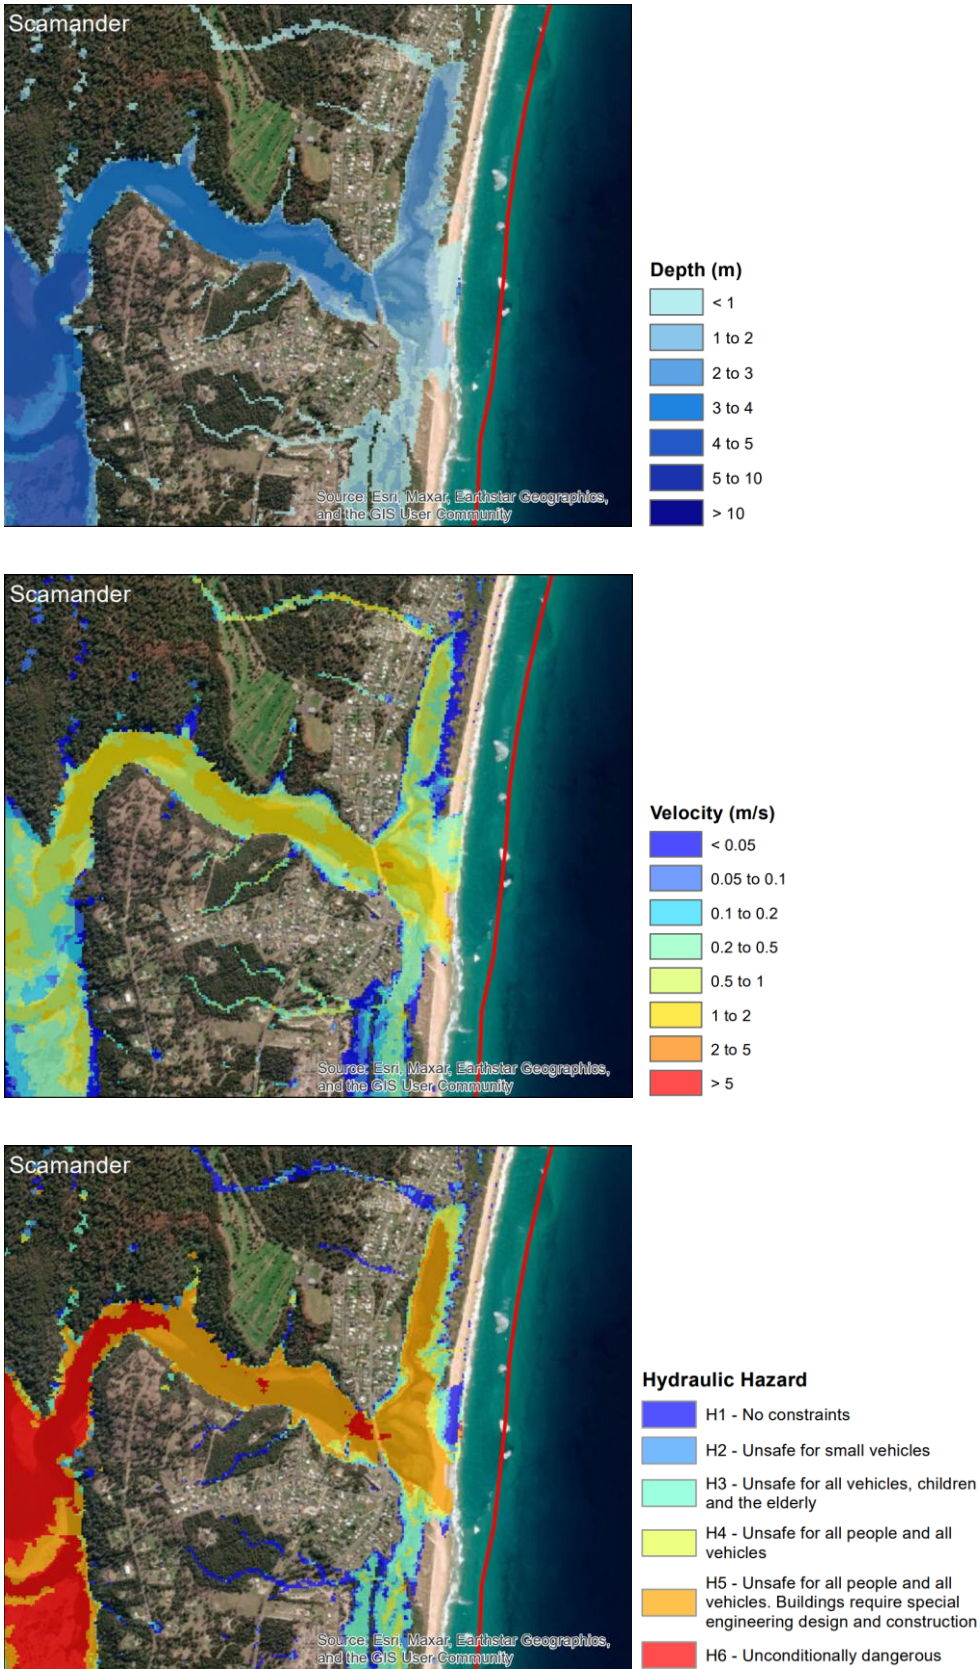
FIGURE 29: MODELLED 1% AEP PEAK FLOOD DEPTH (TOP), PEAK VELOCITY (MIDDLE), PEAK HYDRAULIC HAZARD (BOTTOM) (FROM WMA WATER, 2023)

Flood waters at more extreme events are in part constrained by the gorge. River flooding spreads across the wide floodplain upstream of the gorge. Downstream of the bridge, flood waters spread into the north and south hind dune marshes. Whilst depth increases with the climate change scenario, the horizontal extent does not change significantly between the 1% AEP and 1% AEP climate change scenarios. Notably, the flood water in the southern hind dune marshes links in with Henderson Lagoon in the 1% AEP event.

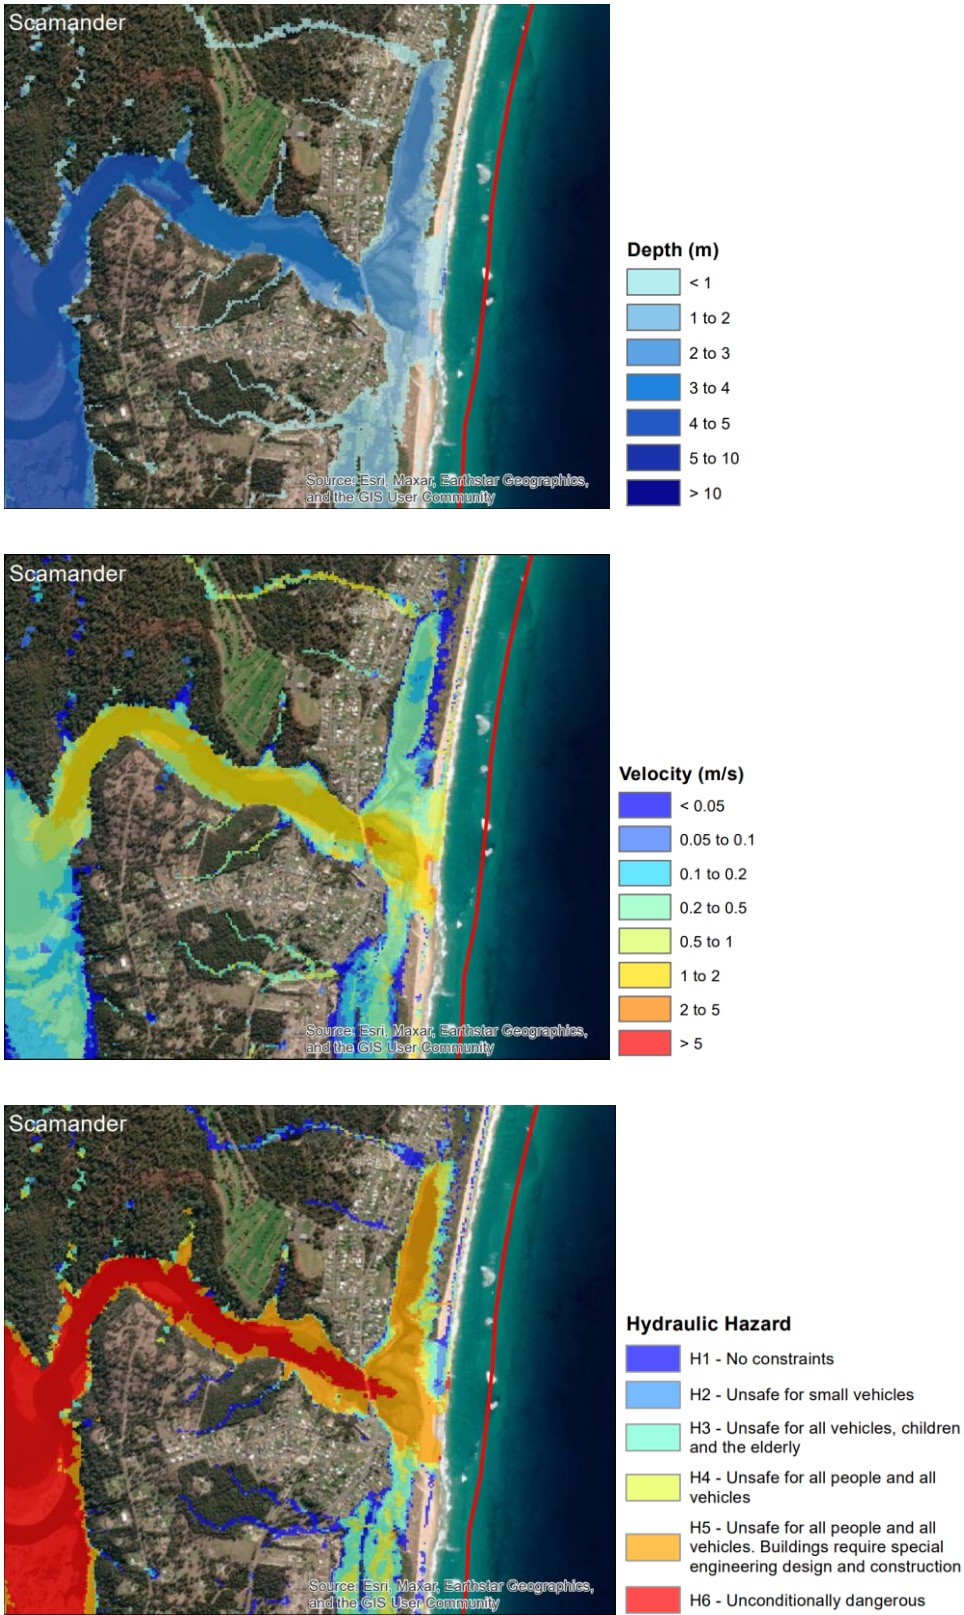
FIGURE 30: MODELLED 1% AEP PLUS CLIMATE CHANGE PEAK FLOOD DEPTH (TOP), AEP PEAK VELOCITY (MIDDLE), PEAK HYDRAULIC HAZARD (BOTTOM) (FROM WMA WATER 2023)

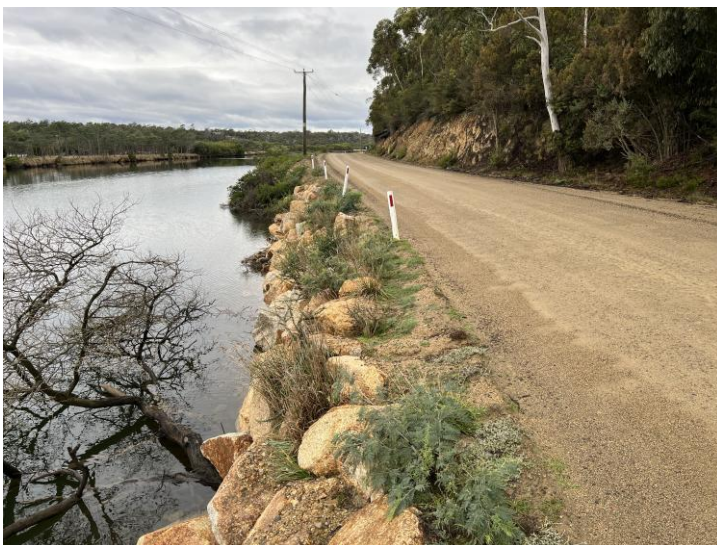
**FIGURE 31: RIVERBANK ROCK PROTECTION ALONG UPPER SCAMANDER ROAD (PHOTO BY N. LEWIS)**

There is an ongoing erosion and risk of further erosion along the river and estuary foreshore. Notably, there is active erosion at Dune Street (described earlier in **Figure 21**). A cursory inspection of the riverbanks along Upper Scamander Road identified riverbank sections protected from rock and gabions (refer **Figure 31** below). In places the riverbank is close to the road and low lying.

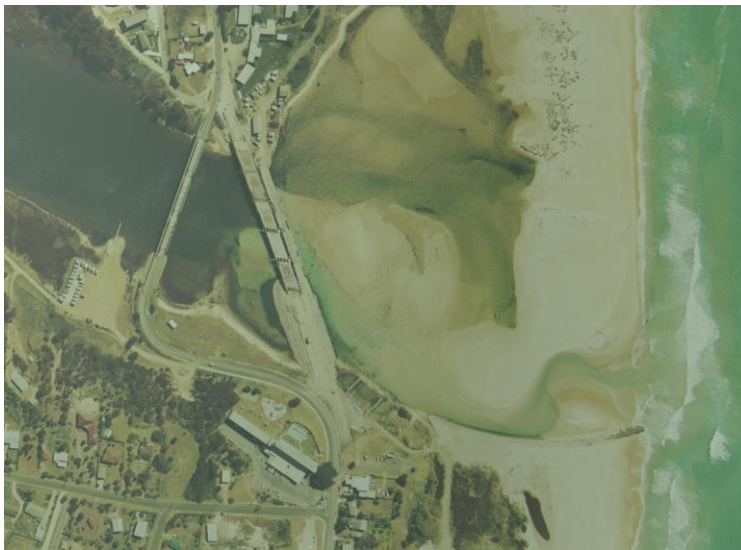
**FIGURE 32: AERIAL IMAGE FROM 2<sup>ND</sup> MARCH 1991 SHOWING THE PRESENCE AND LOCATION OF THE TRAINING WALL**

Until 2015, the training wall remained in place and appears to have been effective in controlling the channel from migrating south. It is noteworthy that during this period the channel did migrate north on occasion and did close on occasion. After 2015, the training wall is less visible, presumably getting damaged in the 2016 storm event. Following this, the channel was once again able to migrate south. Whilst remnants of the training wall are visible today, it is now severely damaged and has failed, collapsed, rocks displaced and in places buried with sand.

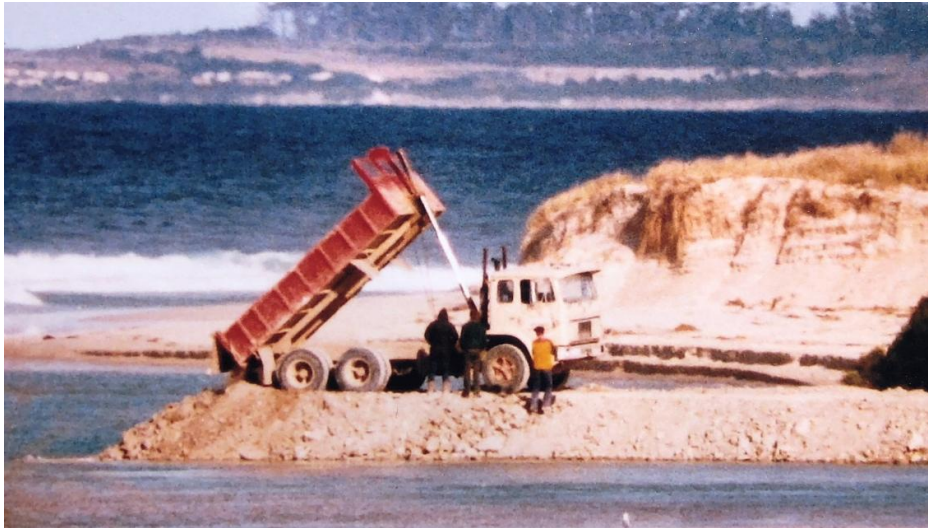
FIGURE 33: CONSTRUCTION OF THE TRAINING WALL IN 1989

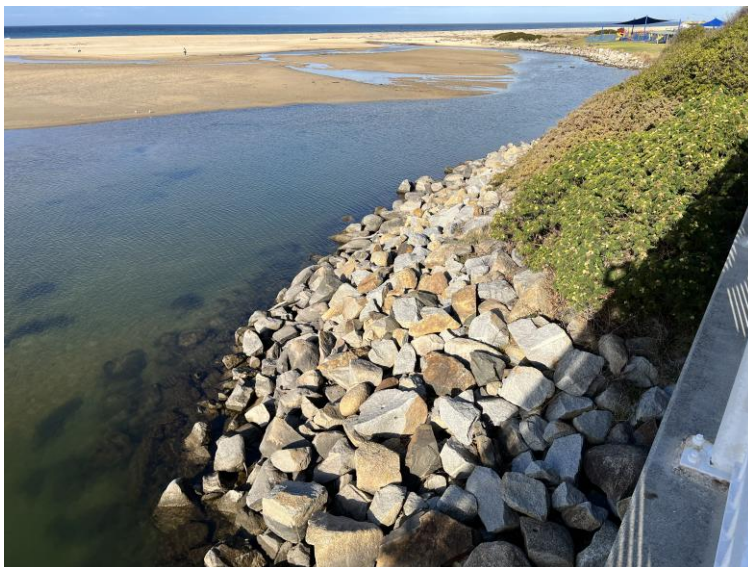
FIGURE 34: BRIDGE ABUTMENT SCOUR PROTECTION (PHOTO BY N. LEWIS)

In 1991, at the time of bridge construction. The abutment, which was built for the bridge and protrudes significantly into the Scamander River channel, was armoured with large rock to protect from scour and erosion (**Figure 34**). A cursory visual inspection indicates that the rock remains largely as placed.

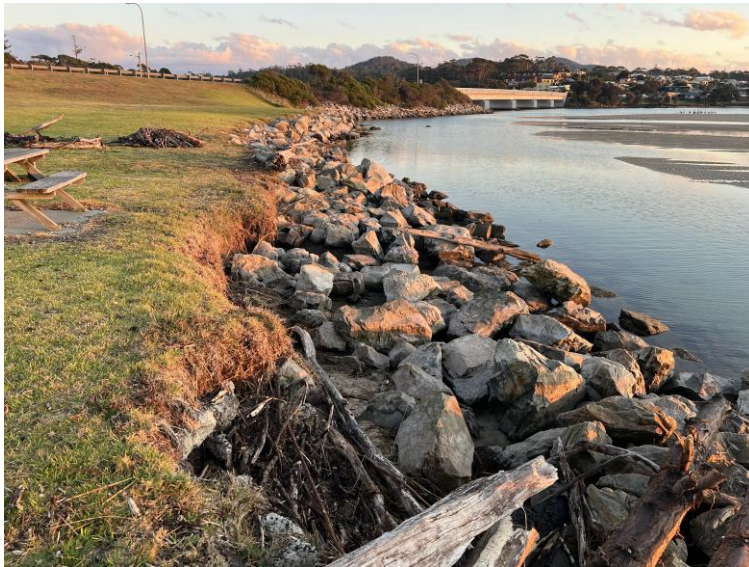
**FIGURE 35: FORESHORE EROSION PROTECTION ROCK WALL (PHOTO BY N. LEWIS)**

erosion is happening in the lee of the revetment (**Figure 35**). No rock underlayer or geofabric were visible, which are key components to rock revetment design. Damage to the revetment may indicate that the rock armour layer is undersized.

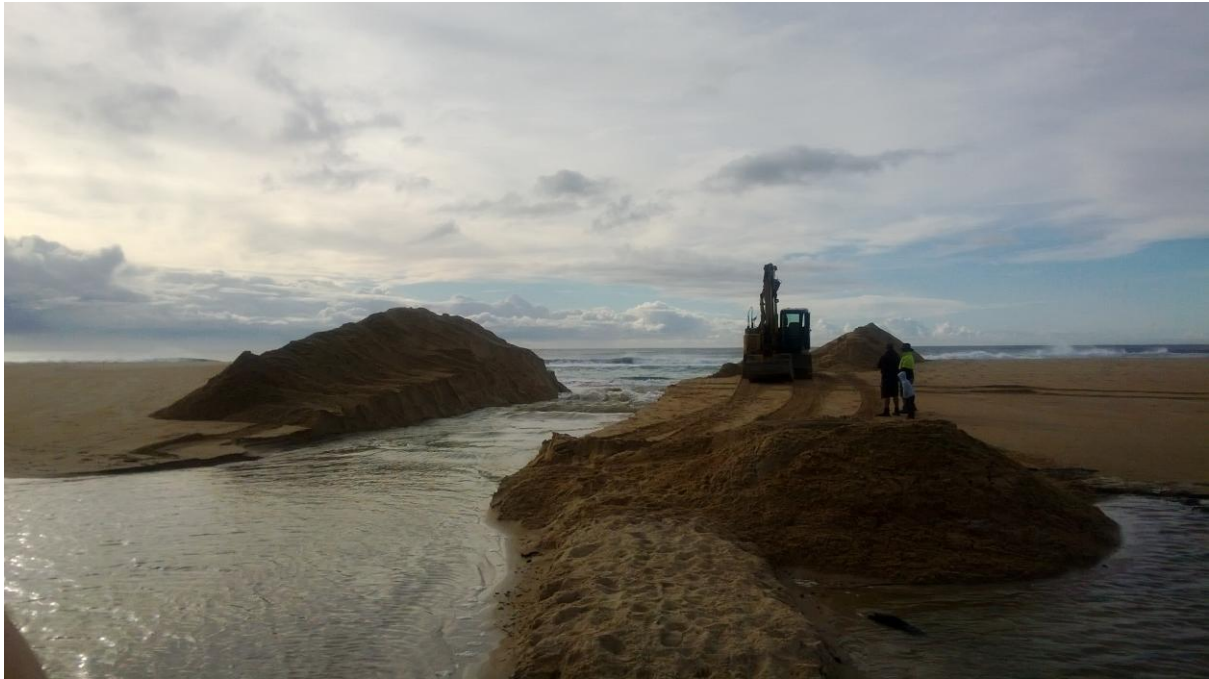
FIGURE 36: BARWAY OPENING PROCEDURE (AT COMPLETION)

Entrance opening is often problematic and inconsistent in success, impacted significantly by the risks posed by storm waves and high surge. **Appendix A** provides a photo record of barway opening in May and June 2025.

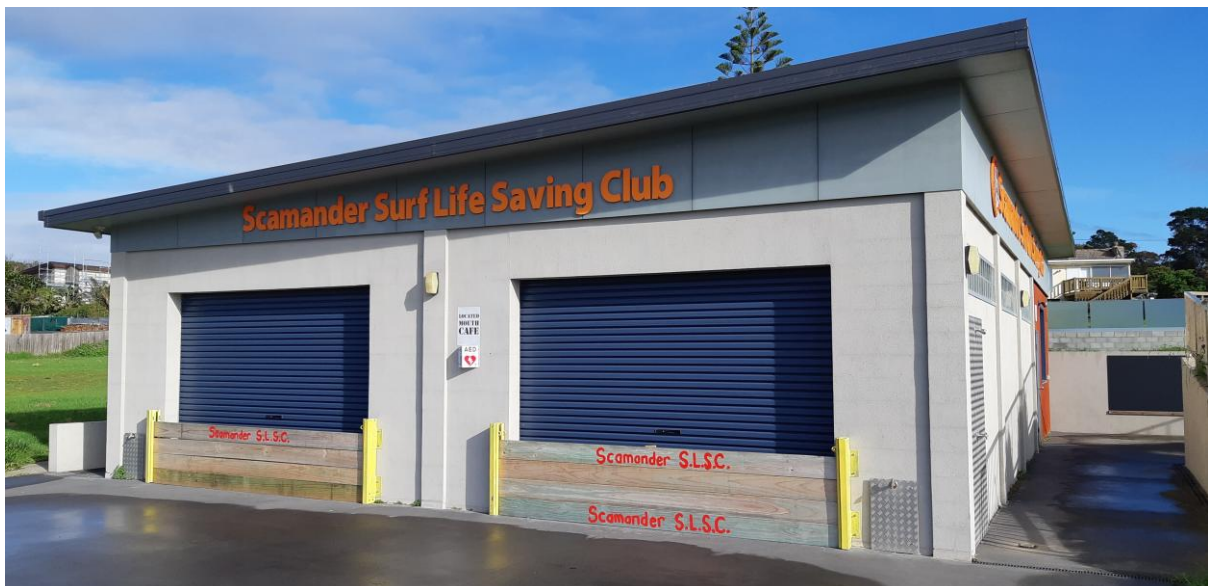
FIGURE 37: POST AND PANEL BOARDS AT SCAMANDER SLSC

Some localised informal mitigation has been implemented. Notably, at the Scamander SLSC, which has experienced inundation during coastal storms have installed post and panel flood board (see **Figure 37**). It is understood that a property along Bridge Esplanade is planning on undertaking property raising (Council pers. comms.).
