Development Applications

DA Number	DA 2025 / 00221
Applicant	M O'Sullivan and N McLeish
Proposal	Visitor Accommodation - Additional Use for Visitor Accommodation
Location	35 St Helens Point Road, Stieglitz (CT 81371/18) Access is currently achieved over 'Footway' (CT 45005/1) and 37 St Helens Point Road, Stieglitz (CT 81371/19)

IDENTIFICATION SURVEY

**RE: Coastal Erosion and Landslip Hazard Appraisal
35 St Helens Point Road, Stieglitz**

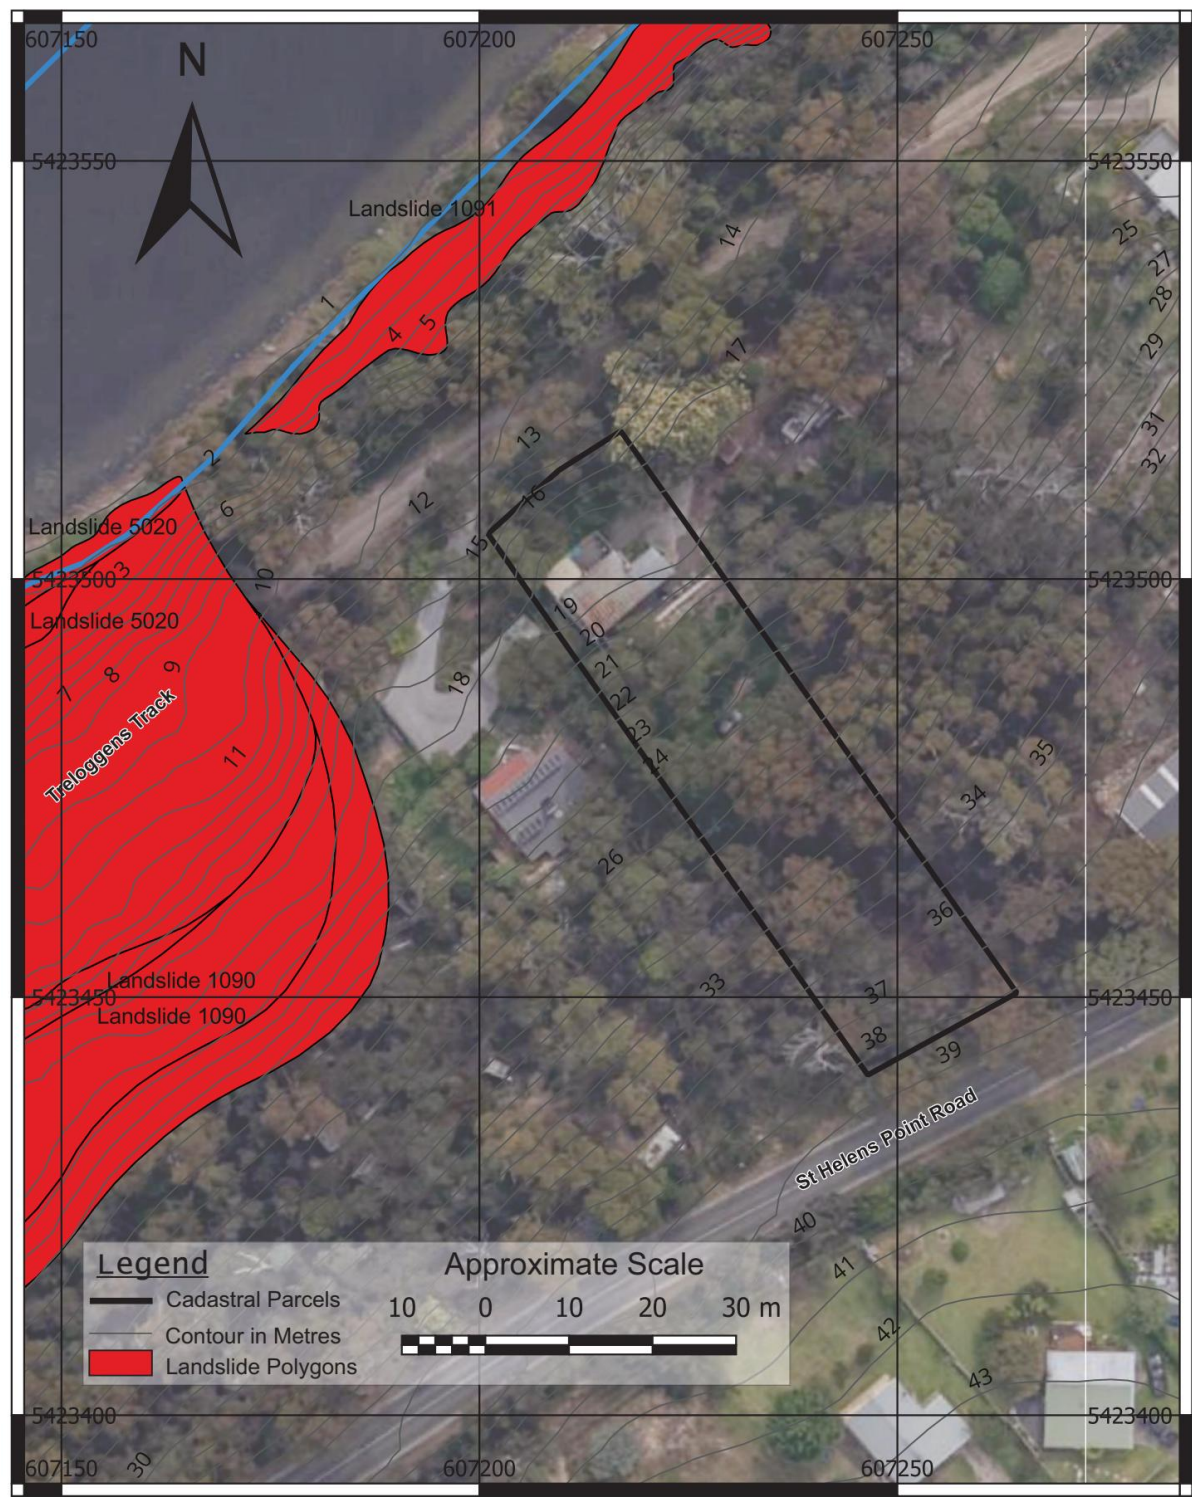
A small recent or active earth slide, Landslide ID. 1091, is located directly downslope from the northwest boundary of the site, downslope of Treloggens Track, along the shoreline. (refer to Figure 1 below).

Figure 1: MRT LIST Landslide Polygon of Tasmania overlayed within the vicinity of the site.

Examination of the MRT LIST Landslide Polygon overlay indicates that there are no known mapped landslide features within the site. A recent or active soil slide, with activity recorded prior to 1971 (Landslide ID No. 1090), is located 28m cross-slope from the south-western boundary of the site, with its affected area extending across property Nos. 23 to 31. A small recent or active earth slide, ID. 5020, is located within this feature along the shoreline.
