Final Report

Lower George River Investigation

Lower George Riverworks Trust

June 2018

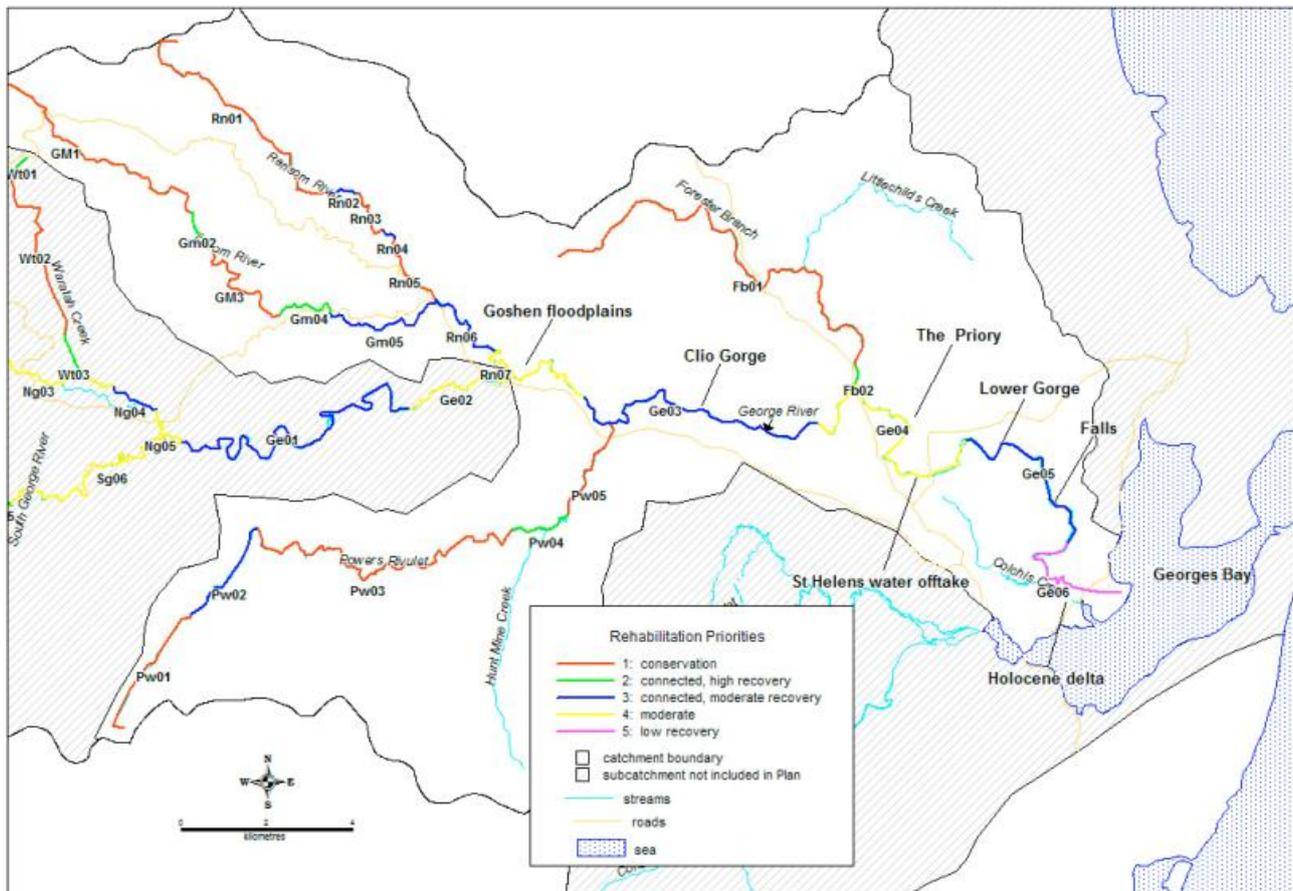
- A set of priority actions. The Lower George River, Rivercare Plan recommends prioritising works based on protecting 'excellent reaches' first to avoid these reaches becoming degraded. It is then recommended to prioritise reaches base on their recovery potential (Figure 4-1). This approach has been suggested as it takes less resources to protect and maintain the good reaches than it does to rehabilitate degraded reaches with a poor recovery potential. The Rivercare Plan identifies that the 'delta reach' of Georges River (the reach between the Lower Gorge and Georges Bay) as having a low recovery potential, and therefore being a low priority compared to other reaches (Figure 4-1).

FIGURE 4-1 REHABILITATION POTENTIALS (SPROD, 2003).

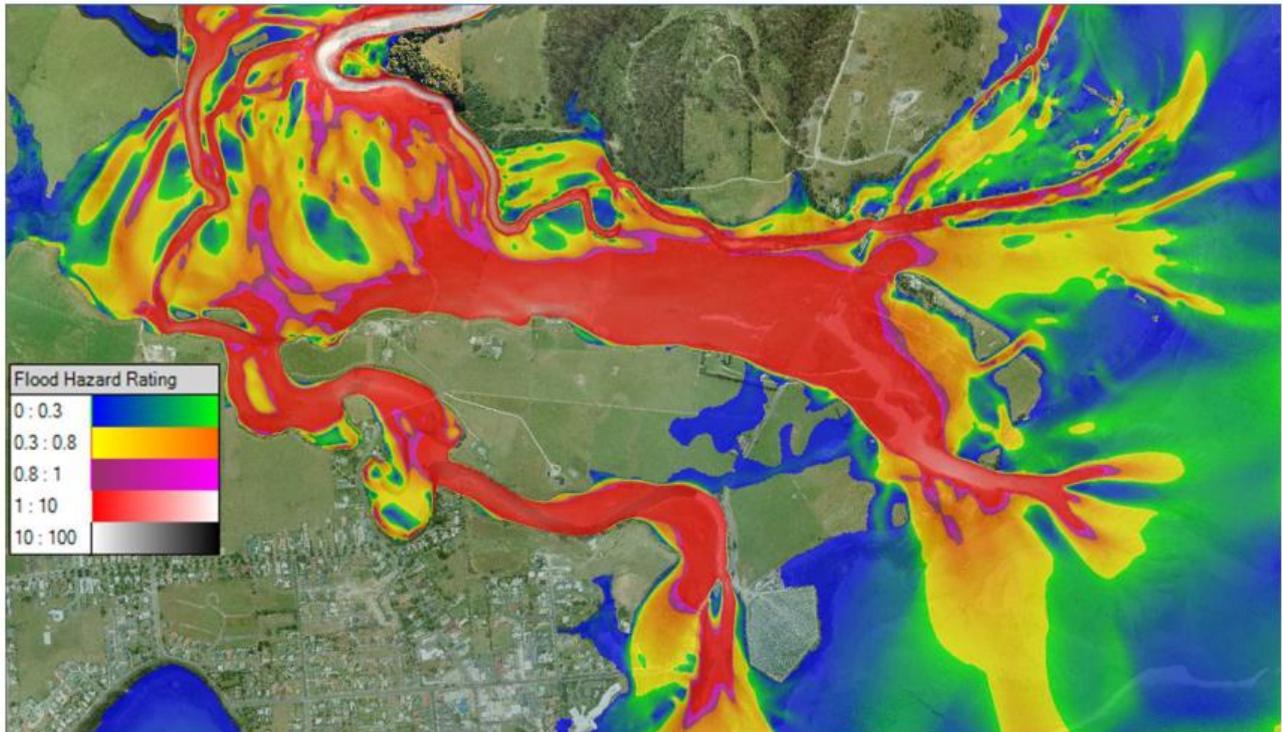
FIGURE 4-3 FLOOD HAZARD RATING FOR A 100 YEAR ARI EVENT UNDER EXISITNG CONDITIONS, WHERE FLOOD HAZARD IS THE FLOOD WATER DEPTH (M) MULITPLIED BY VELOCITY (M/S) (PITT & SHERRY, 2013)

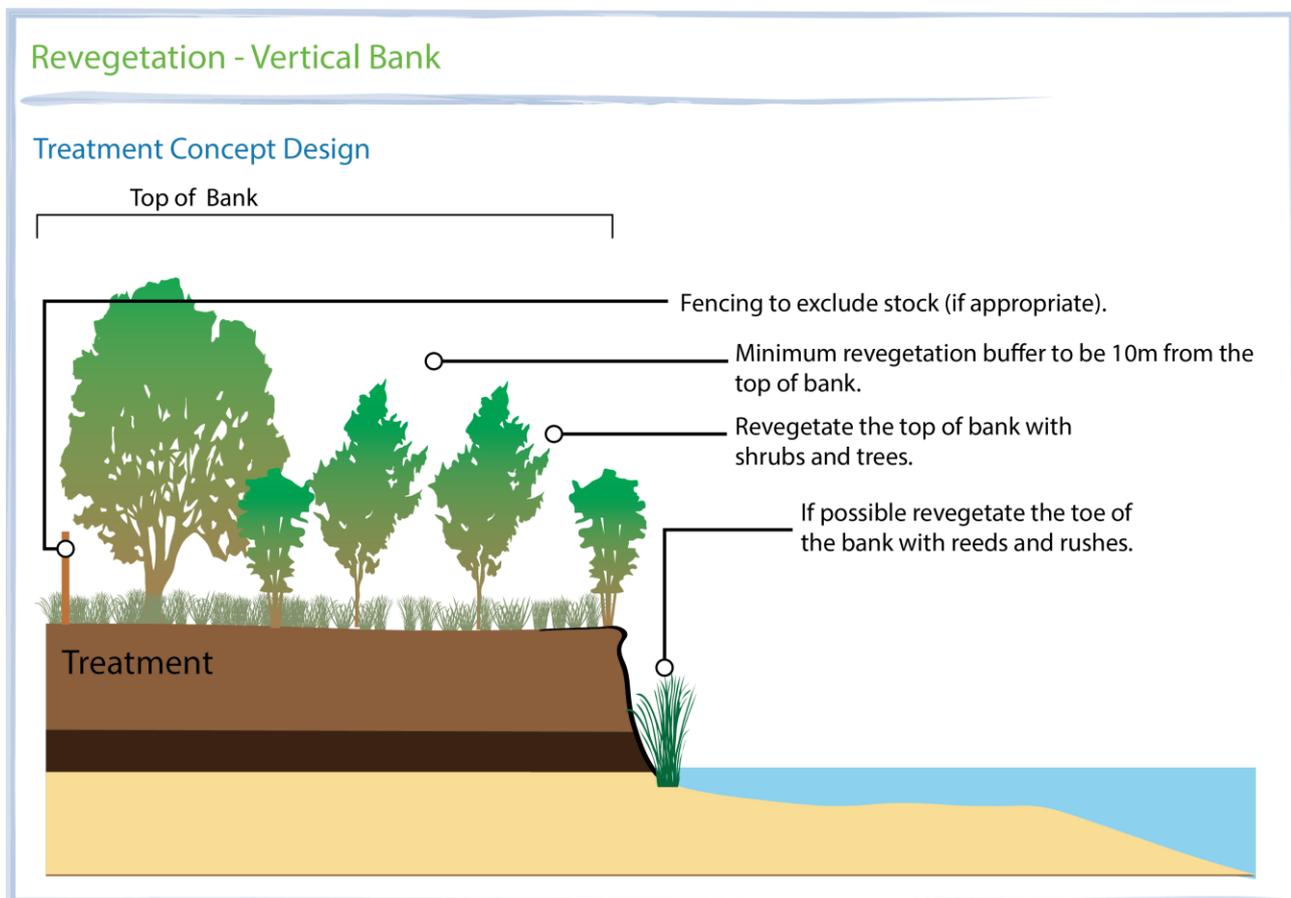
FIGURE 6-1 CONCEPT REVEGETATION ARRANGEMENT INVOLVING A VERTICAL BANK PROFILE.

Concept revegetation arrangements for both vertical bank profiles and sloped bank profiles are illustrated in Figure 6-1 and Figure 6-2 respectively.

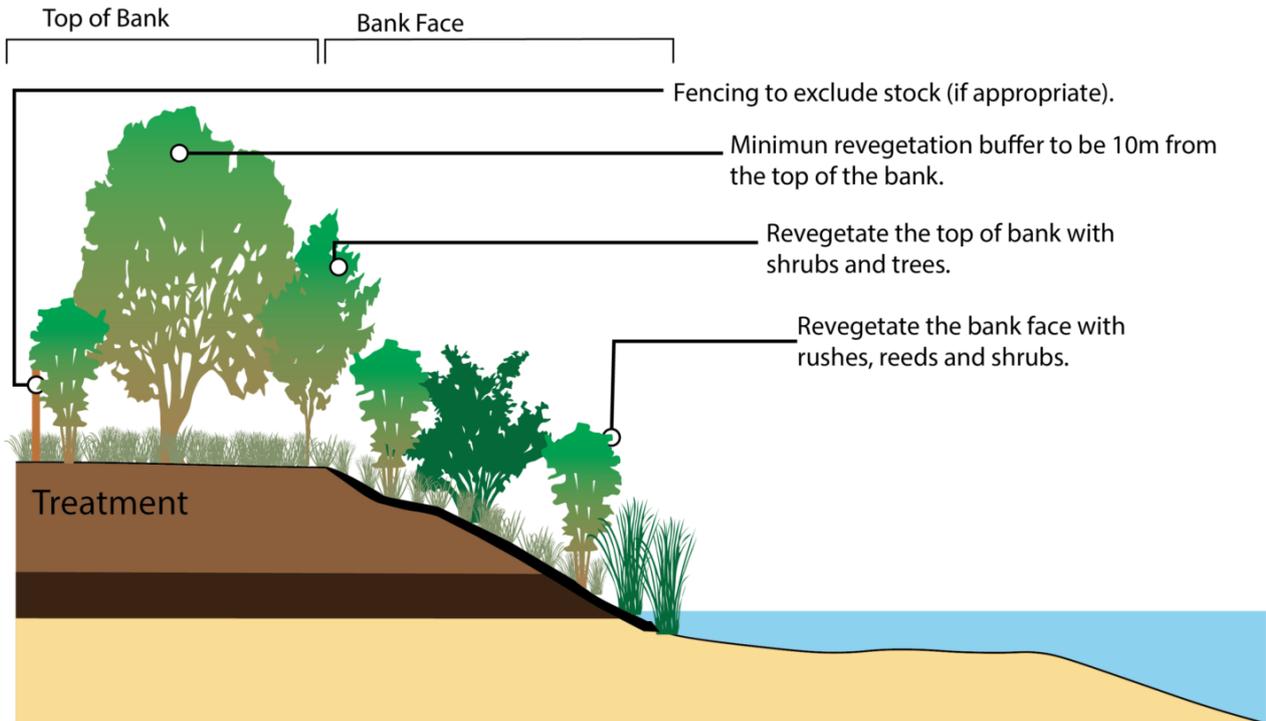
FIGURE 6-2 CONCEPT REVEGETATION ARRANGEMENT FOR A SLOPED BANK PROFILE.
