## **Development Applications**

| <b>Proposal</b> | Residential - Alterations to Existing Dwelling plus Construction of Detached Dwelling Extension and Garage/Workshop |
| <b>Location</b> | 77 St Helens Point Road, Stieglitz |

proposed dwelling alterations + outbuilding with  
unit as detached dwelling extension

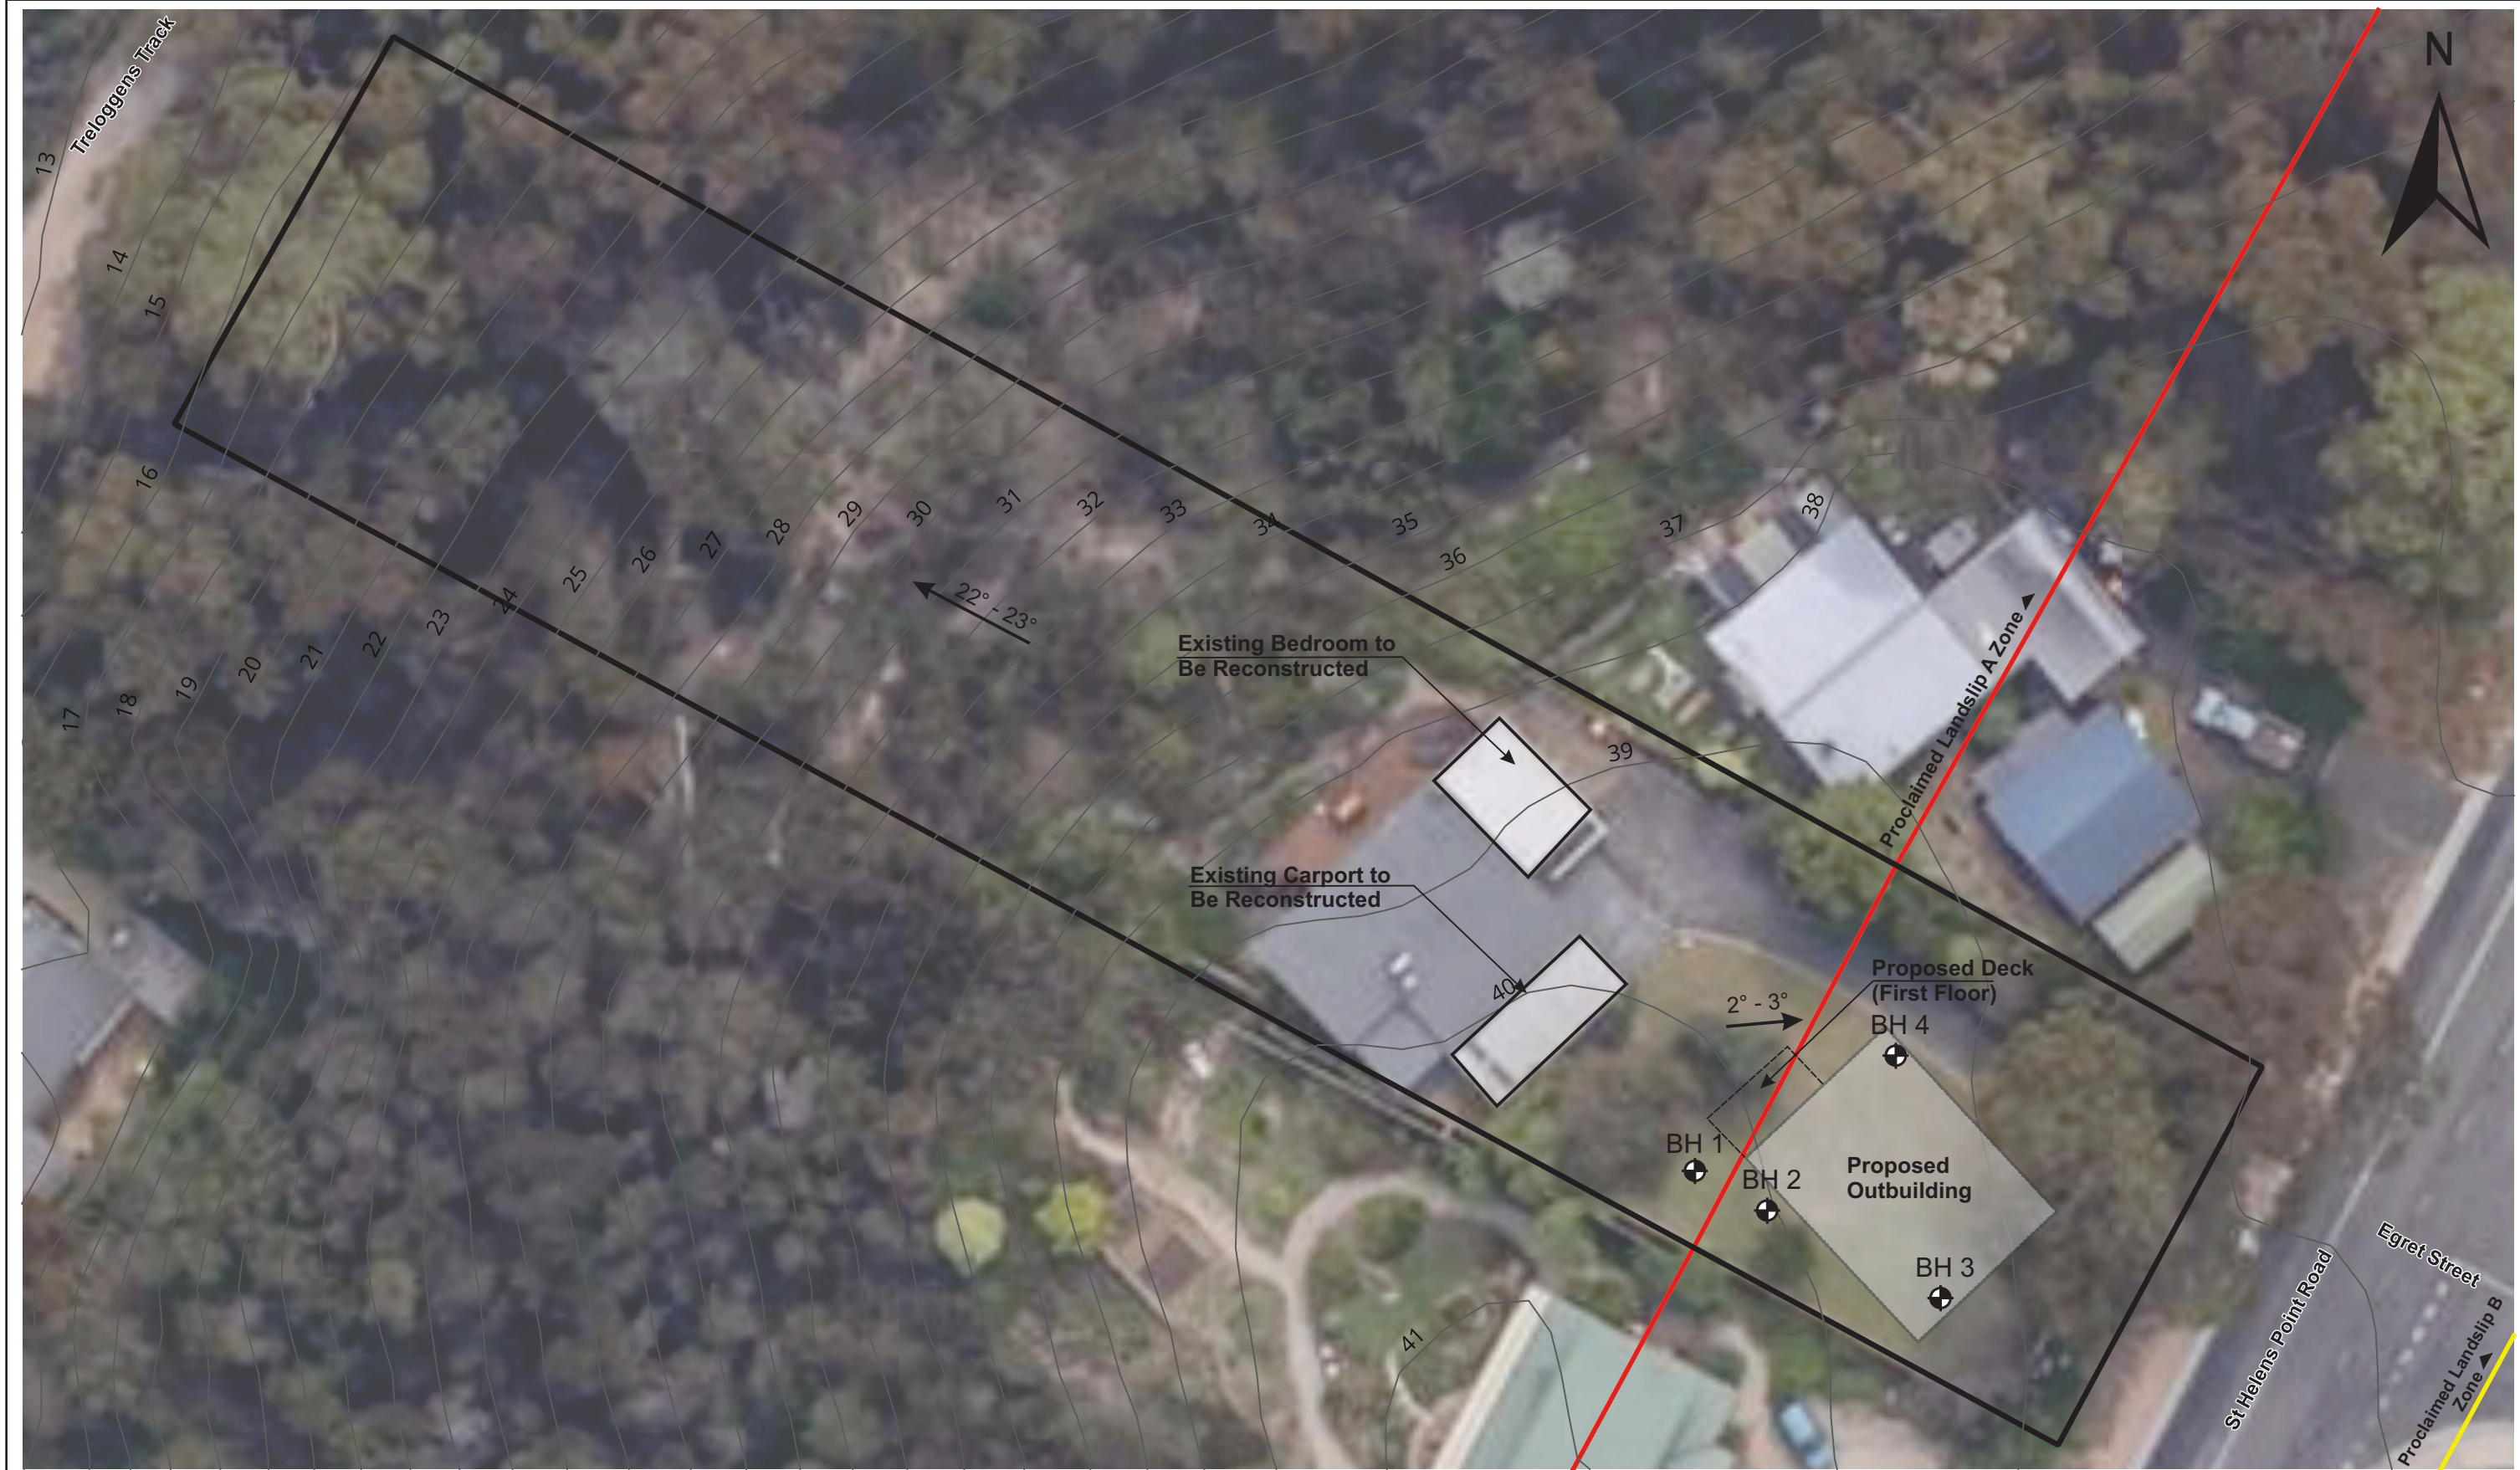
Figure 1: Site Plan

- BH 1  
● Approximate Borehole Location
- 5°  
→ Approximate Slope angle in Degrees
- Contour in Metres (LiDAR Derived)

We understand that the proposed development comprises a new outbuilding located within the front eastern portion of the site and within the Landslip B area, with alterations to the existing dwelling located further to the west within the Landslip A area (Figure 1).

The logs of the boreholes are included in Appendix A, with their locations shown on the site plan attached as Figure 1.

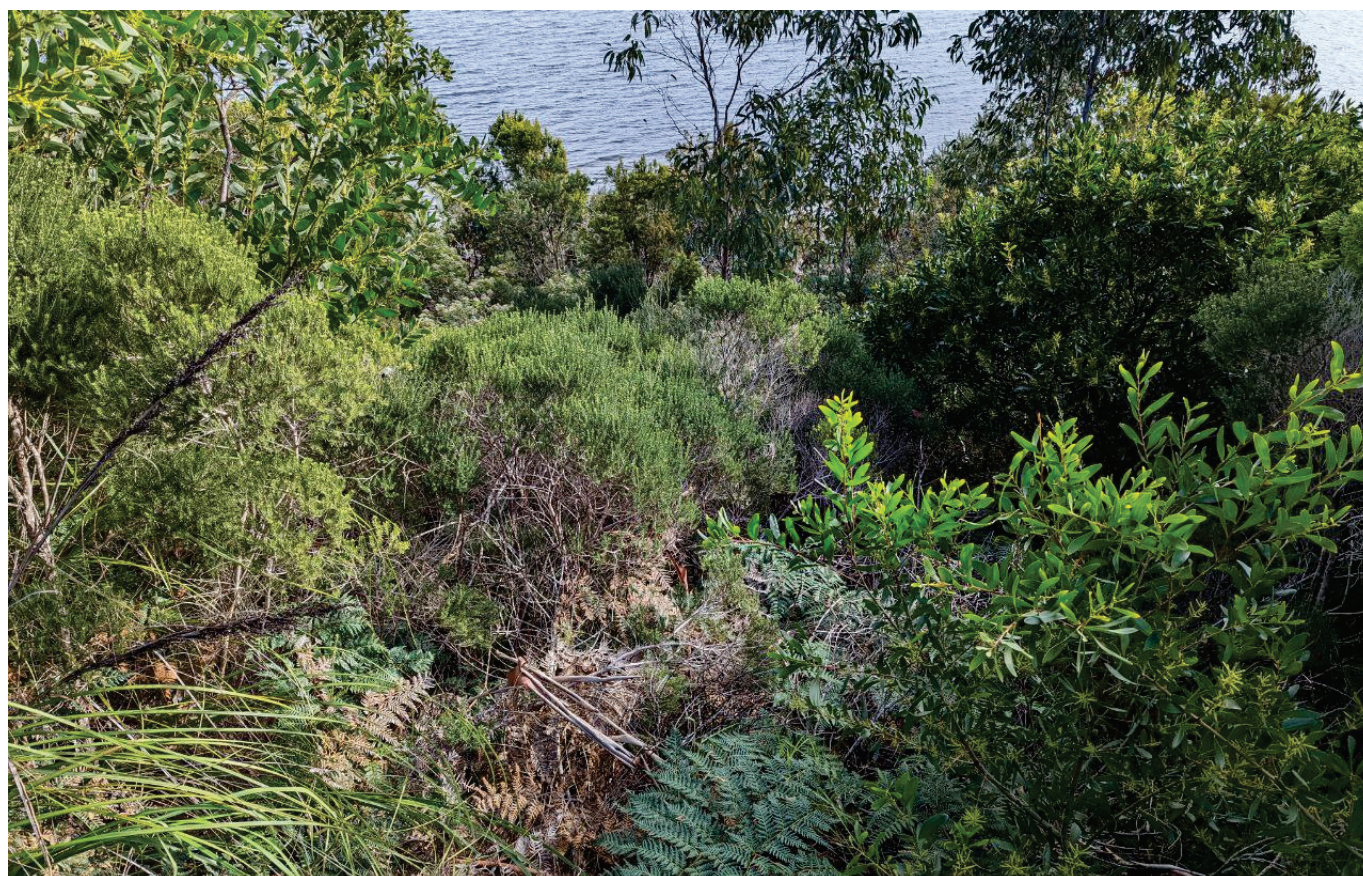
Plate 2 - View of the slope and vegetation downslope of the existing dwelling, looking to the northwest

surface falling steeply to the northwest towards the bay with typical slope angles of 22° to 23° (Plate 2).

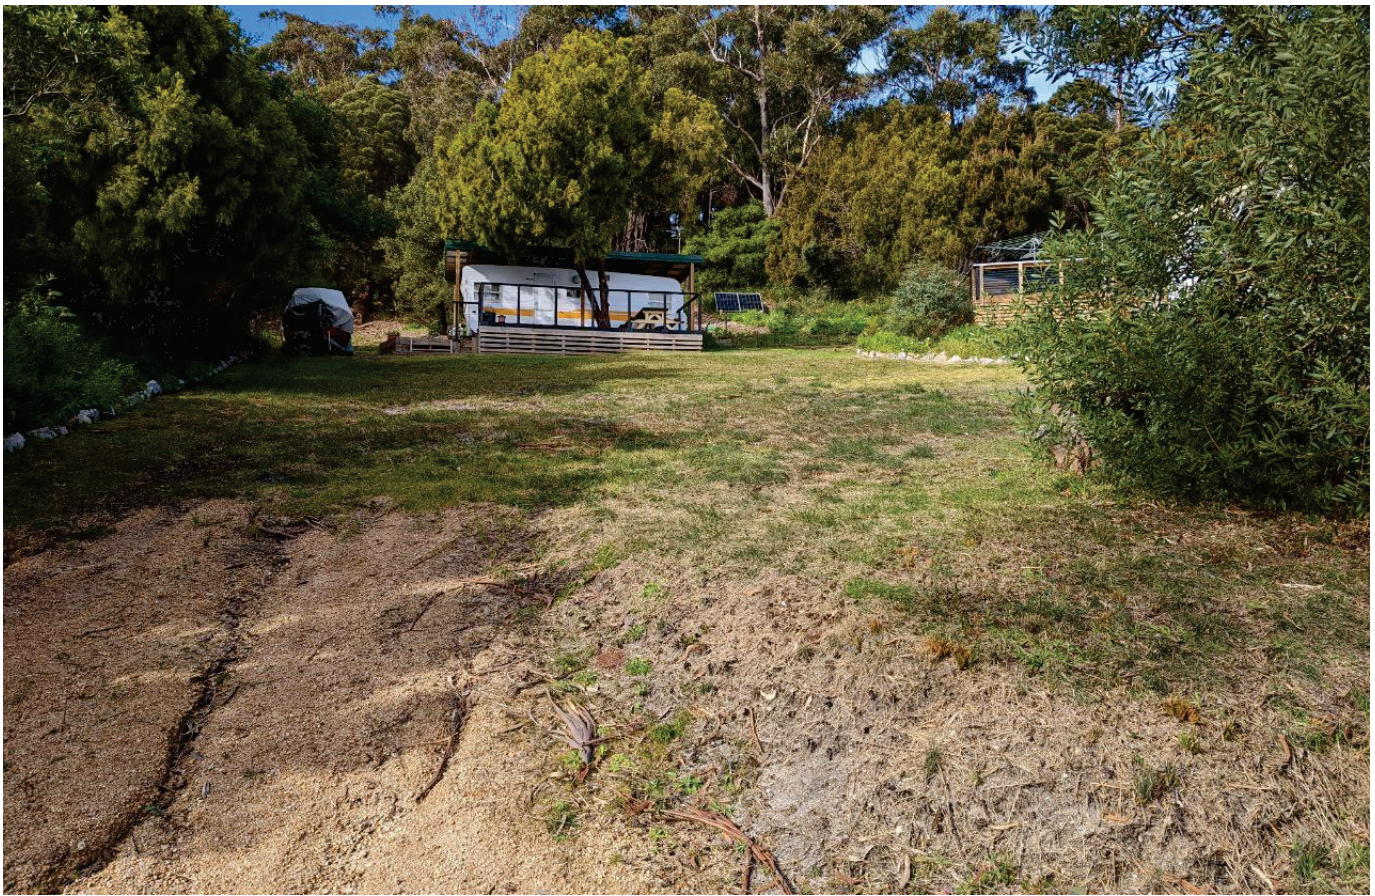
Plate 3 - Shallower slopes within affected area of the landslide ID 5080, immediately to the northwest of the site

The ground surface within the affected area of Landslide ID 5080 to the northwest of the site has a more gradual slope angle of 13° to 14° (Plate 3) due to the past downslope movement.

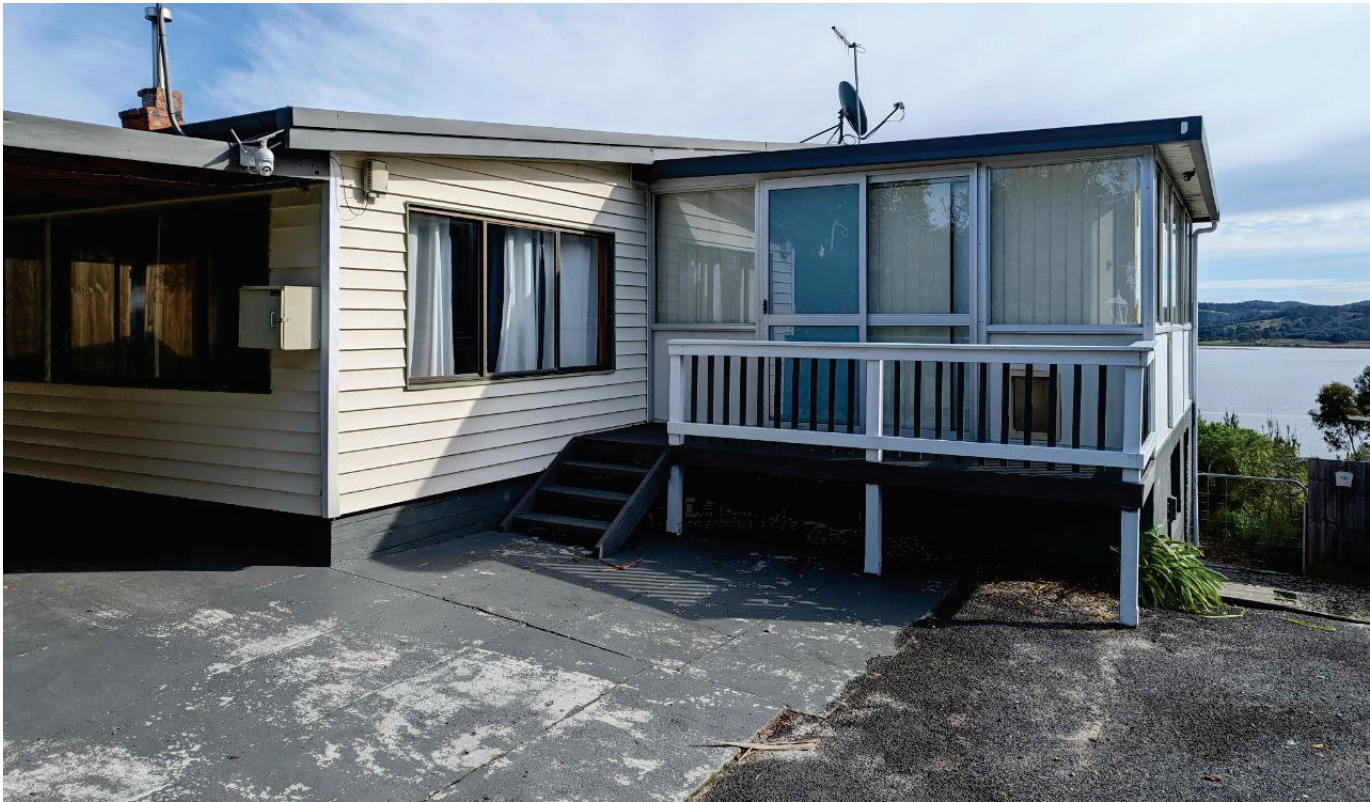
Plate 4 - View of the existing dwelling looking to the east

The existing light-clad dwelling is generally in good condition, showing no obvious signs of damage (Plate 4).
