Our Ref: 244026 L24-06-24 Rev.A

BODC - STRUCTURAL ASSESSMENT - ST MARYS RECREATION GROUND - HAREFIELD RD, ST MARYS

PHOTOGRAPHIC SURVEY

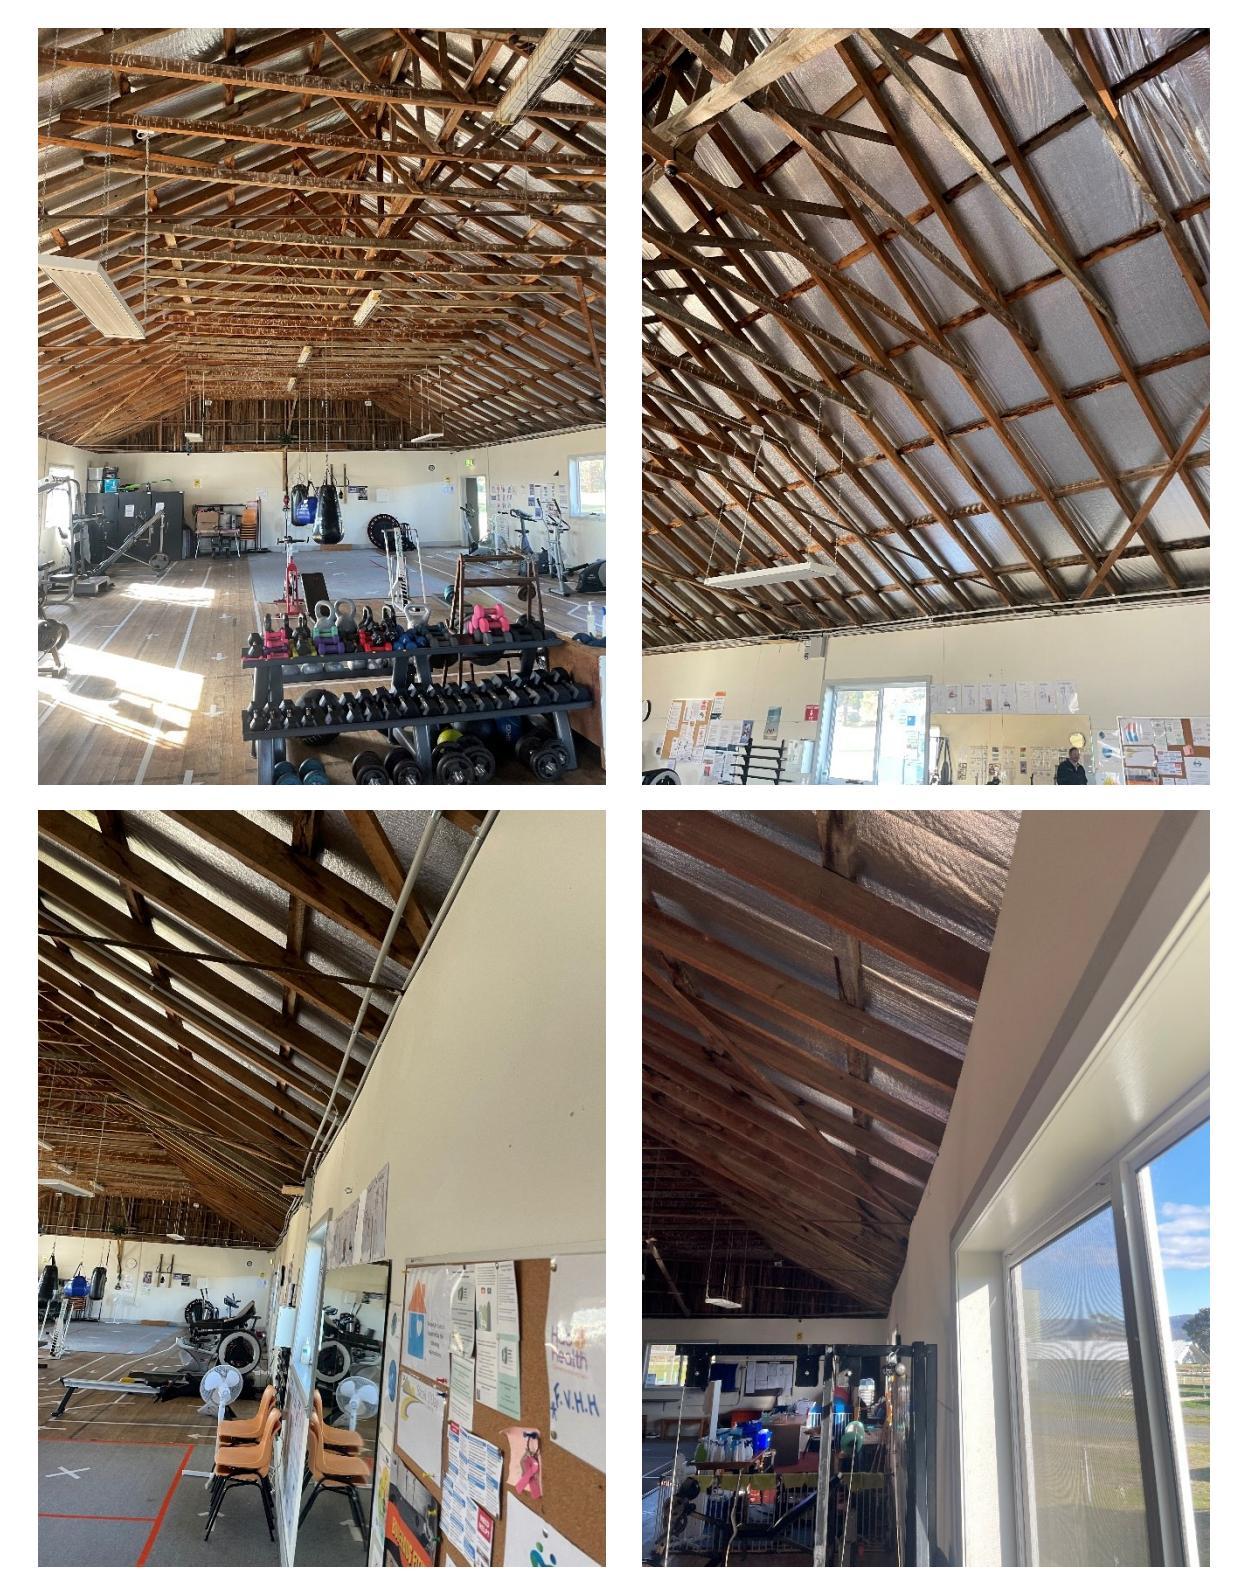
- Major displacement and outward bowing of external walls between steel tie rods.
- Deflection of roof sheet.
- External downpipe cut off right at building corner resulting in ponding water.
- Water stains to end wall interior cladding, due to potential water ingress or roof condensation.

Wall and roof damage has largely been caused by long term timber sagging related to the age of the material, and wind load damage due to insufficient bracing.

- Given the outward bowing of the external walls, the roof structure in current condition would not be capable of supporting any additional ceiling, insulation or services.
- Reinstate top plate in accordance with AS1684.
- Install additional proprietary 16mm Reidbraces in between existing steel tie rods to limit displacement.
- Bird proof.
